# 11th Month Home Inspection Report

**137 Green Wood Circle**

Ally Property Inspections

1122171

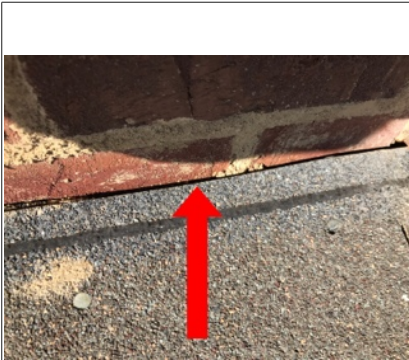
Flashing does not appear to be installed between the roofing and brick on the left side of the lower front shed roofs. Recommend repair by qualified roofer.

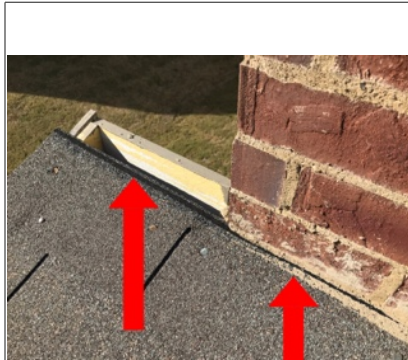
Flashing does not appear to be installed between the roofing and brick on the left side of the lower front shed roofs. Recommend repair by qualified roofer.

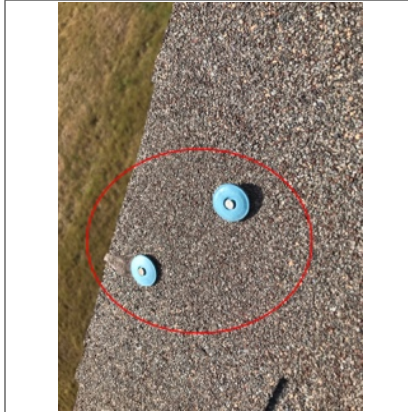
Recommend removing the nails from the front left shed roof and repairing the holes. Recommend repair by qualified roofer.

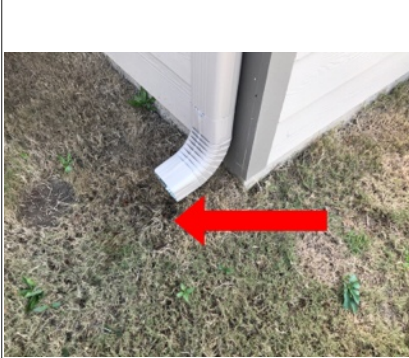
Recommend installing splash blocks underneath all down spouts.

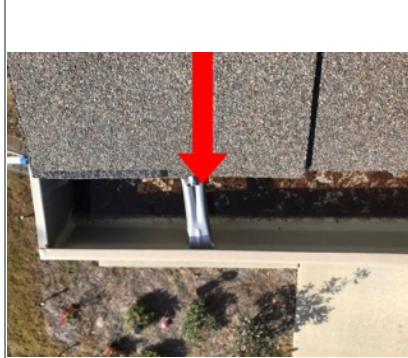
The gutter above the garage is holding water. Recommend repair by qualified gutter contractor.

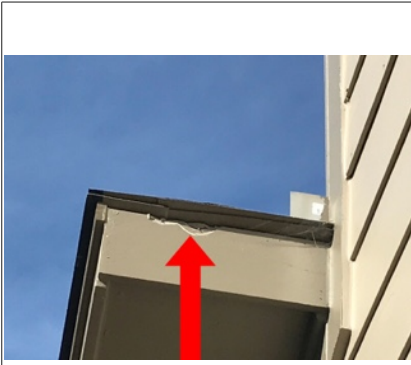
There is minor damage to the lower fascia on the left rear side of the house. Recommend repair by qualified carpenter.

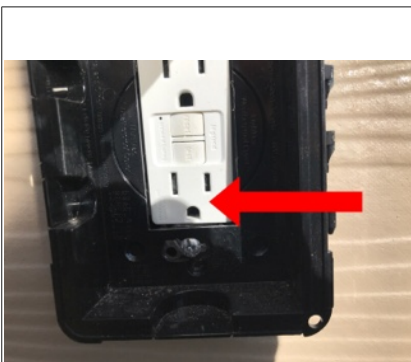
The bottom of the electrical receptacle on the left side of the house is loose. Recommend repair by qualified electrician.

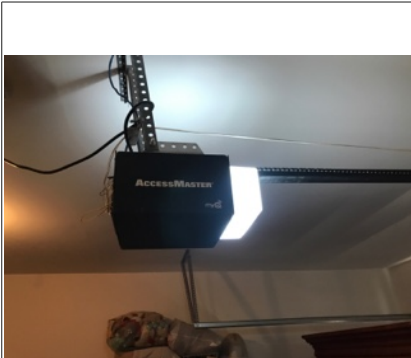
**Operation**  Not Operable  Safety hazard  Photo eyes and pressure reverse tested

The safety reverse is not operating properly on the overhead door opener. Recommend repair by qualified overhead door technician.

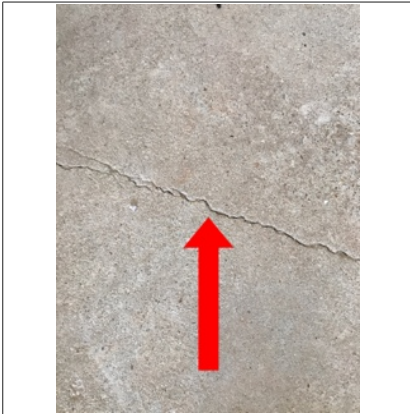
Typical cracks in garage floor. No action recommend.

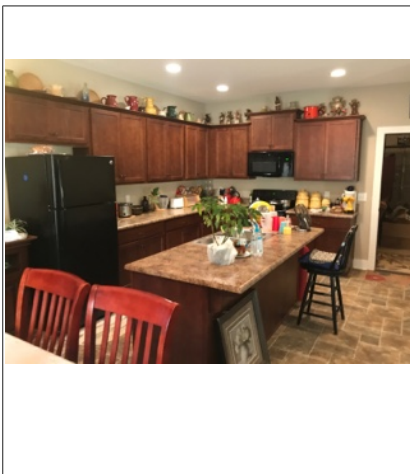
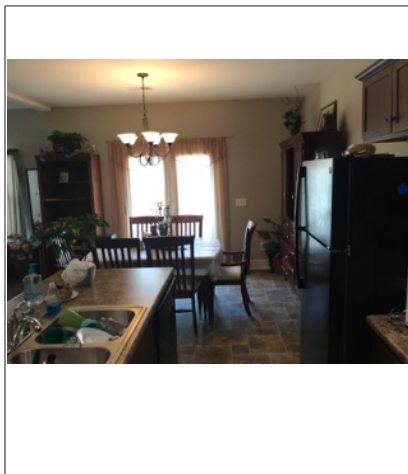
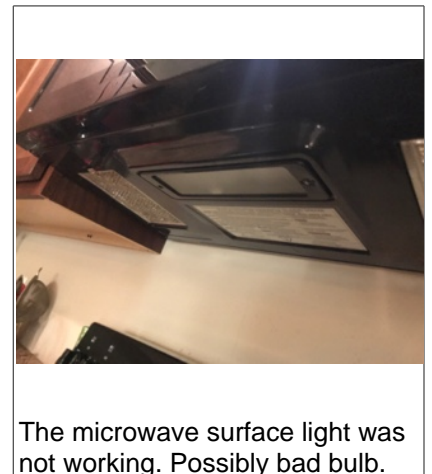
The microwave surface light was not working. Possibly bad bulb.

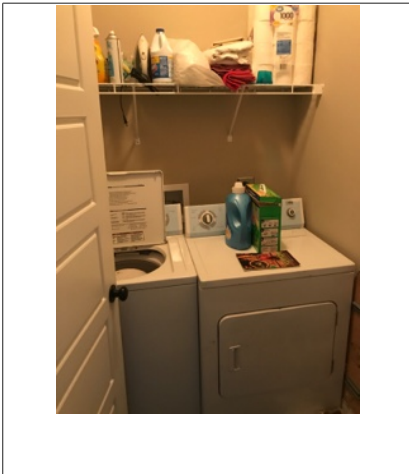
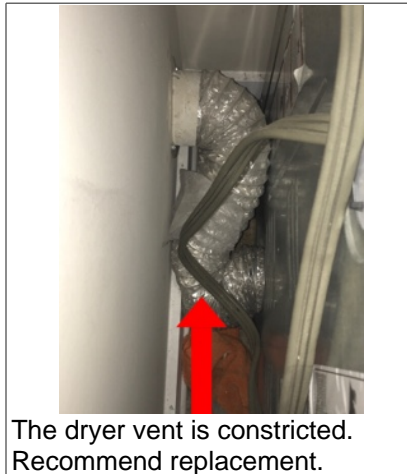
The dryer vent is constricted.  
Recommend replacement.

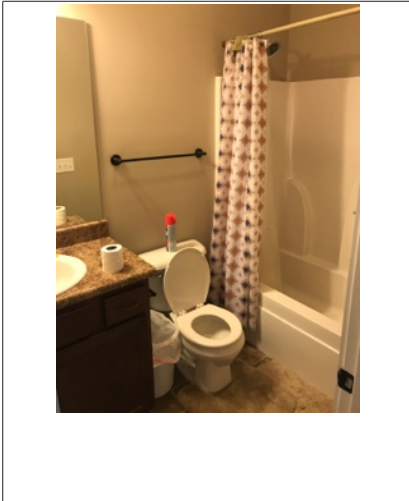
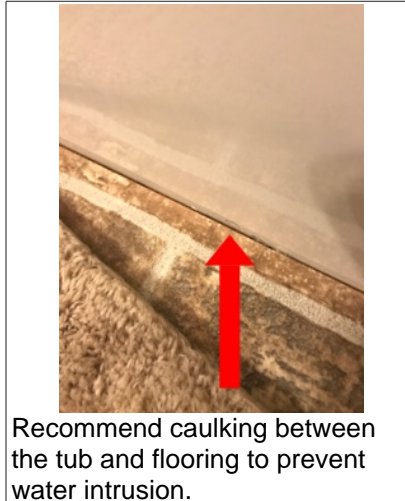
Recommend caulking between the tub and flooring to prevent water intrusion.

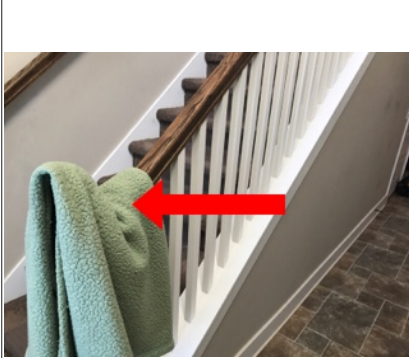
The lower stairs balustrade is loose. Recommend repair by qualified carpenter.

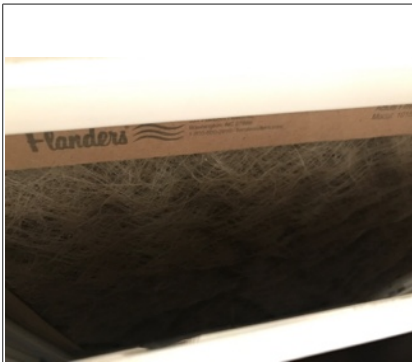
Recommend replacing the air filters.

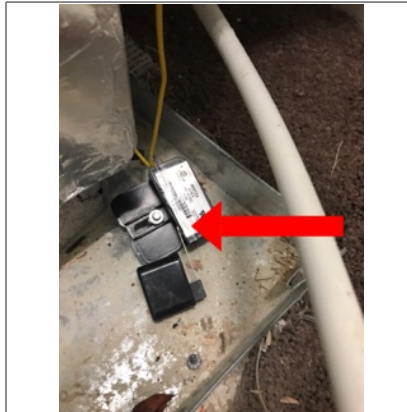
The overflow switch is disconnected from the pan on system one. Recommend repair by qualified HVAC technician.
