Annual Home Maintenance Inspection Report

Woodbury Dr, Sterrett , AL 35147

Friday, October 9, 2020

Ally Property Inspections
P O Box 43302
Vestavia, AL 35243
2056070031

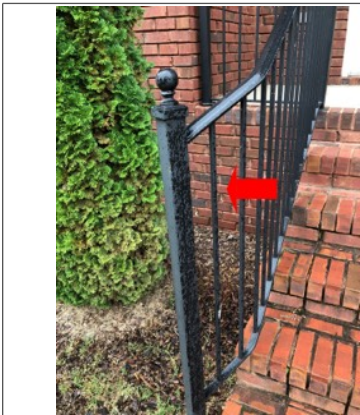
The front porch handrails are loose. Recommend repair by a qualified contractor.

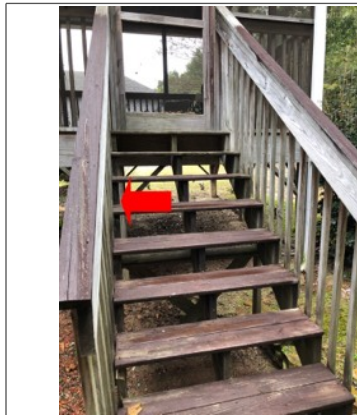
The handrails for the rear deck steps are loose. Recommend repair by a qualified carpenter.

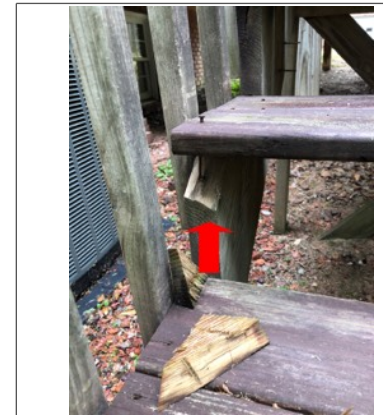
The rear deck steps stringers are split. Recommend repair by a qualified carpenter.

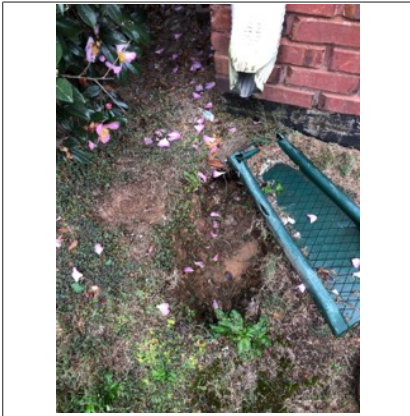
Negative Grade Recommend additional backfill

There is erosion occurring on the left side below the gutter downspout.

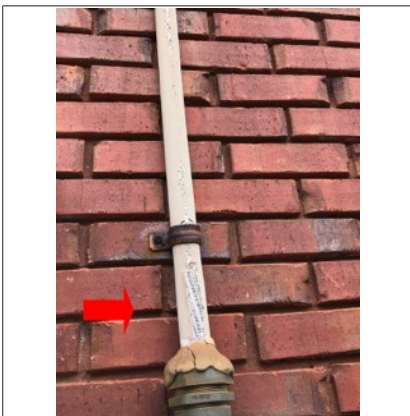
The electrical service entry cable outer sheathing is starting to deteriorate. Recommend evaluation by a qualified electrician.

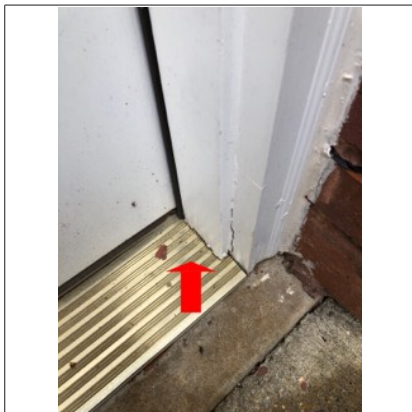
Condition Damaged/Rusted

There is moisture damage starting to occur on the garage exterior door frame. Recommend evaluation/ repair by a qualified carpenter.

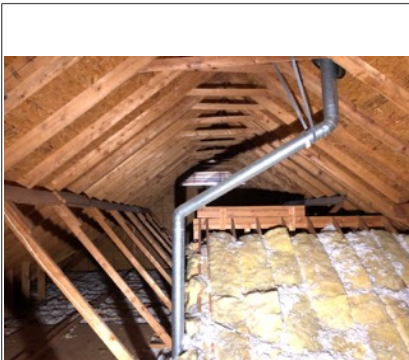
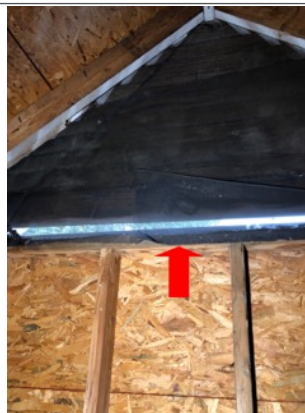
There are bats in the attic.
Recommend evaluation by a
qualified pest removal contractor.
