## Commerical Inspection Report

**3870 Cascade Rd, Atlanta, GA 30331**

Monday, September 21, 2020

921201

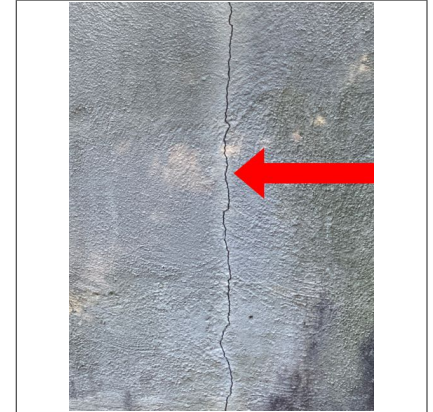
The concrete below the gable on the rear left side of the building was damaged. Recommend repair by qualified brick mason.

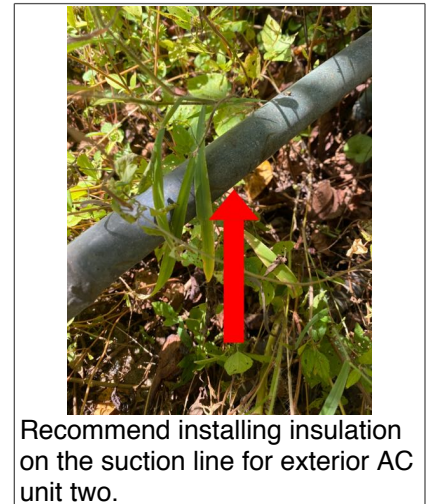
Recommend installing insulation on the suction line for exterior AC unit two.

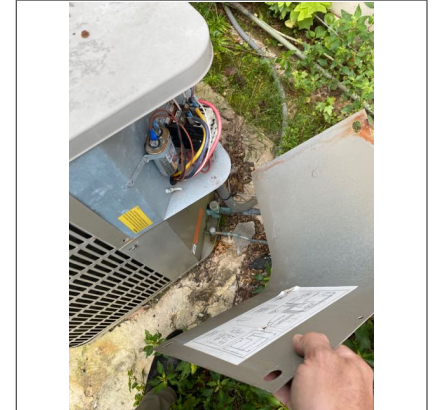
Recommend mechanically fastening the rear cover to exterior AC unit three

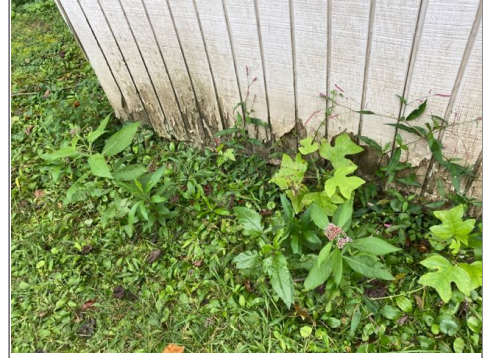
The rear left garage was in overall poor condition.

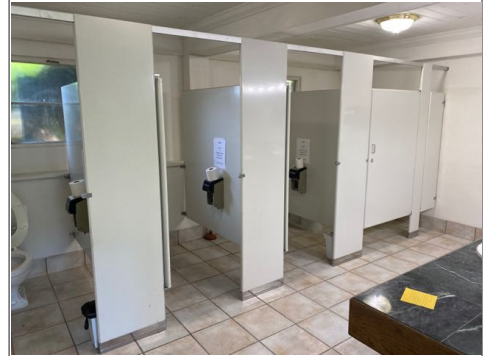
The electrical receptacles in the women's restroom were loose. Recommend repair by qualified electrician.

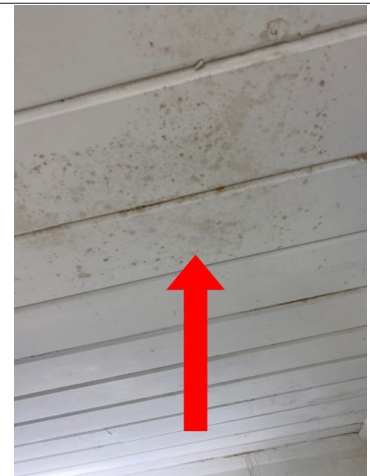
There was possible fungal growth on the ceiling in the men's restroom. Recommend evaluation/repair by mold remediation specialist.

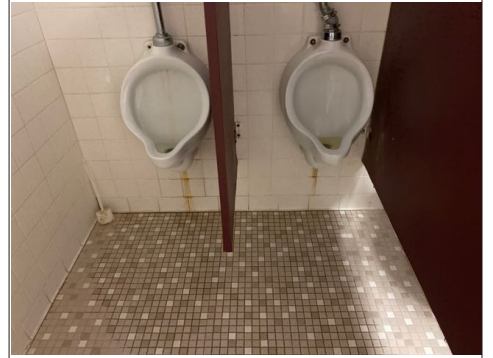
Both of the urinals in the men's bathroom were leaking. Recommend repair by qualified plumber.

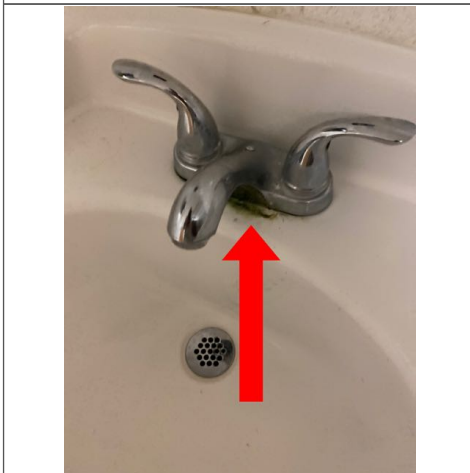
The left sink faucet in the men's bathroom was not securely attached. Recommend repair by qualified plumber.

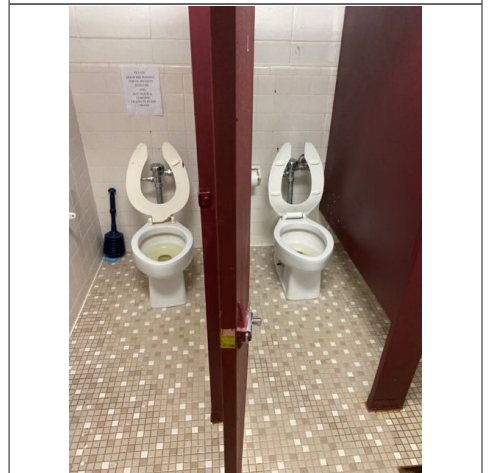
The toilets in the women's bathroom were not securely attached to the floor. Recommend repair by qualified plumber.

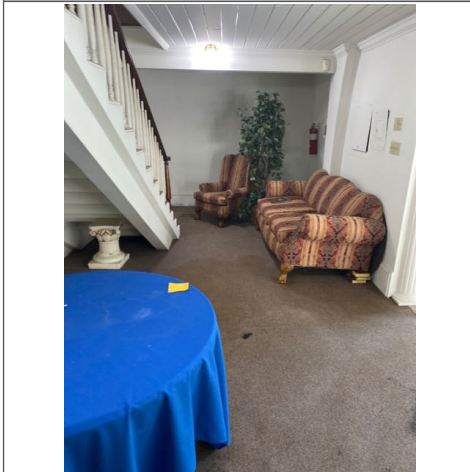
1. There was active moisture damage at the bottom of the rear walls in the front foyer. Recommend repair by qualified contractor.
2. There was active moisture damage on the ceiling between the front entry and stairwell. Recommend repair by qualified contractor after the roof leaks are repaired.

There was active moisture damage at the bottom of the rear walls in the front foyer. Recommend repair by qualified contractor.

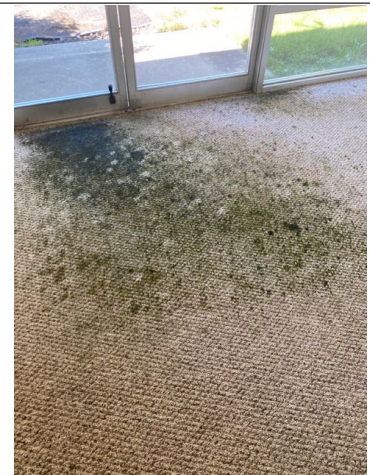
1. There was possible fungal growth on the flooring in front of the main entry doors. Recommend evaluation/repair by mold remediation specialist.
2. There was possible fungal growth on the floors in many areas in the sanctuary. Recommend evaluation/repair by mold remediation specialist.

There was possible fungal growth on the flooring in front of the main entry doors. Recommend evaluation/repair by mold remediation specialist.

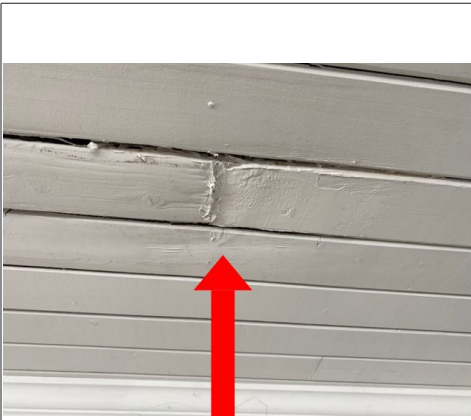
There was old moisture damage on the ceilings in several areas.

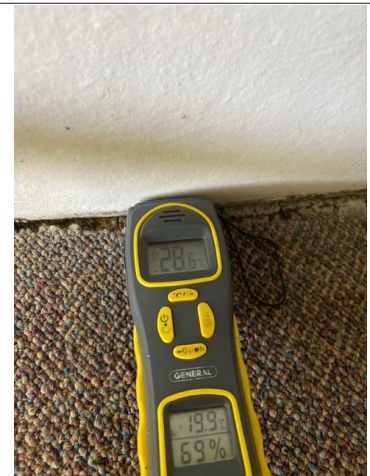
3. There was active moisture damage on the baseboards throughout the stairwell. Recommend repair by qualified contractor.
4. The moisture content was elevated in the walls below the windows in the chapel. Recommend repair by qualified contractor.
5. There was active moisture intrusion in the rear right corner of the building. Recommend repair by qualified contractor.
6. The moisture content was elevated in the walls below the windows in the police department. Recommend repair by qualified contractor.

There was active moisture damage on the baseboards throughout the stairwell. Recommend repair by qualified contractor.

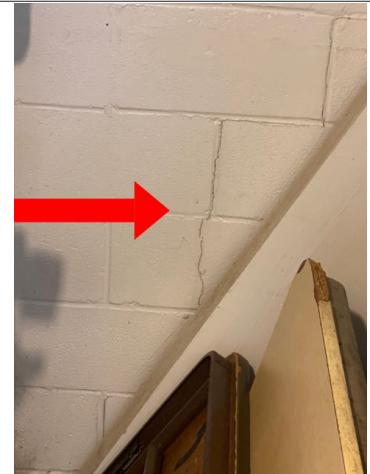
There was a minor vertical crack in the wall in the rear left side of the sanctuary. No action recommended.

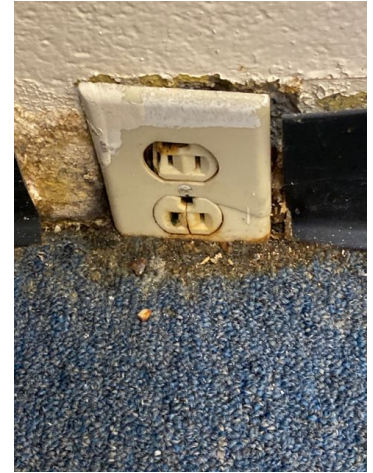
1. The electrical receptacle on the right side of the front wall was damaged. Recommend repair by qualified electrician.

The electrical receptacle on the right side of the front wall was damaged. Recommend repair by qualified electrician.

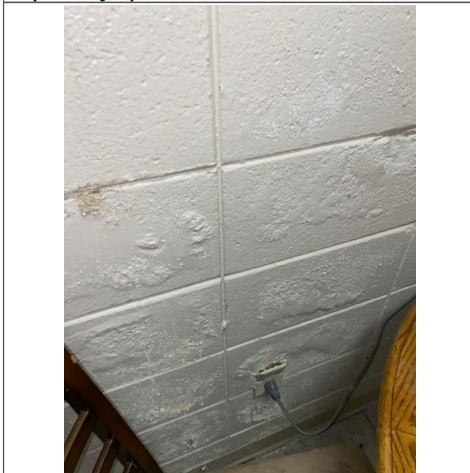
There were moisture stains on the left walls in several areas and the moisture content was elevated. Recommend repair by qualified contractor.

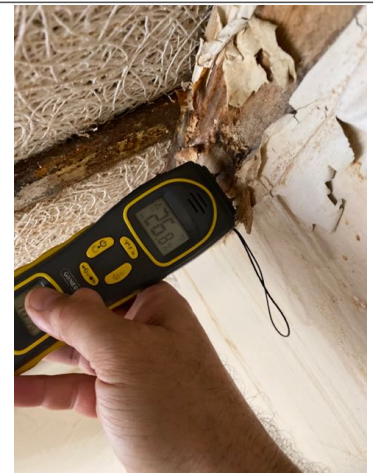
There was active moisture damage on the right beam in the bookstore. Recommend evaluation/repair by qualified contractor.

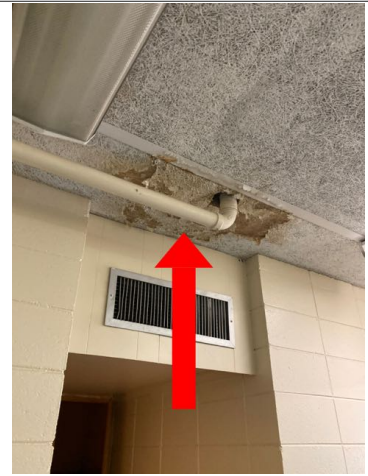
There was active moisture damage on the ceilings throughout the building. Recommend repair by qualified contractor.

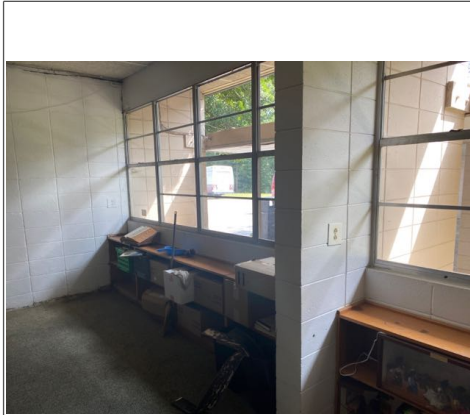
The front electrical receptacles on the left wall of the library we're not working. Recommend repair by qualified electrician.

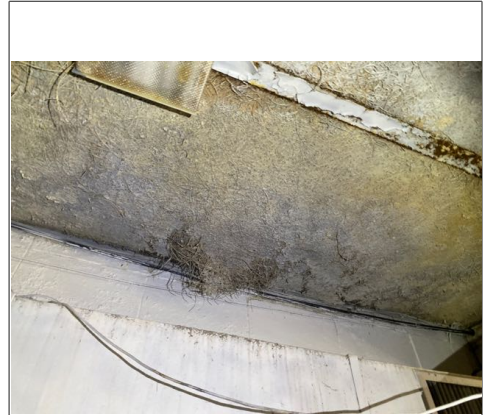
There was active moisture damage on the ceiling and walls in the front of the library. Recommend repair by qualified contractor after the roof is repaired.

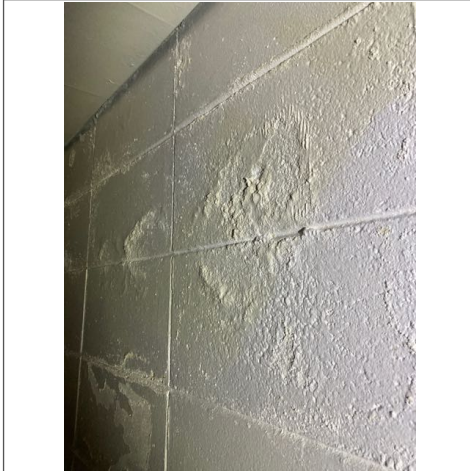
There was active moisture damage on the ceiling and walls in the front of the library. Recommend repair by qualified contractor after the roof is repaired.

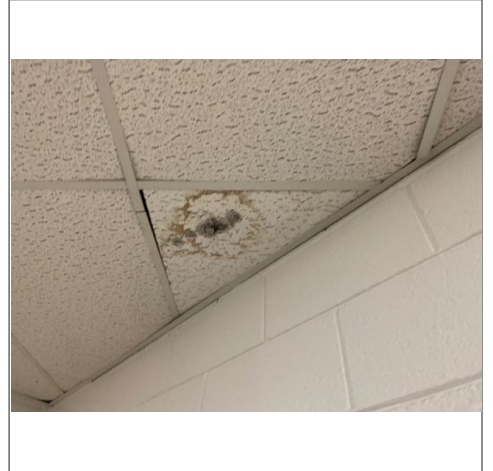
There was active moisture damage on the ceilings throughout the building. Recommend repair by qualified contractor after the roof is repaired.

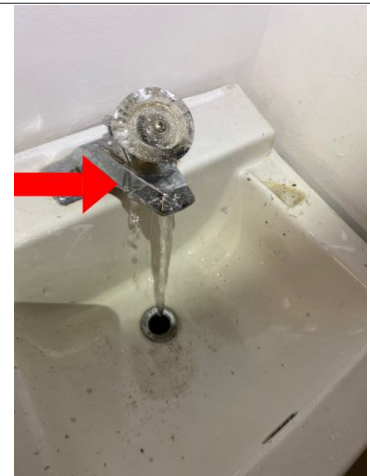
The sink faucet was leaking in the upper front right room. Recommend repair by qualified plumber.

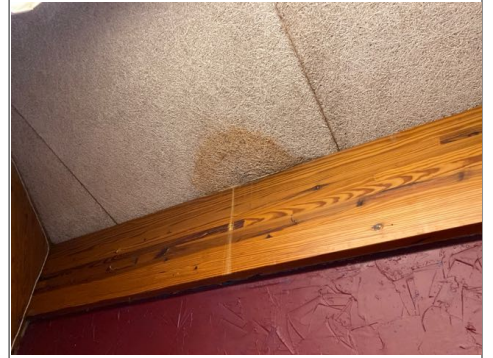
1. There were several moisture stains on the ceiling and the moisture content was elevated. Recommend repair by qualified contractor.

There were several moisture stains on the ceiling and the moisture content was elevated. Recommend repair by qualified contractor.

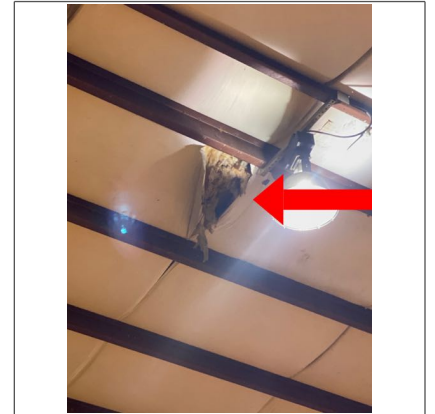
1. The ceiling insulation was damaged in several areas and there were moisture stains present. Recommend repair by qualified contractor after the roof leaks are repaired.

The ceiling insulation was damaged in several areas and there were moisture stains present. Recommend repair by qualified contractor after the roof leaks are repaired.

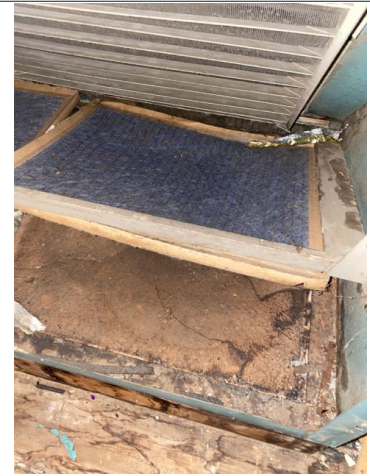
There was heavy corrosion inside furnace four. Recommend evaluation by qualified HVAC technician.

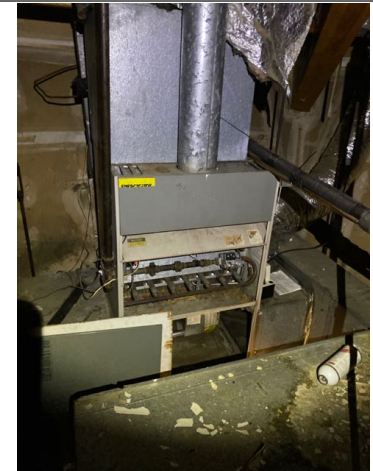
There was heavy corrosion inside furnace two. Recommend evaluation/repair by qualified HVAC technician.

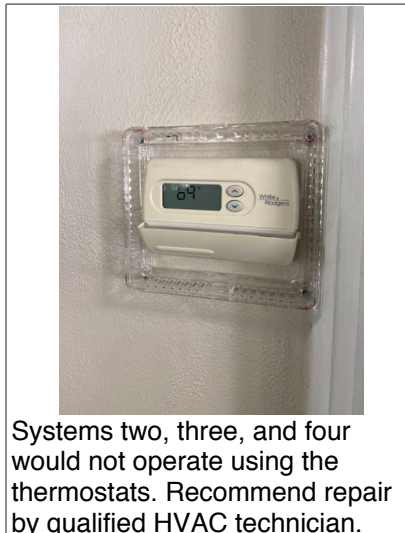
1. Systems two, three, and four would not operate using the thermostats. Recommend repair by qualified HVAC technician.

Systems two, three, and four would not operate using the thermostats. Recommend repair by qualified HVAC technician.

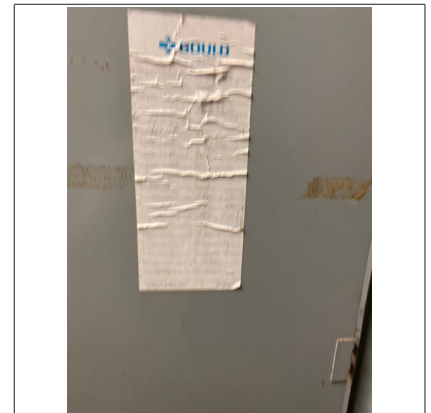
A breaker filler plate was missing in the lower right side of electrical sub panel one. Recommend repair by qualified electrician.

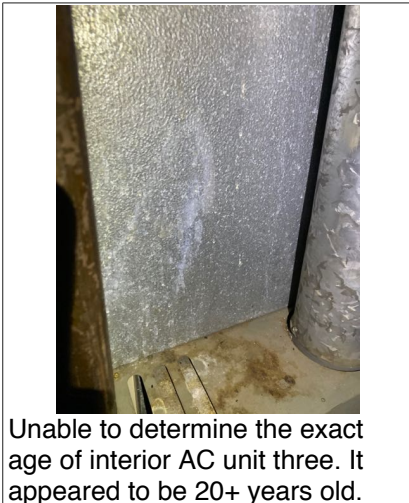
Unable to determine the exact age of interior AC unit three. It appeared to be 20+ years old.
