Investor Inspection Report

Fulmar Dr, Irondale , Alabama 35210

Inspection Date: Tuesday,
February 11, 2020

Report Number:
211201

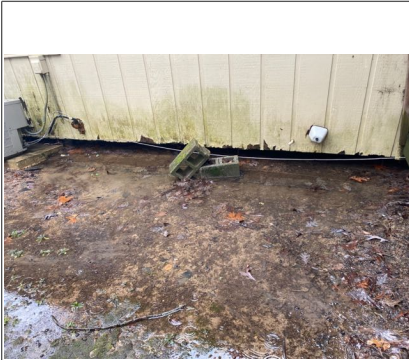
There was standing water on the rear side of the building due to improper grading. Recommend repair by qualified contractor.

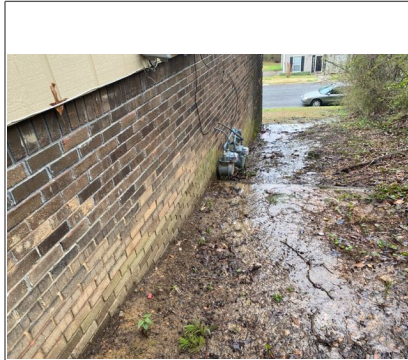
There was standing water on the left side of the building due to improper grading. Recommend repair by qualified contractor.

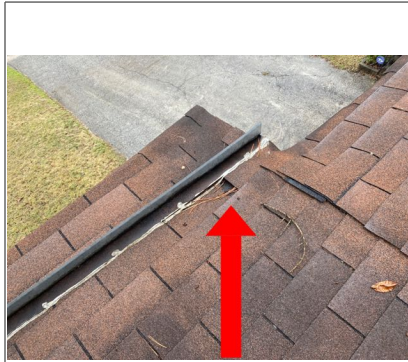
1. There was moisture damage on the left side of the porch roof for 4928 and the shingle was damaged. Recommend repair by qualified roofer.

There was moisture damage on the left side of the porch roof for 4928 and the shingle was damaged. Recommend repair by qualified roofer.

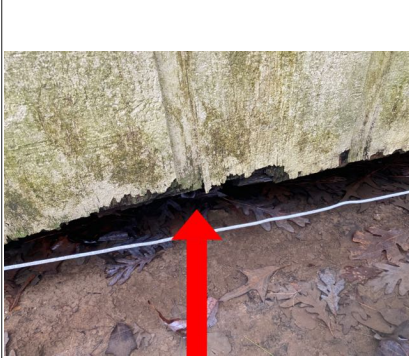
1. There was moisture damage in many areas on the wooden portions of the exterior on the front and rear sides of the building. Recommend repair by qualified carpenter.

There was moisture damage on the siding and trim in many areas on the rear side of the building. Recommend repair by qualified carpenter.

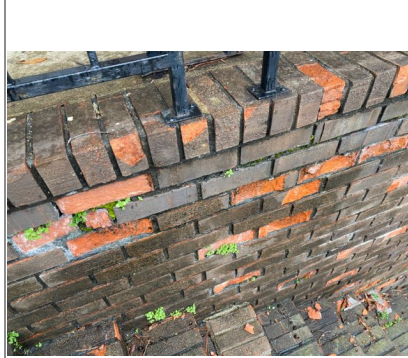
2. Brick spalling was occurring in many areas around the front porches, and the brick mortar needed to be repointed in several areas. Recommend repair by qualified brick mason.

Brick spalling was occurring in many areas around the front porches, and the brick mortar needed to be repointed in several areas. Recommend repair by qualified brick mason.

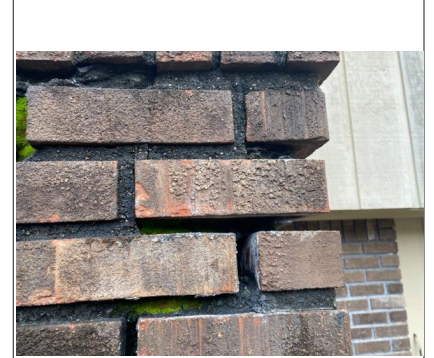
Brick spalling was occurring in many areas around the front porches, and the brick mortar needed to be repointed in several areas. Recommend repair by qualified brick mason.

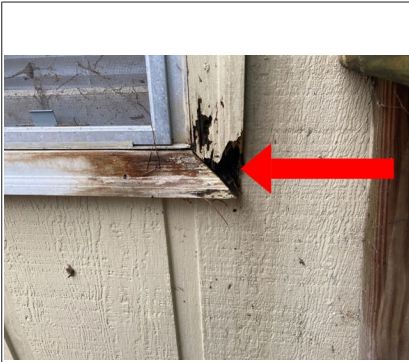
There was moisture damage on the siding and trim in many areas on the rear side of the building. Recommend repair by qualified carpenter.

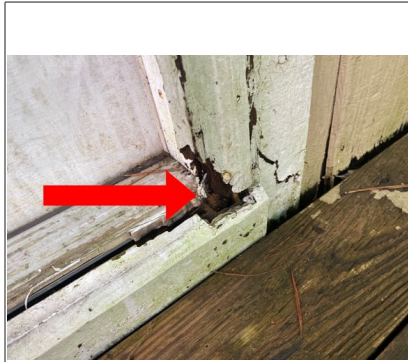
There was moisture damage on the siding and trim in many areas on the rear side of the building. Recommend repair by qualified carpenter.

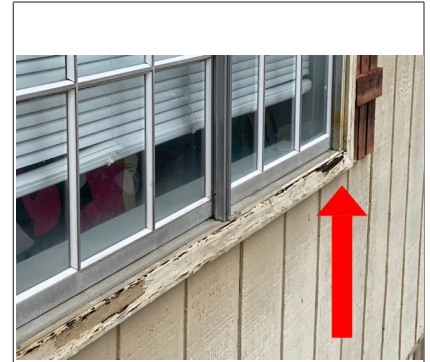
There was moisture damage on the soffit and window trim on the front side of the house. Recommend repair by qualified carpenter.

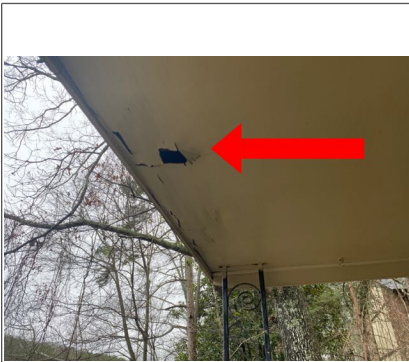
There was moisture damage on the soffit and trim on the front side of the building. Recommend repair by qualified carpenter.

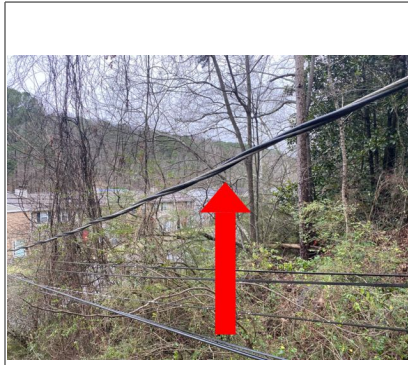
1. The main electrical service cable could be reached from the porch of 4926. Recommend repair by qualified electrician.

The main electrical service cable could be reached from the porch of 4926. Recommend repair by qualified electrician.

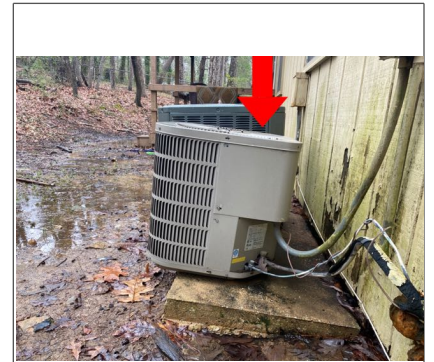
The exterior AC unit for 4926 was not level. Recommend repair by qualified HVAC technician.

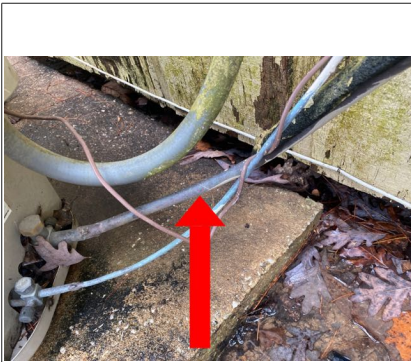
Recommend replacing the insulation on the suction line for the exterior AC unit for 4926.

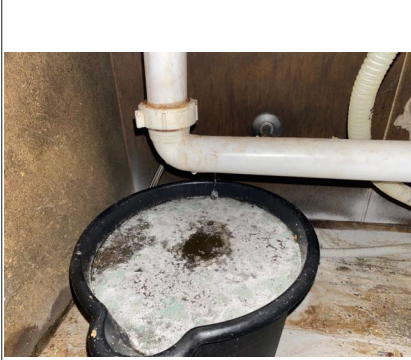
The left sink drain was leaking in 4926. Recommend repair by qualified plumber.

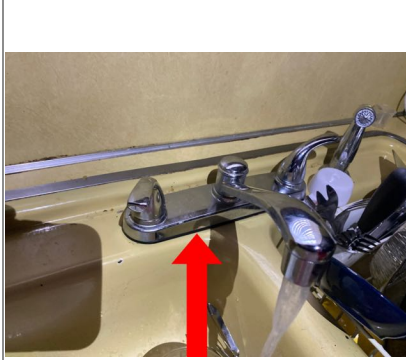
Recommend attaching the base of the sink faucet in 4928.

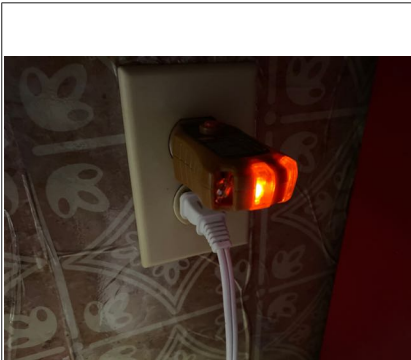
1. The electrical receptacles in 4926 and 4928 were not GFCI protected. Recommend repair by qualified electrician.

The electrical receptacles in 4926 and 4928 were not GFCI protected. Recommend repair by qualified electrician.

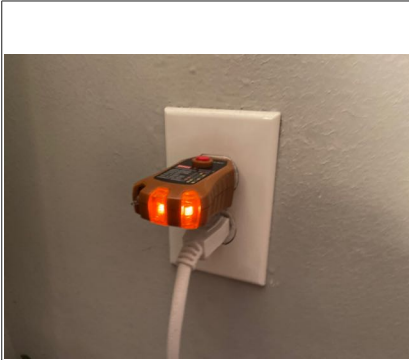
1. The electrical receptacles the bathrooms were not GFCI protected. Recommend repair by qualified electrician.

The electrical receptacles the bathrooms were not GFCI protected. Recommend repair by qualified electrician.

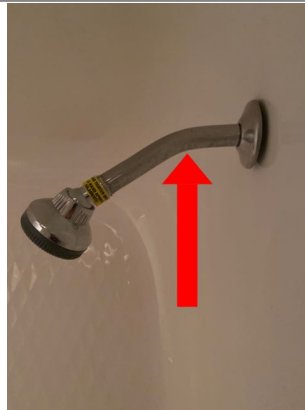
The shower spout and tub/shower controls in the bathrooms for 4926 were loose. Recommend repair by qualified plumber.

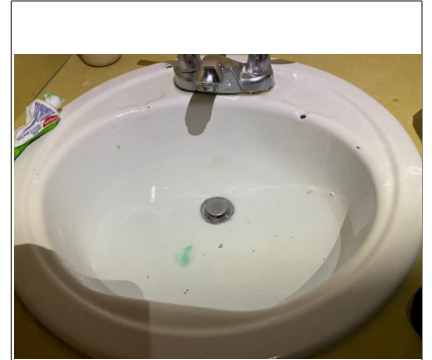
The drainage in the hallway bathroom sink for 4928 was poor. Recommend repair by qualified plumber.

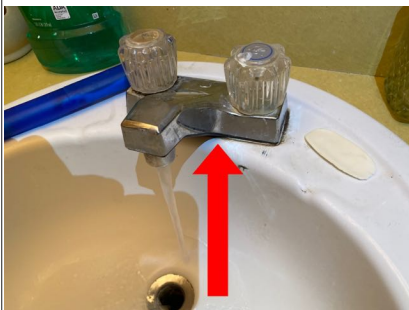
Recommend attaching the base of the sink faucet in the master bathroom for 4928.

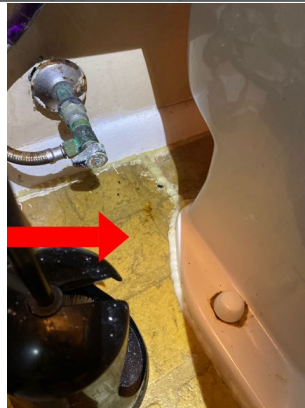
The toilet appeared to be leaking in the master bathroom for 4928. Recommend repair by qualified plumber.

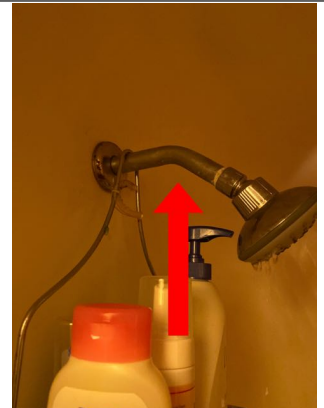
The shower spout for the master bathroom in 4928 was loose. Recommend repair by qualified plumber.

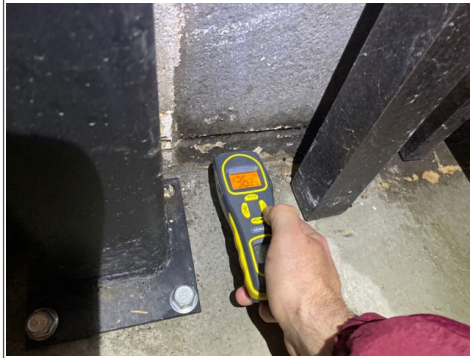
1. There was active moisture penetration and the moisture content was elevated on the foundation walls in several areas in both units. Recommend repair by waterproofing specialist.

There was active moisture penetration on the bottom of the left foundation wall for 4926. Recommend repair by waterproofing specialist.

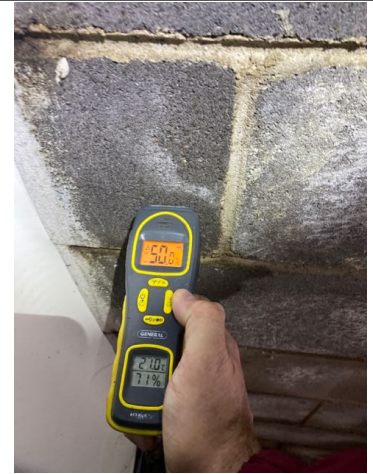
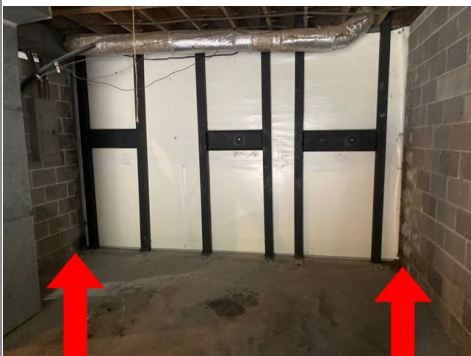
There was active moisture penetration on the rear side of the right and left foundation walls for 4926. Recommend repair by waterproofing specialist.

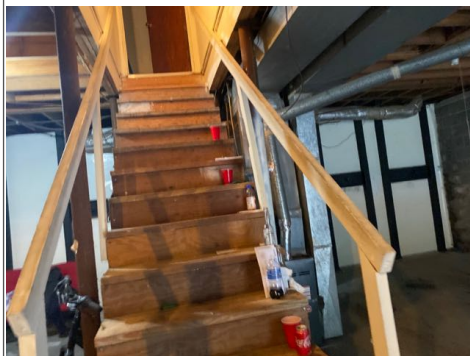
1. Recommend installing balusters on the handrail for the stairs in 4926.

Recommend installing balusters on the handrail for the stairs in 4926.

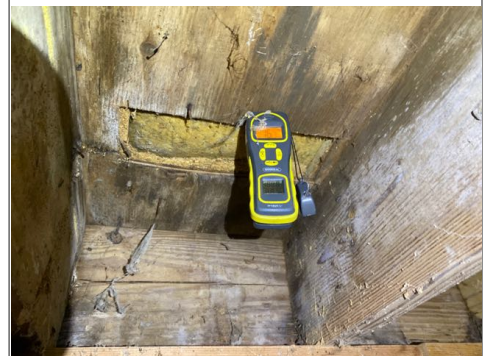
2. There were moisture stains on the subfloor in front of the porch for 4926 and the moisture content was slightly elevated. Recommend repair by qualified contractor.

There were moisture stains on the subfloor in front of the porch for 4926 and the moisture content was slightly elevated. Recommend repair by qualified contractor.

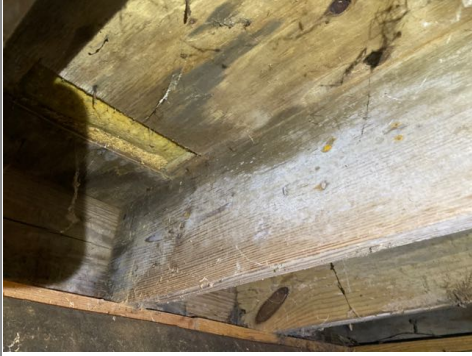
2. There was possible fungal growth on the framing in front of the porch in 4926. Recommend evaluation/repair by mold remediation specialist.

There was possible fungal growth on the framing in front of the porch in 4926. Recommend evaluation/repair by mold remediation specialist.

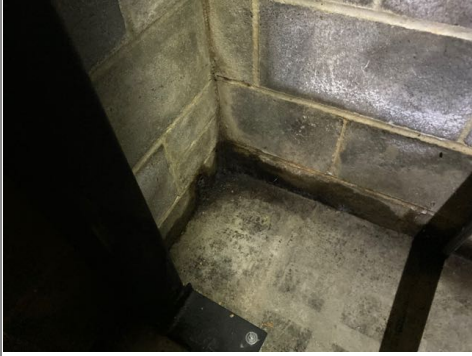
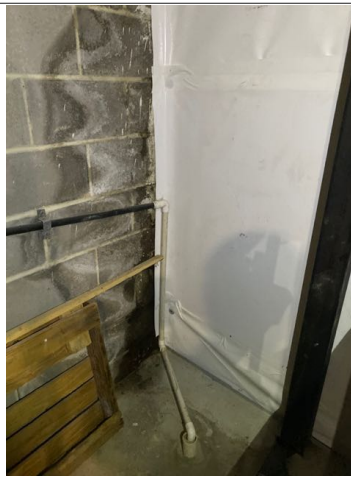
There was active moisture intrusion in the foundation wall on the front right corner and on the left side of the laundry area for 4928. Recommend repair by waterproofing specialist.

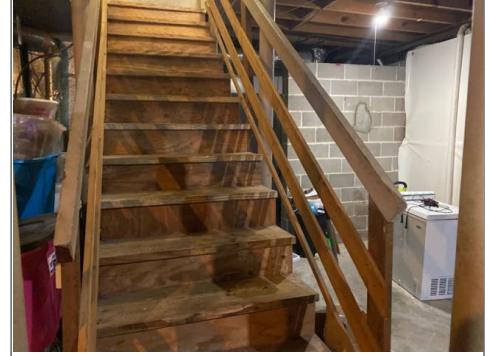
3. The stairs handrails for 4928 were loose. Recommend repair by qualified carpenter.

The stairs handrails for 4928 were loose. Recommend repair by qualified carpenter.

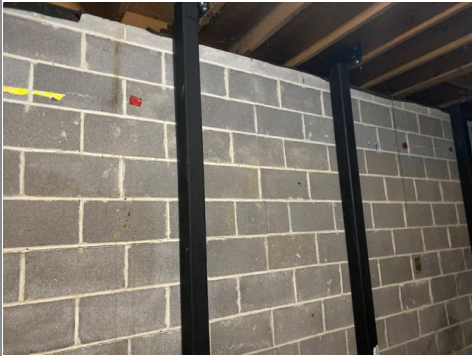
1. Structural repairs and waterproofing repairs had been performed in both units. Recommend asking the current owner for documentation regarding the repairs.

Structural repairs and waterproofing repairs had been performed in both units. Recommend asking the current owner for documentation regarding the repairs.

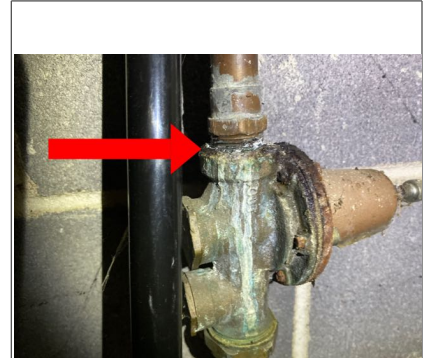
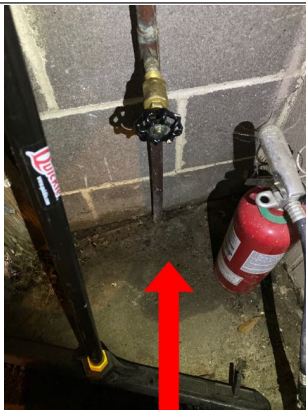
The water pressure regulator for 4928 appeared to be leaking. Recommend repair by qualified plumber.

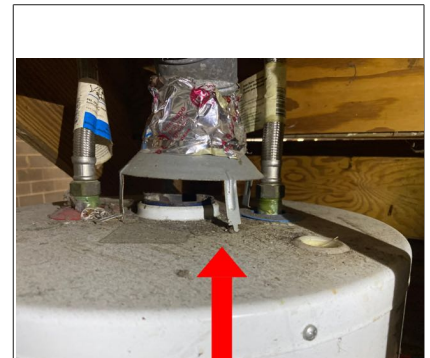
The draft hood on the water heater for 4926 was not mechanically fastened to the top of the water heater. Recommend repair by qualified plumber.

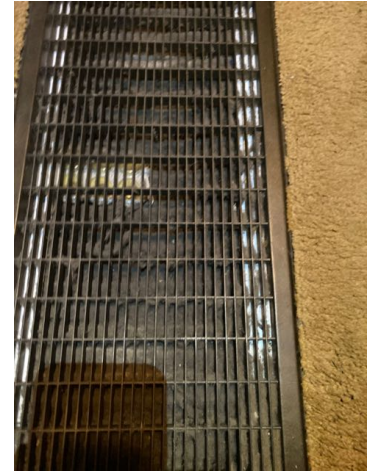
Recommend replacing the air filters

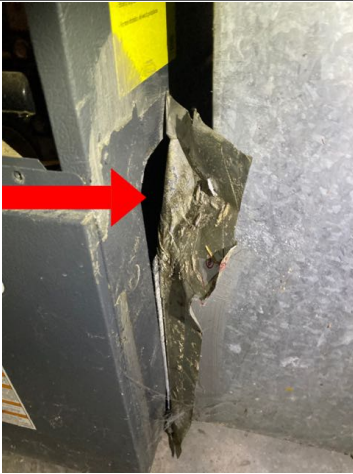
The return ductwork at the furnace for 4926 needed to be re-taped. Recommend repair by qualified HVAC technician.

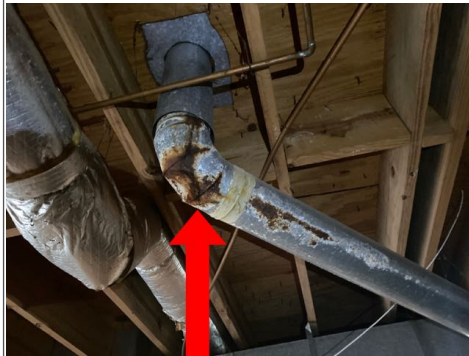
1. There was corrosion on the vent pipe for the furnace for 4926. Recommend repair by qualified HVAC technician.

There was corrosion on the vent pipe for the furnace for 4926. Recommend repair by qualified HVAC technician.
