New Construction Inspection Report

5608 Brayden Circle, Lot 3081

Monday, July 6, 2020

Report Number:

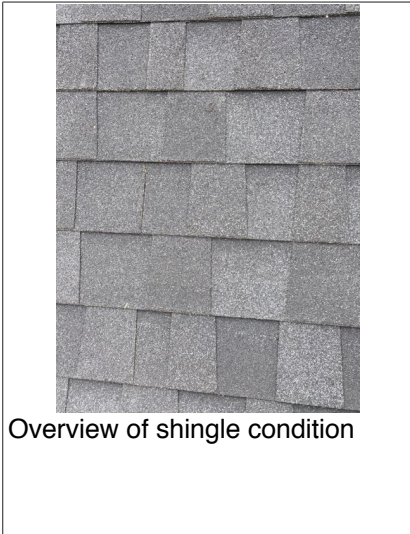
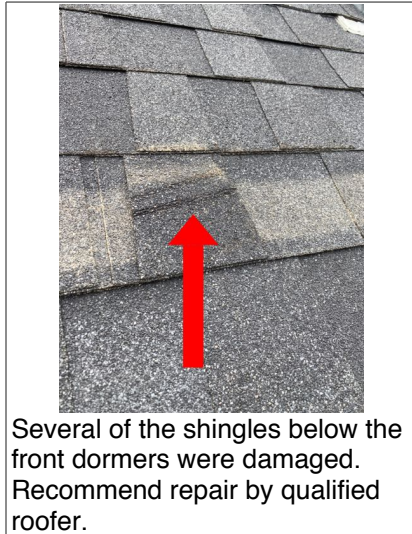
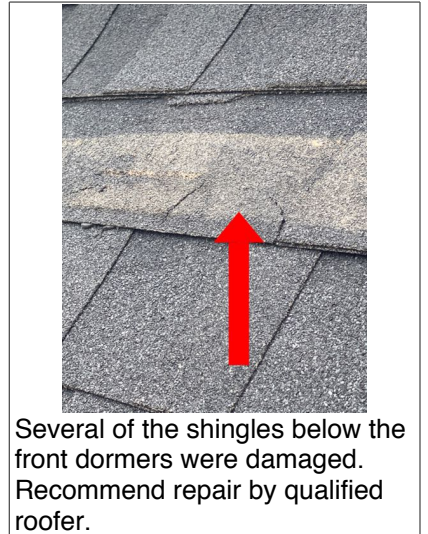
1. Several of the shingles below the front dormers were damaged. Recommend repair by qualified roofer.

Roof #1 Satisfactory Broken/Loose Tiles/Shingles Recommend roofer evaluate

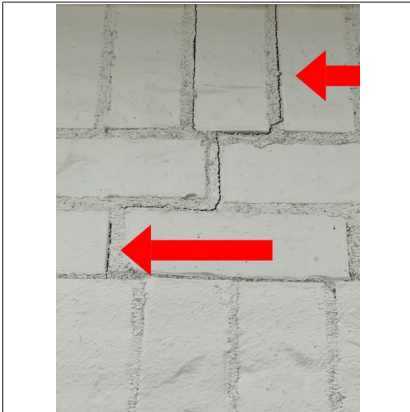
There was a minor step crack in the brick mortar between the overhead door openings. Recommend repair by qualified brick mason.

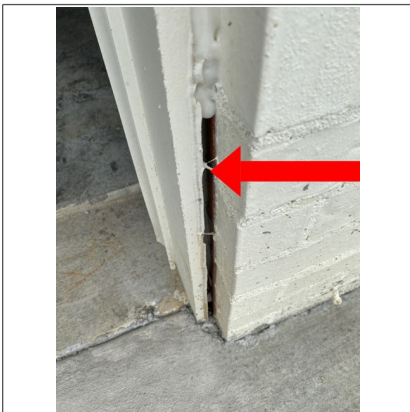
There was a large gap on the bottom right side of the left overhead door opening that appeared too large to be caulked. Recommend repair by qualified carpenter.

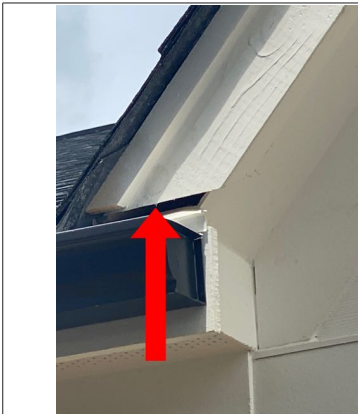
There was a large gap at the bottom of the rear fascia on the left gable. Recommend repair by qualified carpenter.

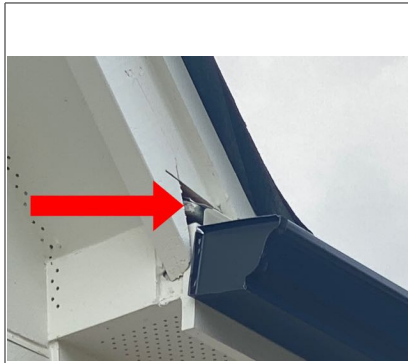
There was a large gap at the bottom of the rear fascia on the right gable. Recommend repair by qualified carpenter.

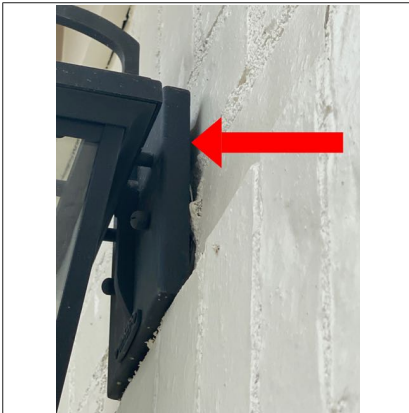
Recommend caulking around the light fixtures above the overhead doors.

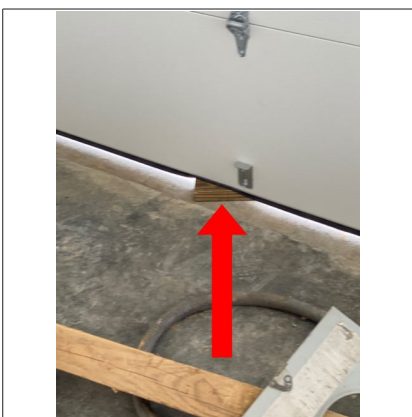
Operation Not Operable Safety hazard Photo eyes and pressure reverse tested

The safety reverse was not operating properly on the right overhead door opener when the door came in contact with an obstruction. Recommend repair by qualified overhead door technician.

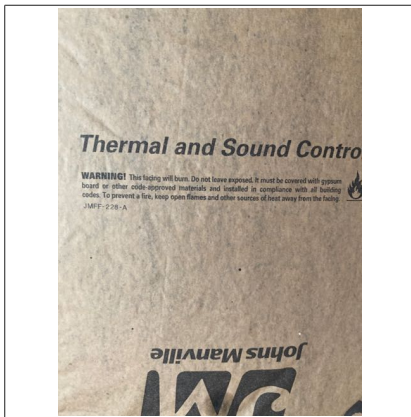
The wall insulation in the second level unfinished room was installed with the vapor retarder facing the living area and was not covered. Recommend repair by qualified contractor.
