Phase Inspection Report

1078 Lawanna Dr, Marietta, GA 30060

Wednesday, January 15, 2020

011520

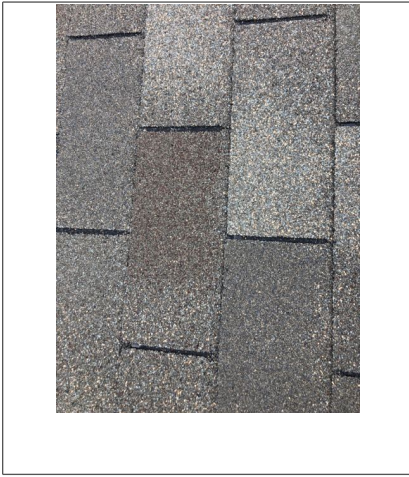
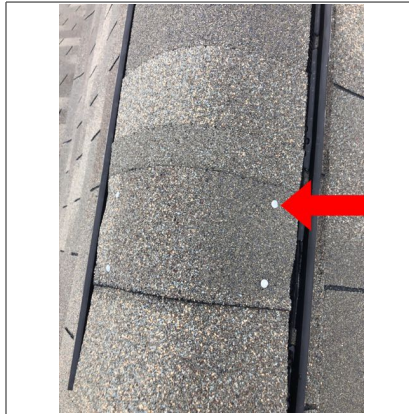
Recommend sealing the exposed nail heads on the ridge shingles.

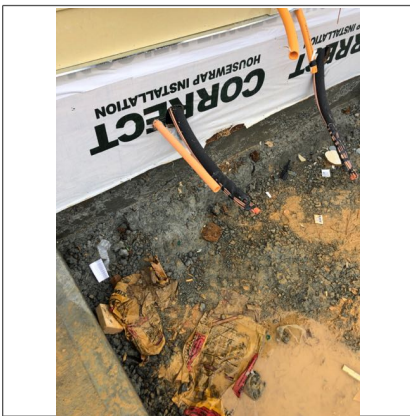
Unit #1 Location:Rear elevation of house.
Comments Not installed
Photos

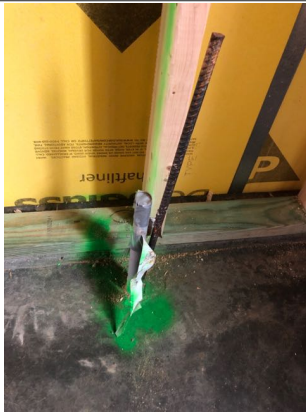
Rebar on the left wall that according to the builder will be removed.
