Pre-Listing Inspection Report

229 Nesbitt Dr NE, Atlanta, GA 30319

Thursday, February 20, 2020

022120

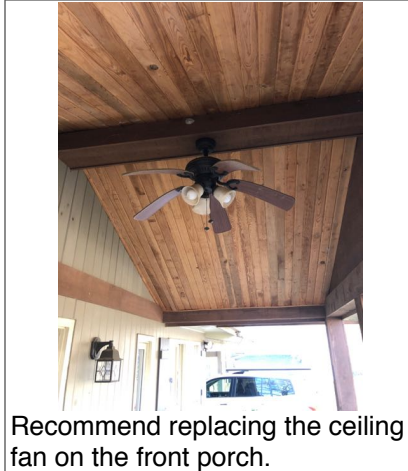
Recommend replacing the ceiling fan on the front porch.

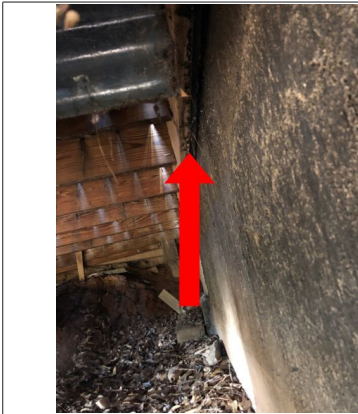
Unable to determine deck attachment to House. Recommend evaluation and repair by qualified contractor.

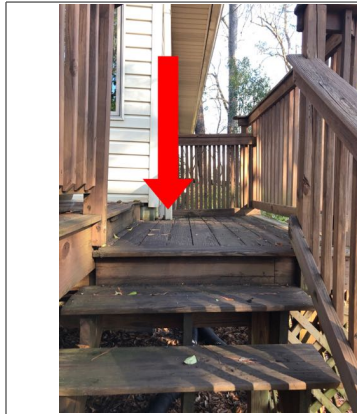
The left rear portion of the landing appeared to be settling. Recommend evaluation and repair by qualified contractor.

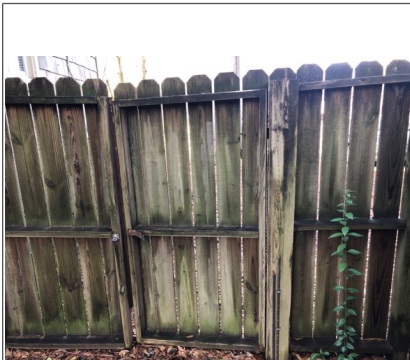
The gate on the left elevation of the house was not operable. Recommend repair by qualified carpenter.

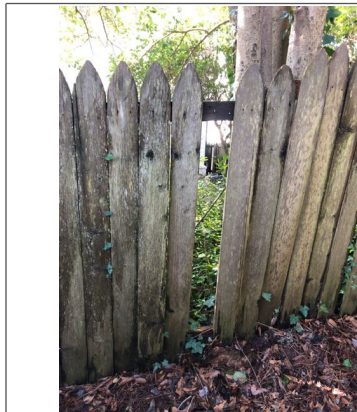
Missing/loose planks on the right side of the fence. Recommend repair by qualified carpenter.

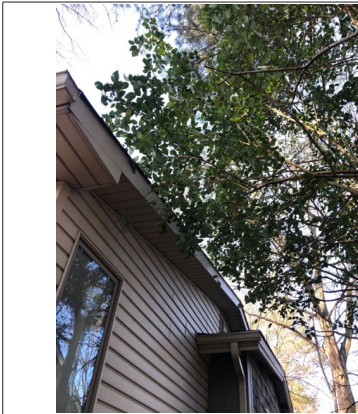
Recommend trimming back the trees that are in contact with the roof on the left rear corner of the house.

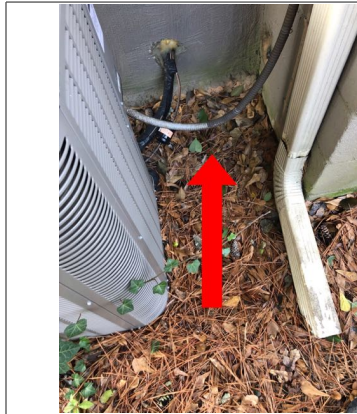
Recommend additional backfill on the left elevation of the house especially in the corner around the exterior AC unit.

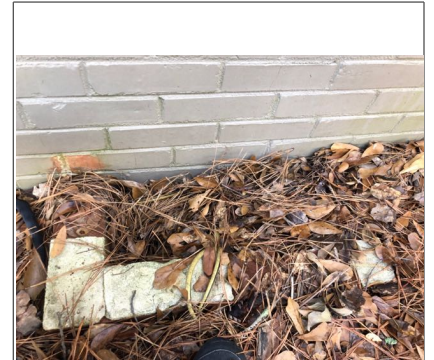
Recommend removing the debris from the crawlspace vent wells.

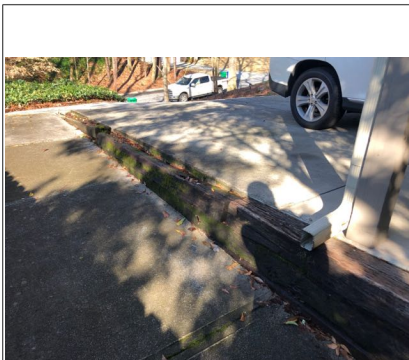
The railroad ties on the front portion of the retaining wall were in poor condition due to rot.

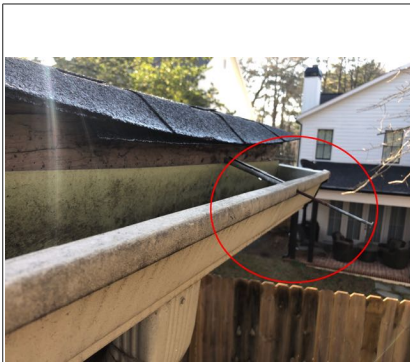
The gutter above the carport needs reattached after the fascia repairs have been made.

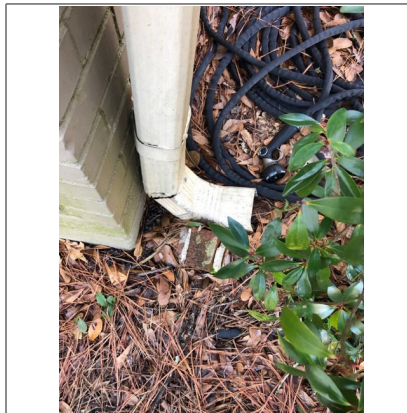
Recommend installing an extension on the downspout on the front right corner of the house.

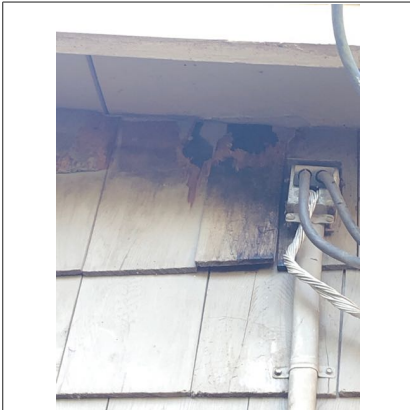
There were two holes on the left elevation of the house above the electrical service entry.
Recommend repair by qualified carpenter.

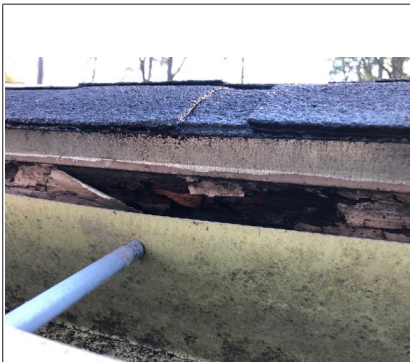
Water damage to the fascia behind the gutter above the carport. Recommend repair by qualified carpenter.

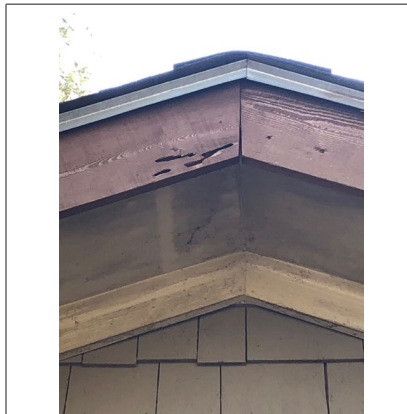
Insect damage to the fascia board above the front entryway door. Recommend repair by qualified carpenter.

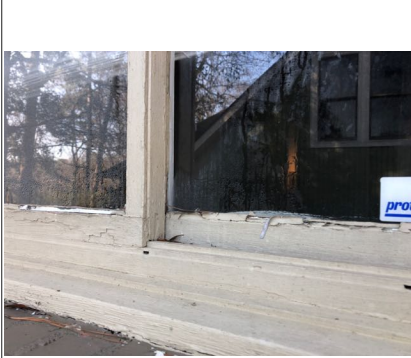
Recommend repainting the front window on the left elevation of the house.

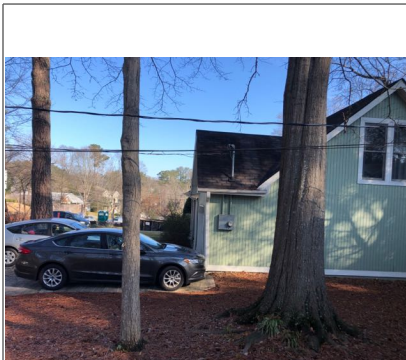
The overhead wires on the electrical service entry are too low. Recommend repair by qualified electrician.

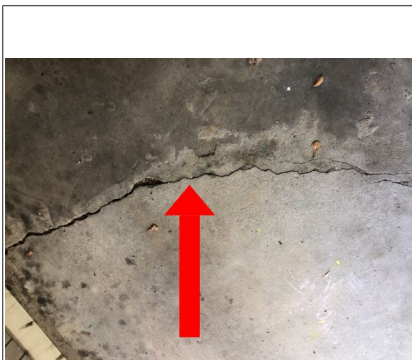
Recommend filling and sealing the large crack on the left side of the carport.

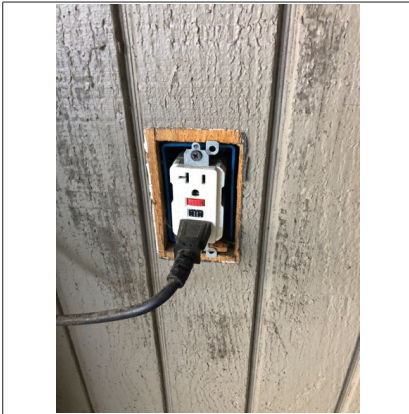
Recommend installing the missing cover plate on the electrical receptacle in the carport.

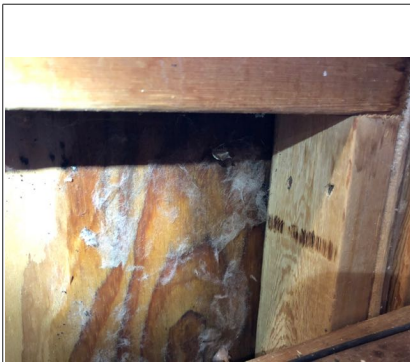
There was water entering the right elevation of the shed at the base of each window and a round the planter. Recommend repair by qualified carpenter.

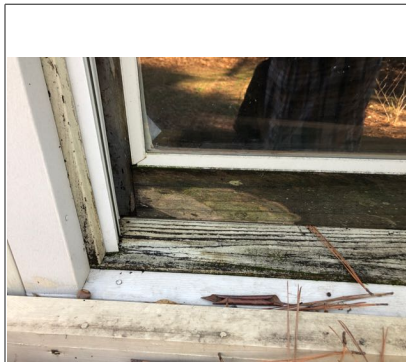
Recommend painting the windows in the shed.

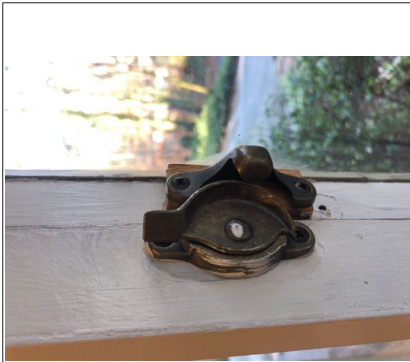
Recommend adjusting the lock on the right window.

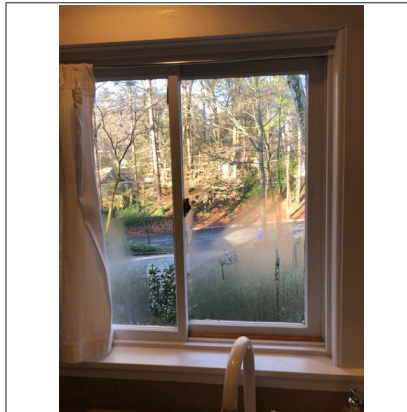
The left window was painted closed.

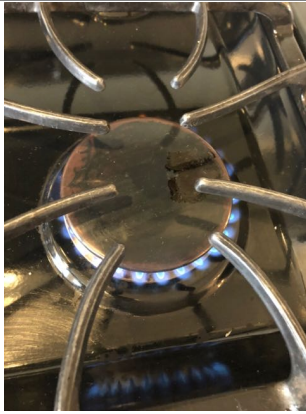
The right front burner on the stove has poor gas flow. Recommend repair by qualified appliance repair technician.

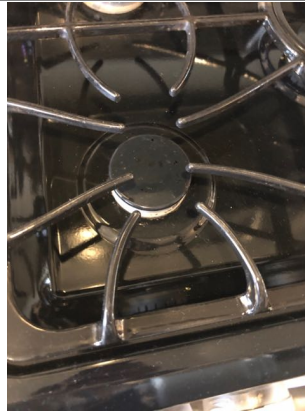
The striker for the left front burner on the stove does not work properly. Recommend repair by qualified appliance repair technician.

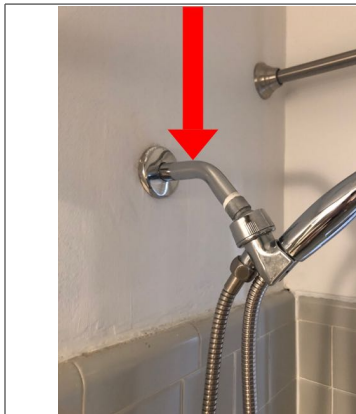
The shower spout was loose.
Recommend repair by qualified plumber.

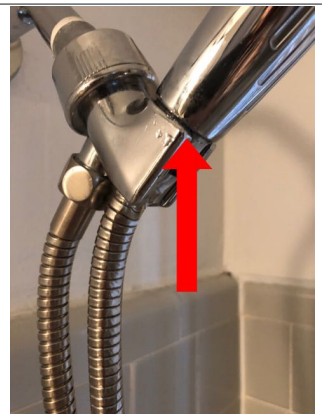
Recommend tightening the shower head.

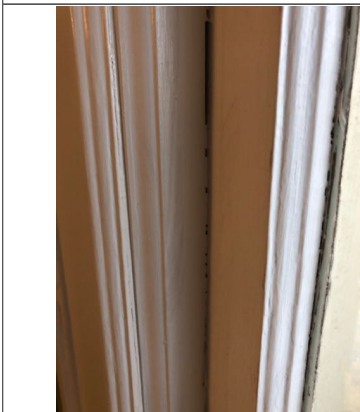
The window was painted shut.

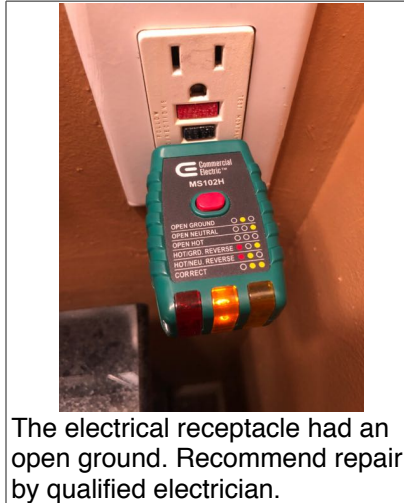
The electrical receptacle had an open ground. Recommend repair by qualified electrician.

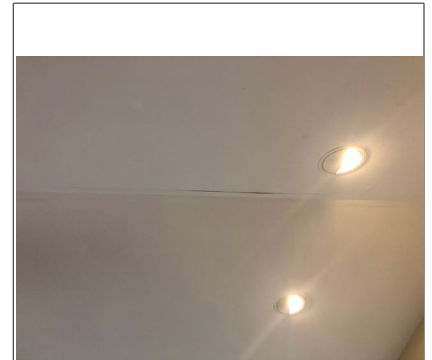
Typical crack in ceiling. No action recommended.

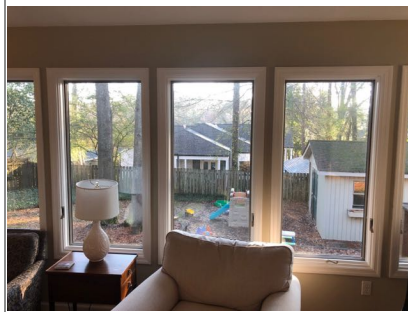
The middle window was unable to be operated. Recommend repair by qualified carpenter.

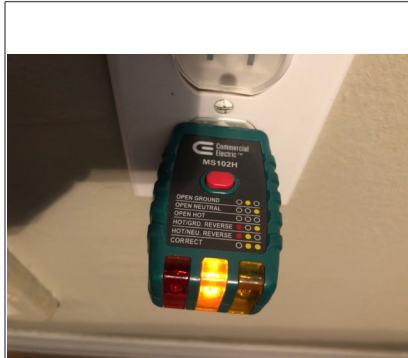
The electrical receptacles in the bedroom had an open ground. Recommend repair by qualified electrician.

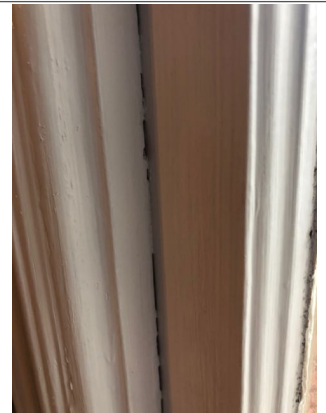
The right window was painted shut.

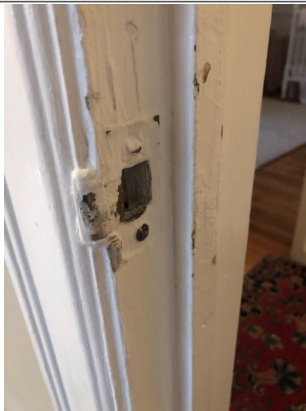
The door did not latch properly. Recommend adjusting the striker plate.

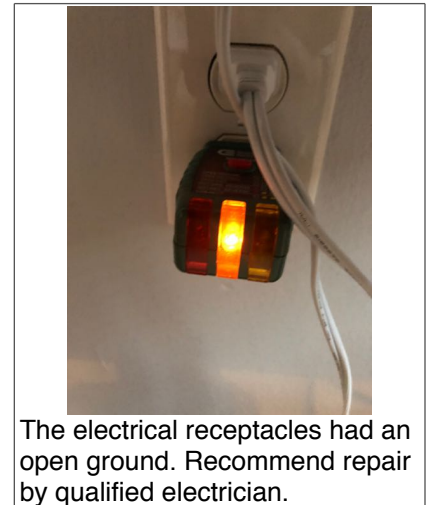
The electrical receptacles had an open ground. Recommend repair by qualified electrician.

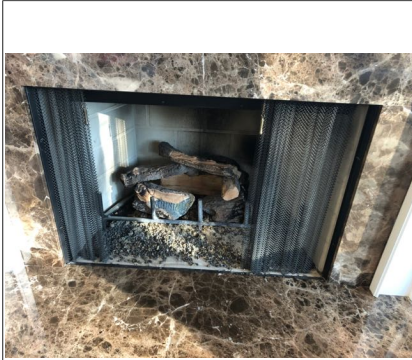
The gas logs were not tested.

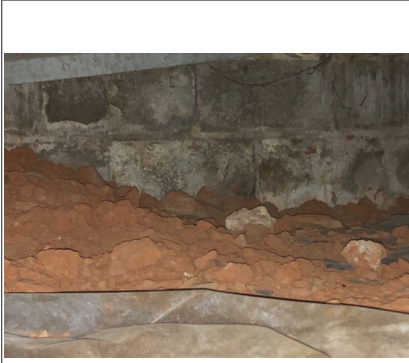
There was water staining and efflorescence on the foundation walls. There did not appear to be any water intrusion in this area.

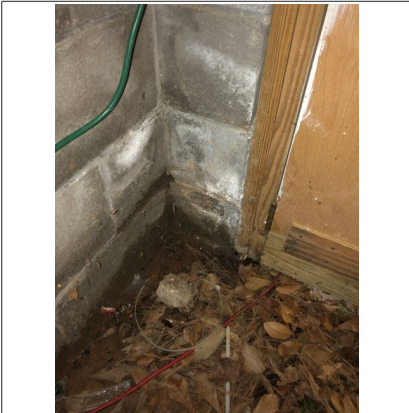
Water entering crawlspace on the left elevation next to the crawlspace entry door. Additional backfill on the exterior of this area will likely resolve this issue.

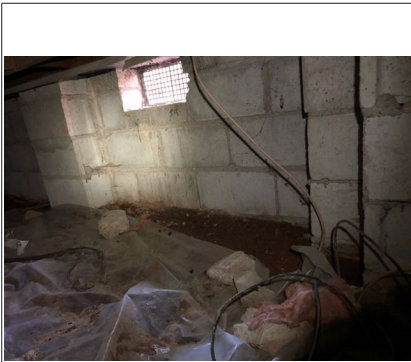
There appears to be a small amount of water entering the crawlspace on the left elevation of the house. Additional backfill on the exterior in this area will likely resolve the issue. Recommend evaluation by waterproofing specialist.

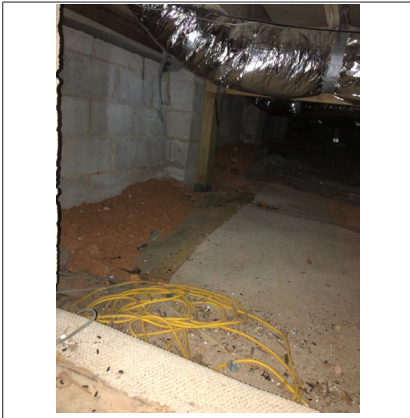
Recommend installing additional vapor barrier over the exposed dirt areas.

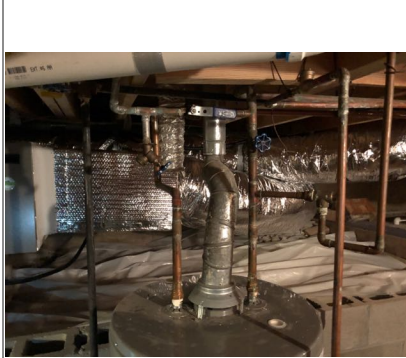
An expansion tank was not installed on the water heater. Recommend repair by qualified plumber.

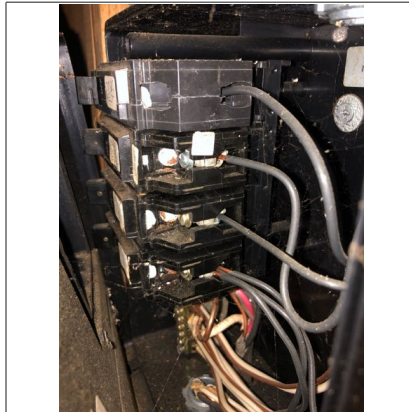
Double tap of the lowest breaker on the right side of the panel. Recommend repair by qualified electrician.
