Home Inspection Report

2699 Whispering Pine Dr, Montgomery , Alabama 36116

Monday, November 2, 2020

Ally Property Inspections
PO Box 43302
Vestavia Hills , AL 35243
2057905510

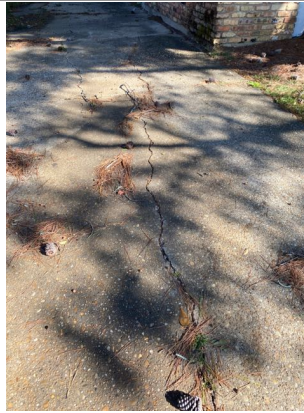
The driveway was in overall marginal condition due to settlement.

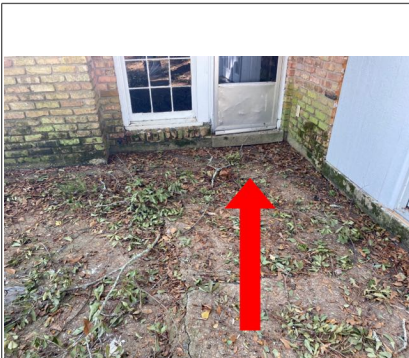
The rear patio was in overall poor condition and was sloped towards the house. Recommend repair by qualified contractor.

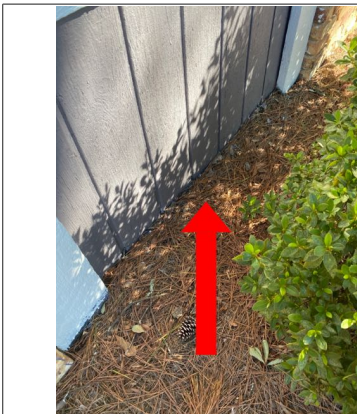
Recommend removing the pine straw that is in contact with the siding and trim on the front left side of the house.

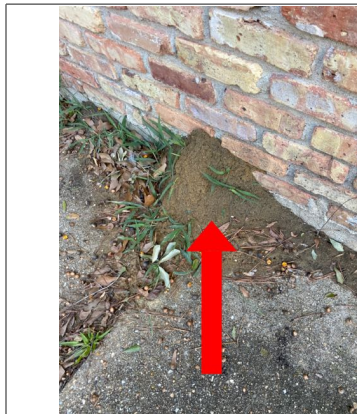
Recommend removing the ant beds that are against the left side of the house.

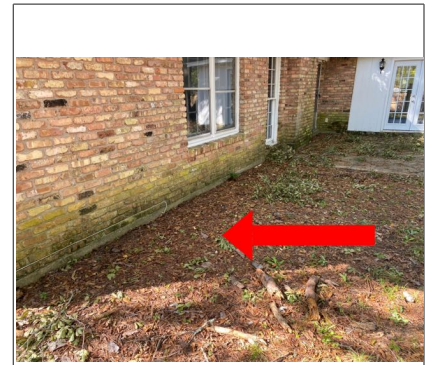
The grading was not adequate on the rear right side of the house. Recommend repair by qualified contractor.

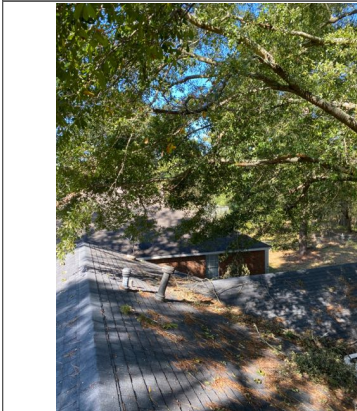
There were many large tree limbs hanging over the house. Recommend removal by tree removal specialist.

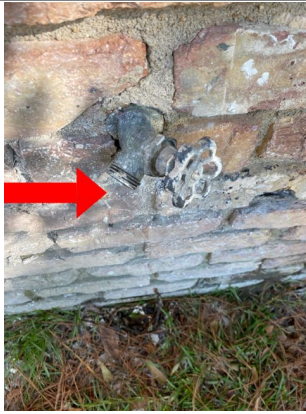
Recommend installing an anti-siphon valve on the hose bib on the front side of the house.

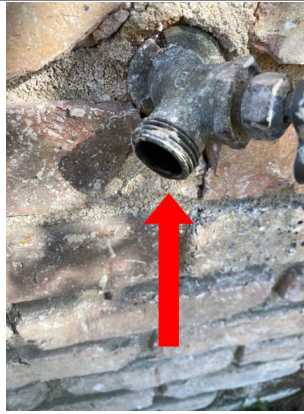
The hose bib on the front side of the house was dripping. Recommend repair by qualified plumber.

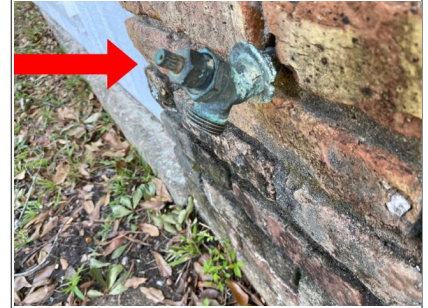
The handle was missing on the hose bib on the left side of the house and an anti-siphon valve was not installed. Recommend repair by qualified plumber.

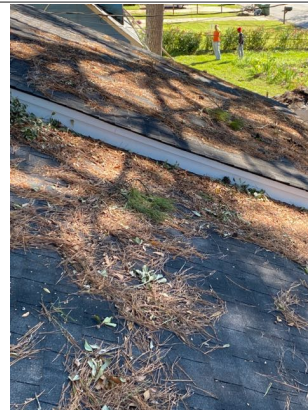
Recommend removing the organic debris from the roof.

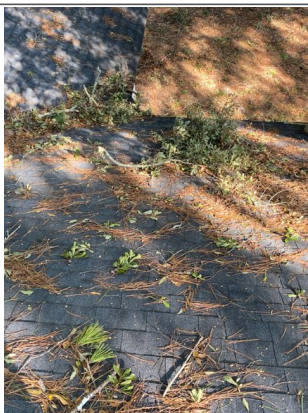
Much of the roof was not visible because it was covered with organic debris.

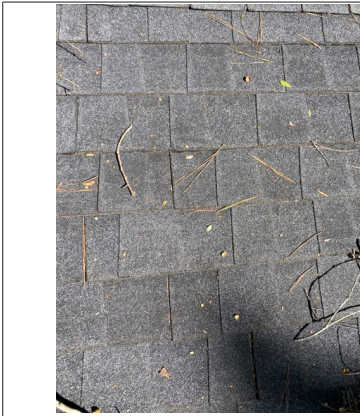
There was significant granular loss on many of the shingles. Recommend evaluation/repair by qualified roofer.

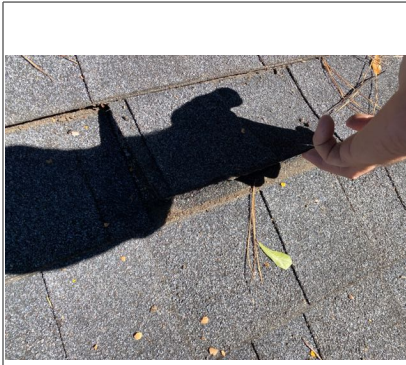
The sealant strips had failed on many of the shingles tested. Recommend repair by qualified roofer.

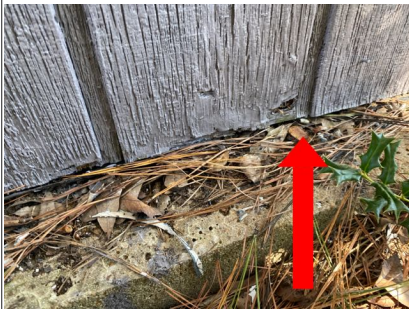
There was moisture damage on the bottom of the siding and trim on the front right side of the house. Recommend repair by qualified carpenter.

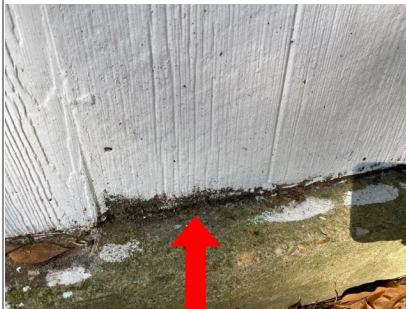
There was moisture damaged in several areas on the bottom of the siding on the sunroom. Recommend repair by qualified carpenter.

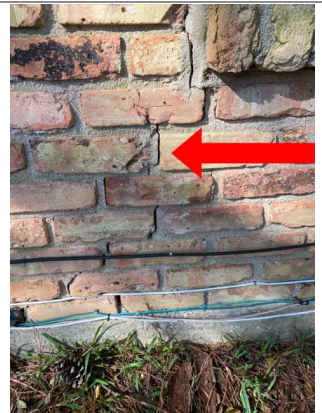
There was a step crack in the brick mortar below the window on the right side of the house. Recommend repair by qualified brick mason.

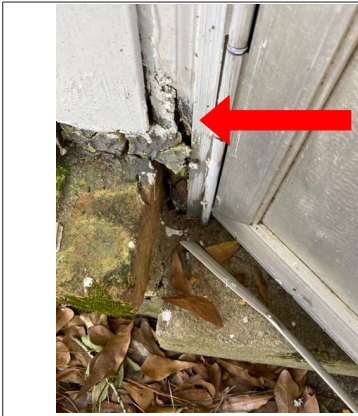
The bottom of the trim was in poor condition on the living room entry door. Recommend repair by qualified carpenter.

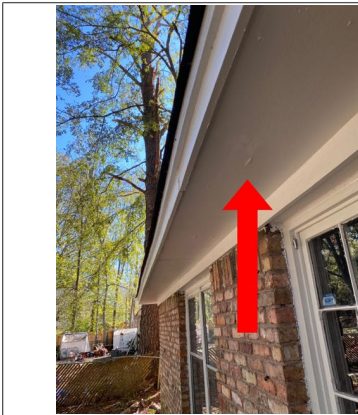
Soffit vents were not installed on the main house. Recommend repair by qualified carpenter.

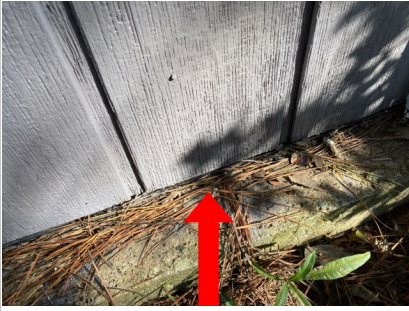
Flashing was not installed between the wood siding and slab on the front side of the house. Recommend repair by qualified carpenter.

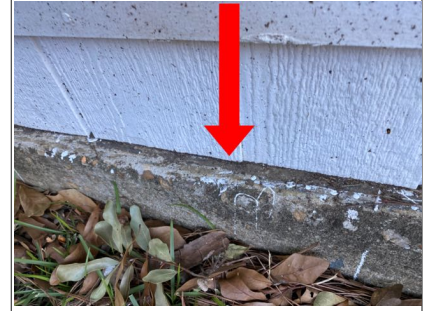
Flashing was not installed between the siding and slab on the sunroom. Recommend repair by qualified carpenter.

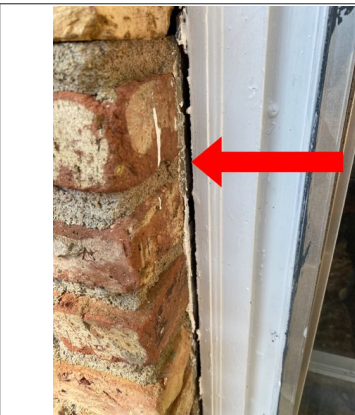
Recommend caulking the door and window openings as needed.

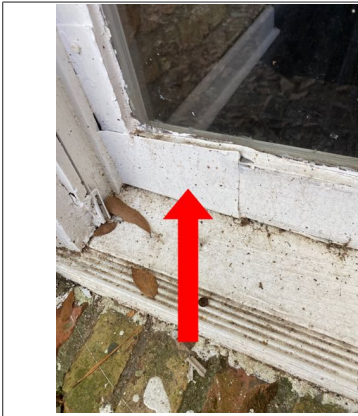
The bottom sash of the left living room window had been poorly repaired. Recommend repair by qualified carpenter.

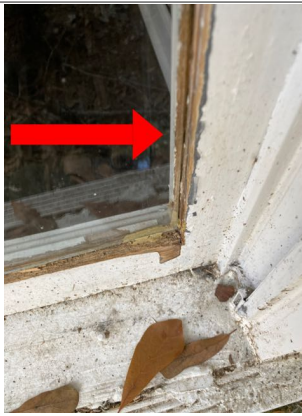
The putty glazing compound needed to be repaired on several of the wood windows. Recommend repair by qualified painter.

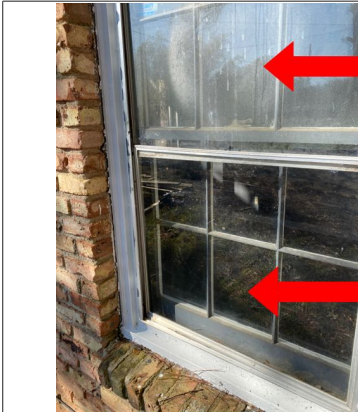
The sashes were not securely attached in the storm window on the right side of the house. Recommend repair by qualified carpenter.

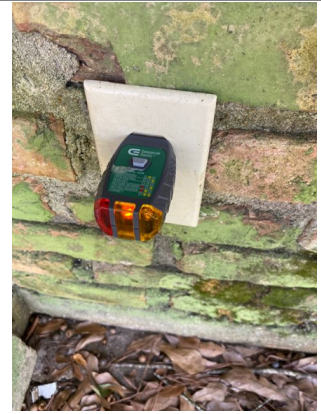
The electrical receptacle on the rear side of the house was not GFCI protected and was not safe for outdoor use. Recommend repair by qualified electrician.

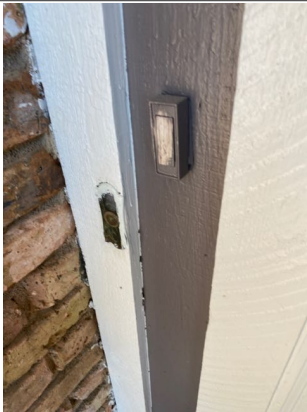
Neither of the doorbells were working.

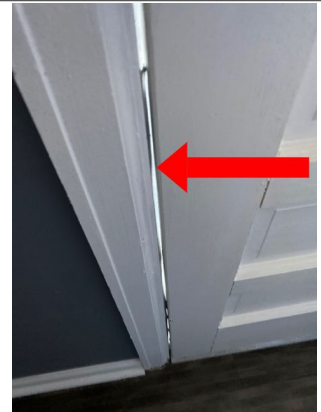
Recommend replacing the weatherstripping on the laundry room entry door.

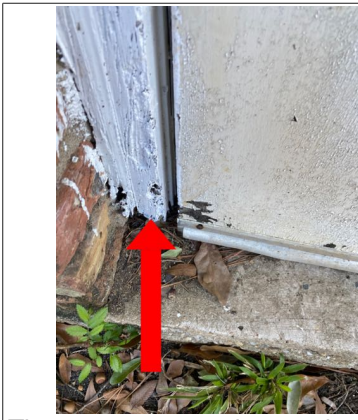
The storage room door and opening were in poor condition. Recommend repair by qualified carpenter.

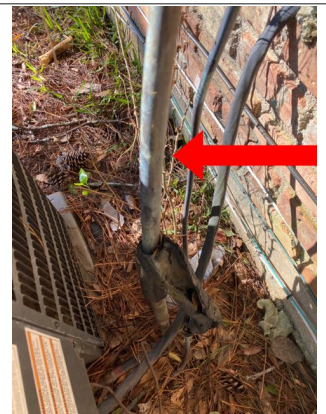
Recommend replacing the insulation on the suction line for the exterior AC unit.

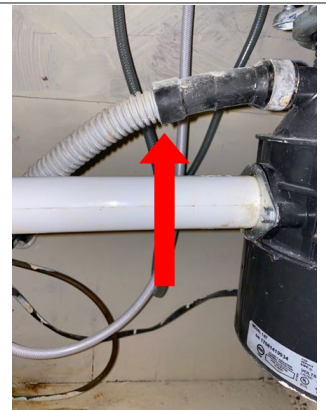
The dishwasher drain line was not high looped which prevents drain water from siphoning into the dishwasher. Recommend repair by qualified plumber.

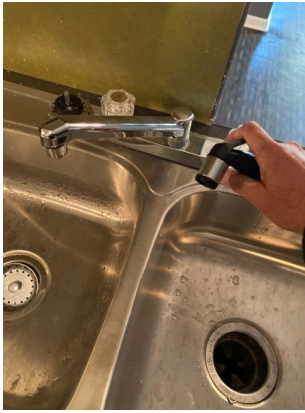
The sink plumbing and disposal were not tested because the sink faucet sprayer attachment would not disengage. Recommend repair by qualified plumber.

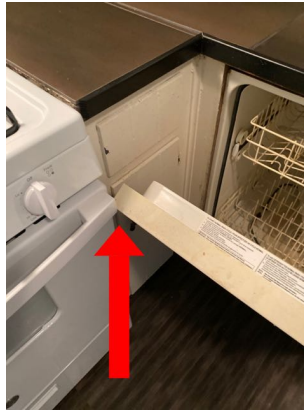
The dishwasher door could not be fully opened without opening the door to the oven.

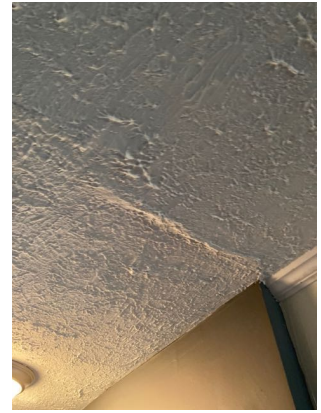
The ceiling has been marginally repaired in several areas.

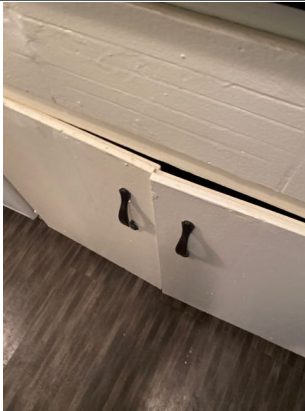
Several of the cabinet doors needed to be adjusted to close properly.

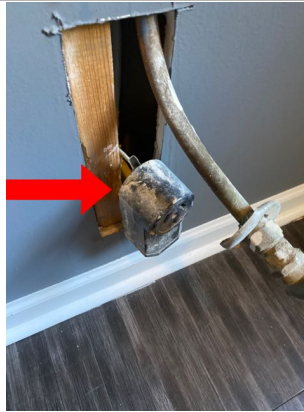
Recommend attaching the electrical receptacle for the dryer to the wall.

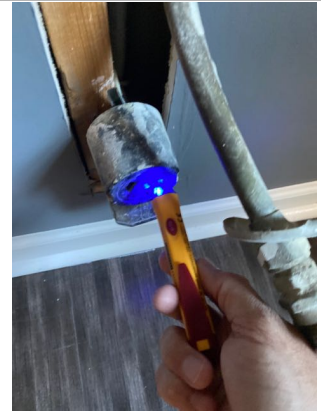
The electrical receptacle for the dryer was not working possibly because an unlabeled breaker in the electrical panel was in the off position. Recommend evaluation by qualified electrician.

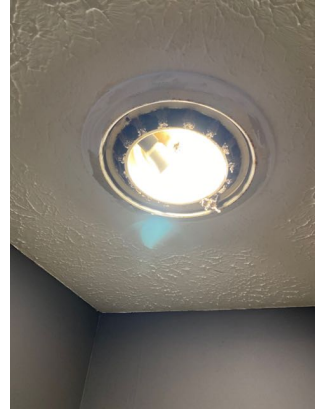
The cover was missing on the light fixture/ventilation fan above the tub.

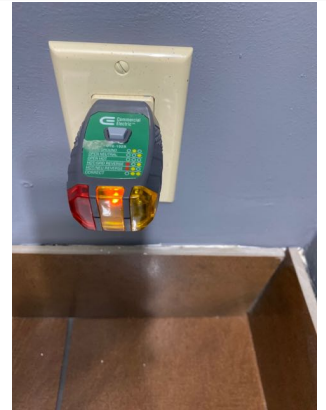
The electrical receptacle was not grounded but was GFCI protected which makes the receptacle safer but there is no protection for electrical equipment connected to the receptacle. Recommend installing a label on the receptacle stating "no equipment ground".

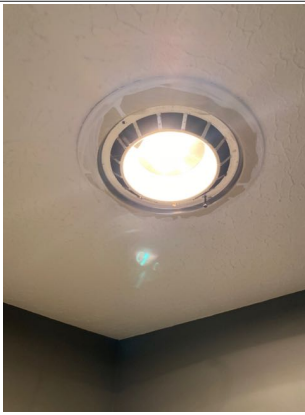
The ventilation fan was not operating properly and the cover was missing. Recommend repair by qualified electrician.

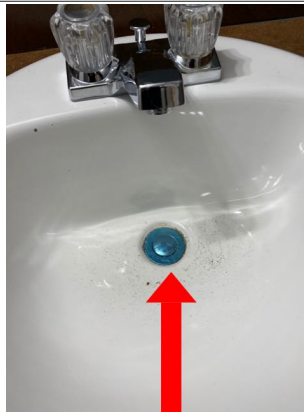
The right sink was not tested because the mechanical drain stopper would not disengage.

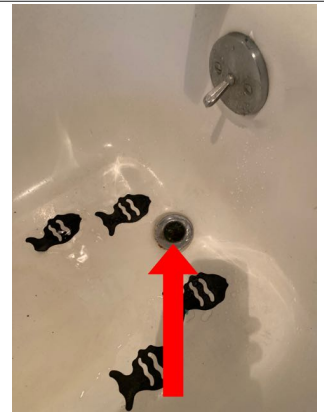
The mechanical drain stopper for the tub was missing.

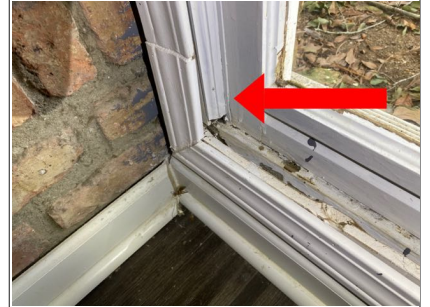
The trim on the bottom of the right window was poorly installed.

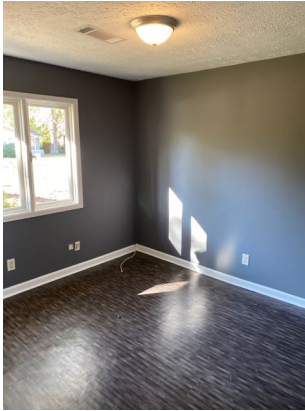
The glass was missing in the left window. Recommend repair by qualified carpenter.

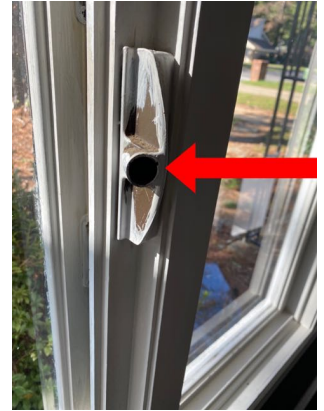
Window opening hardware was missing on the right window. Recommend repair by qualified carpenter.

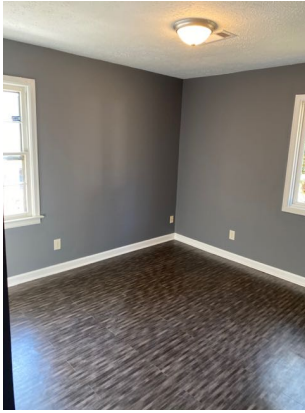
Window opening hardware was missing on the front left window. Recommend repair by qualified carpenter.

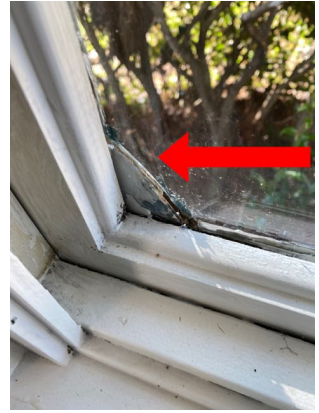
The glass was cracked in the bottom of the front left window. Recommend repair by qualified carpenter.

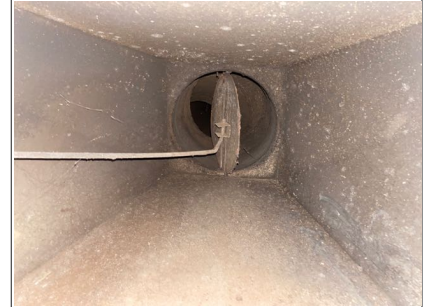
Recommend having the chimney flue cleaned and examined by a qualified chimney sweep.

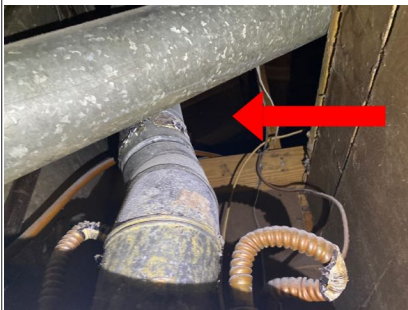
A ceiling was not installed in the utility closet and was open to the attic. Recommend repair by qualified carpenter.

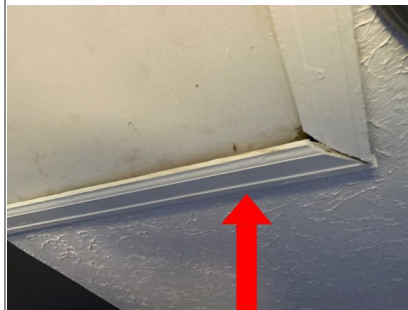
The trim was not securely attached around the attic access opening. Recommend repair by qualified carpenter.

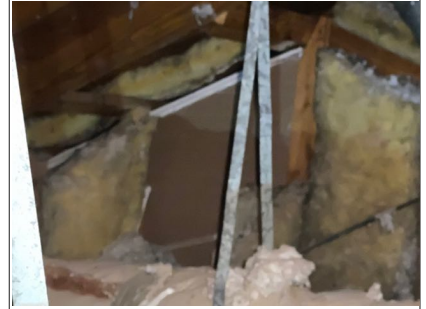
Recommend replacing the missing batt insulation in the attic above the living room.

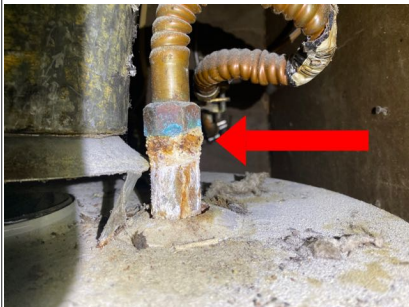
There was corrosion on the plumbing lines to the water heater. Recommend evaluation/repair by qualified plumber.

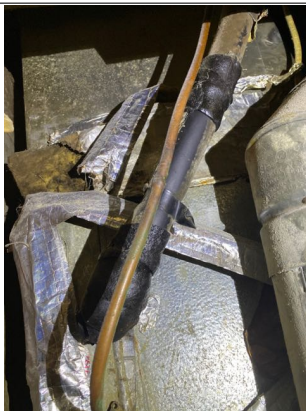
The supply ductwork at the interior HVAC system needed to be repaired. Recommend repair by qualified HVAC technician.

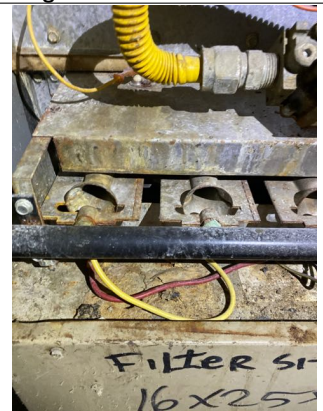
Recommend having the system cleaned and examined by a qualified HVAC technician.

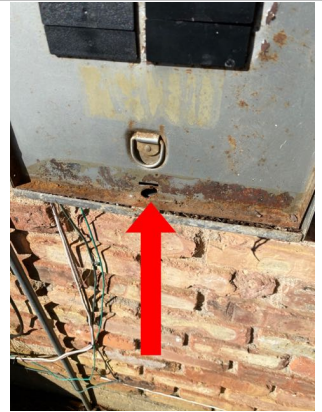
Recommend mechanically fastening the dead front cover to the main electrical panel.

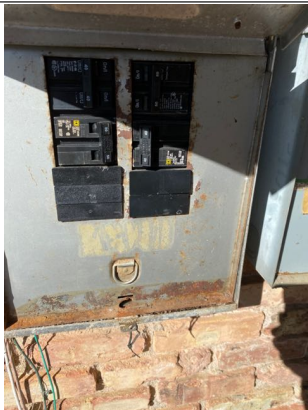
Recommend labeling the breakers in the main electrical panel.

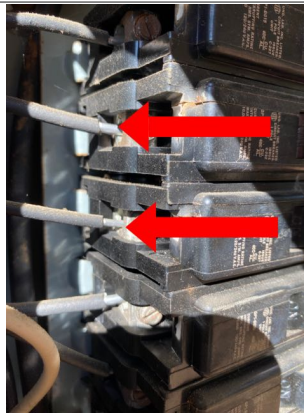
There was solid aluminum branch wiring present. Recommend evaluation/repair by qualified electrician.

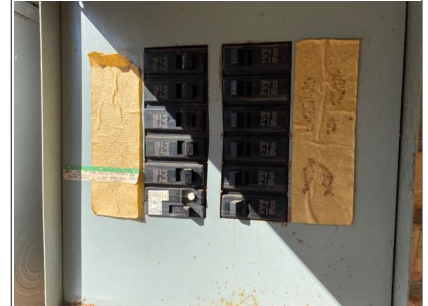
Recommend labeling the breakers in the electrical sub panel.

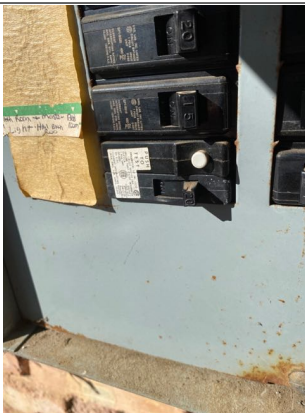
The unlabeled GFCI breaker in the lower left side of the electrical sub panel would not trip when tested. Recommend repair by qualified electrician.
