Thermography Report

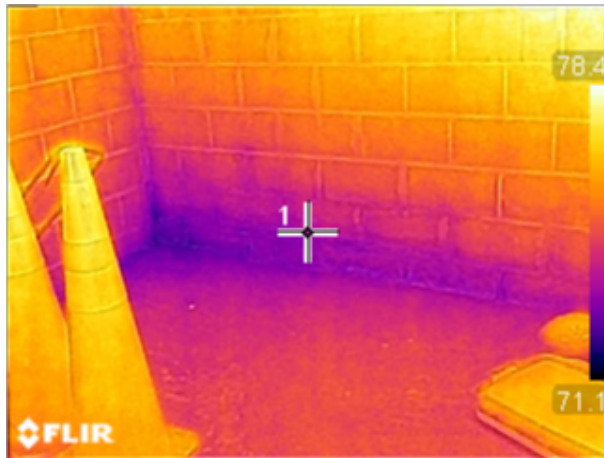
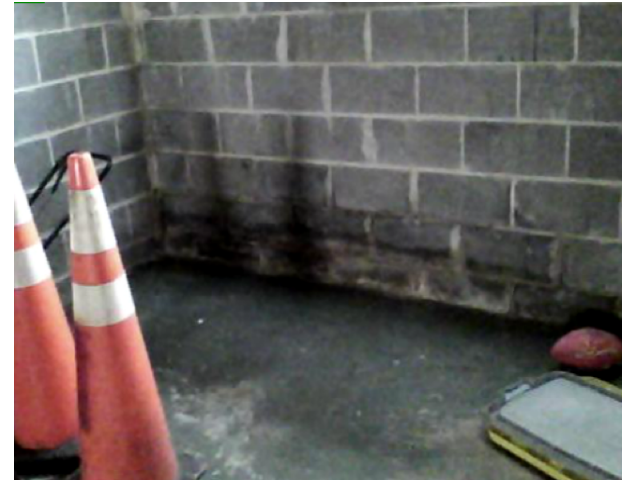
FLIR0063.jpg

Spot	73.3
------	------

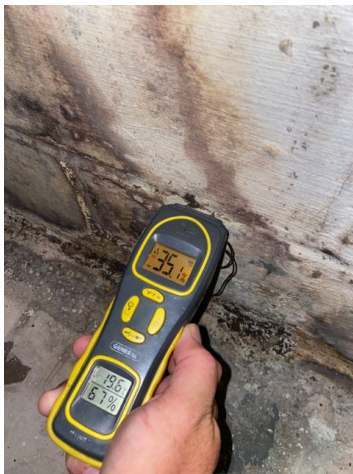
There were moisture stains on the foundation walls underneath the front porch and the moisture content was elevated. Recommend repair by waterproofing specialist.

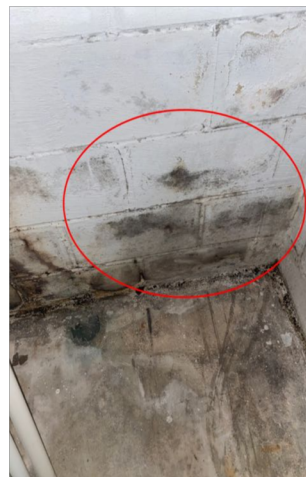
There was possible fungal growth on the foundation walls underneath the front porch. Recommend evaluation/repair by mold remediation specialist

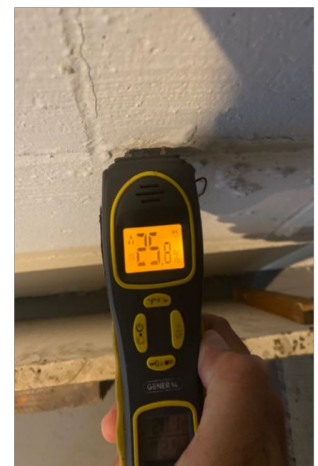
The moisture content was elevated on the front right and rear right foundation walls. Recommend repair by waterproofing specialist.

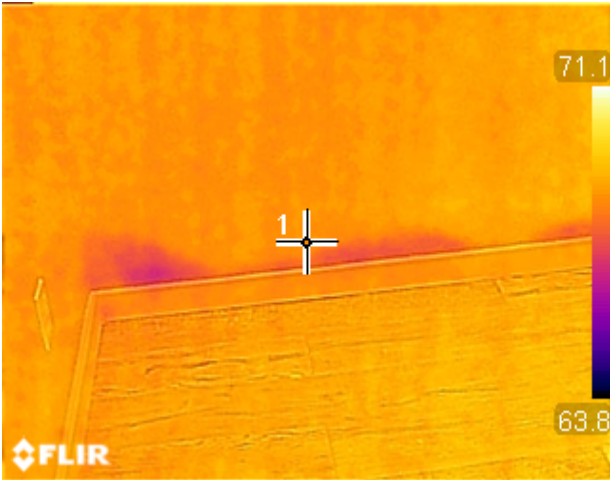
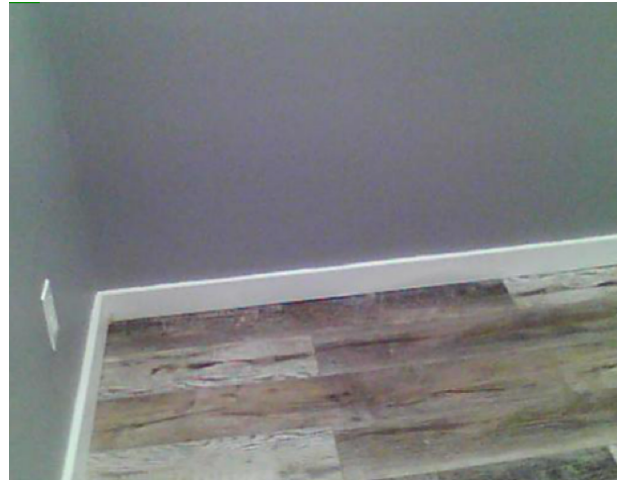
FLIR0047.jpg

Spot	68.5
------	------

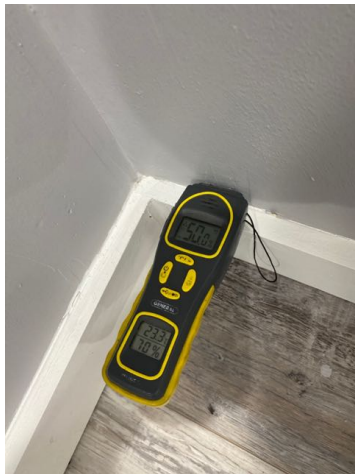
The moisture content was elevated in the bottom of the wall in the rear left side of the rear basement room. Recommend repair by waterproofing specialist.

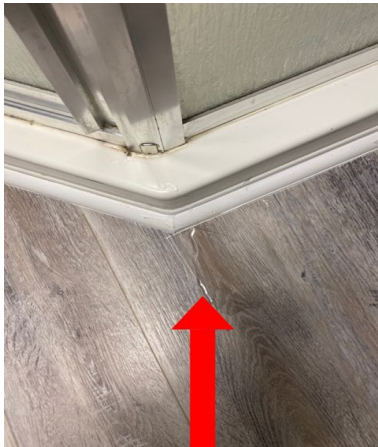
Water was leaking from the bottom of the shower enclosure when the shower was in use. Recommend repair by qualified carpenter.
