Annual Home Maintenance Inspection Report

Woodbury Dr, Sterrett , AL 35147

Friday, October 9, 2020

Ally Property Inspections
P O Box 43302
Vestavia, AL 35243
2056070031

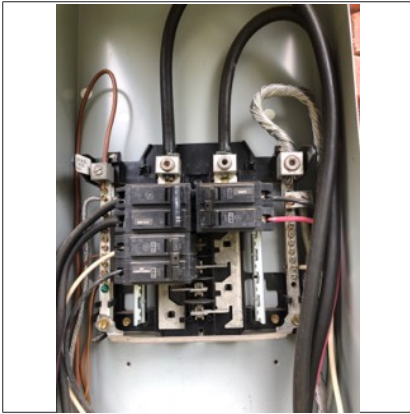
Location Left exterior
Condition Satisfactory
Adequate Clearance to Panel Yes
Amperage/Voltage 200a
Breakers/Fuses Breakers
Appears grounded Yes
GFCI breaker No
AFCI breaker No
Main wire Aluminum Condition: Satisfactory
Branch wire Copper
Branch wire condition Satisfactory

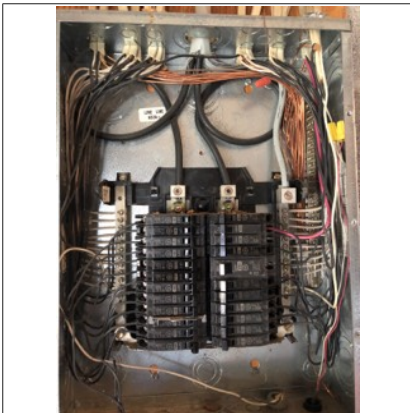
Location(s) Location 1: Garage
Branch wire Copper
Condition Satisfactory
