## Commerical Inspection Report

**3870 Cascade Rd, Atlanta, GA 30331**

Monday, September 21, 2020

921201

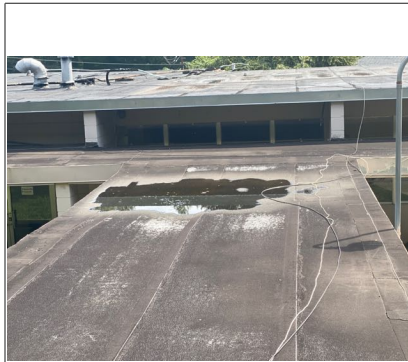
Water was ponding on the rear left side of the walkway covering the rear side of the courtyard. Recommend repair by qualified roofer.

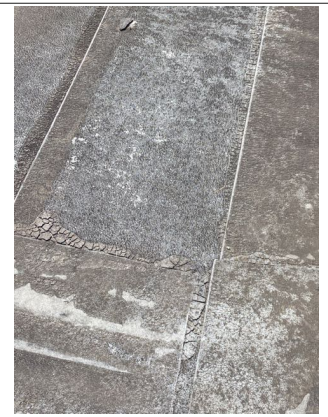
1. The block retaining wall on the right side of the main entrance was damaged in several areas and leaning. Recommend repair by qualified contractor.
2. Most of the rolled roofing on the walkway covering was in poor condition due to cracking. Recommend evaluation/repair by qualified roofer.

Most of the rolled roofing on the walkway covering was in poor condition due to cracking. Recommend evaluation/repair by qualified roofer.

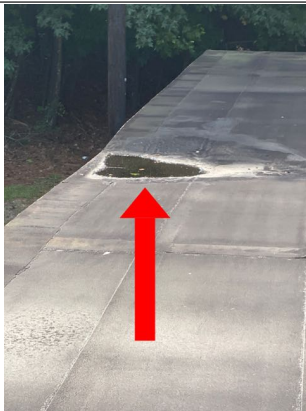
Water was ponding on the walkway covering on the left side of the gym where there was moisture damage on the ceiling of the walkway. Recommend repair by qualified roofer.

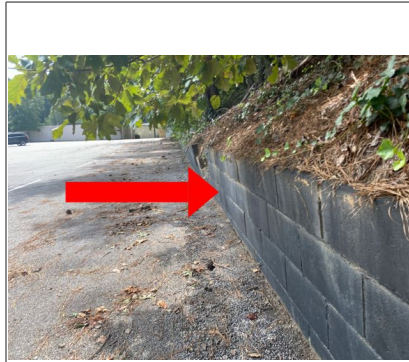
The block retaining wall on the right side of the main entrance was damaged in several areas and leaning. Recommend repair by qualified contractor.

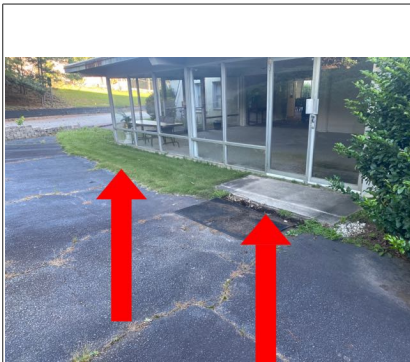
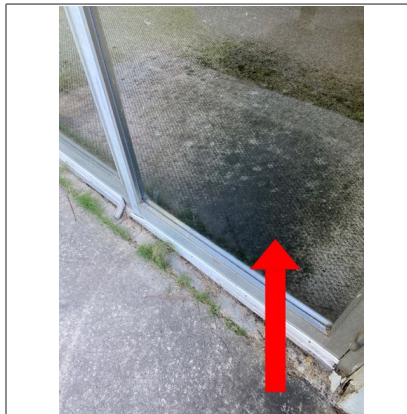
The grading was negative on the front side of the building and surface water appear to be entering through the entry doors. Recommend repair by qualified contractor.

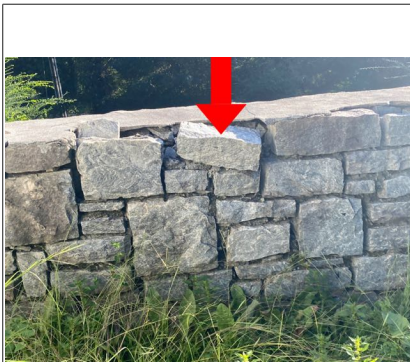
Several of the stones in the retaining walls on the right side of the building were loose. Recommend repair by qualified brick mason.

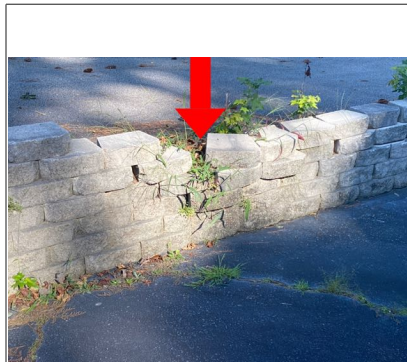
Several blocks were loose in the front left retaining wall. Recommend repair by qualified landscaper.

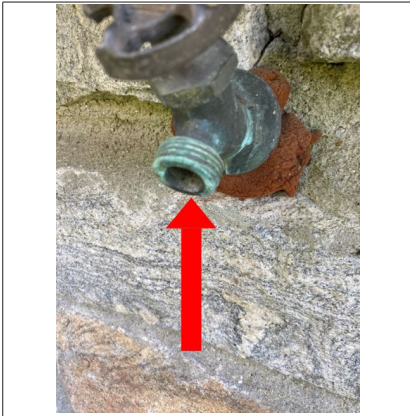
Recommend installing anti-siphon valves on the hose bibs.

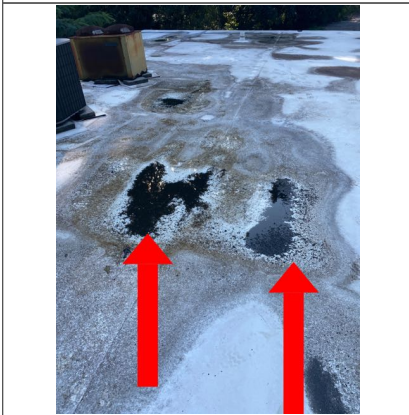
1. Water was ponding in several areas on the flat roof. Recommend evaluation/repair by qualified roofer.

Water was ponding in several areas on the flat roof. Recommend evaluation/repair by qualified roofer.

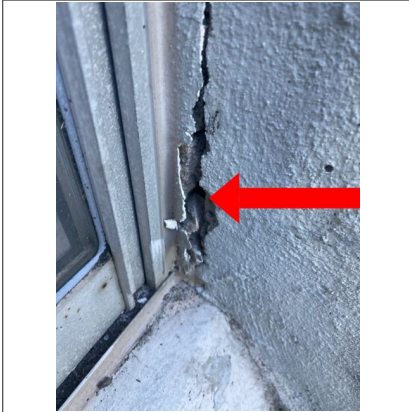
Recommend sealing the opening on the lower right side of the window next to the left entry door.

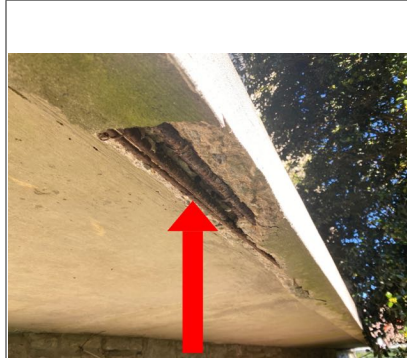
The concrete below the gable on the rear left side of the building was damaged. Recommend repair by qualified brick mason.

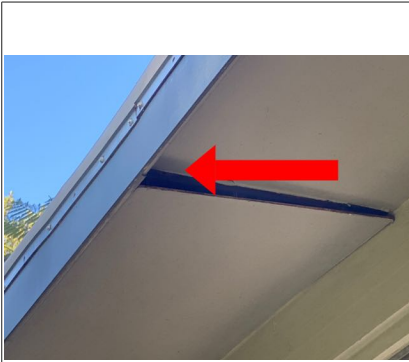
The soffit was loose in several areas on the right side of the building. Recommend repair by qualified carpenter.

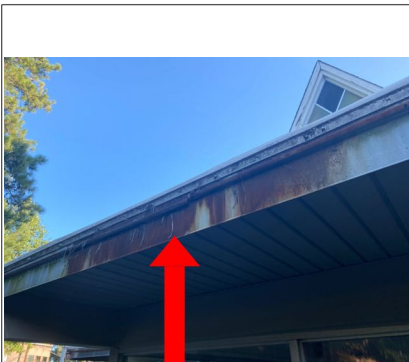
There was corrosion on the lower fascia on the front side of the building. Recommend painting.

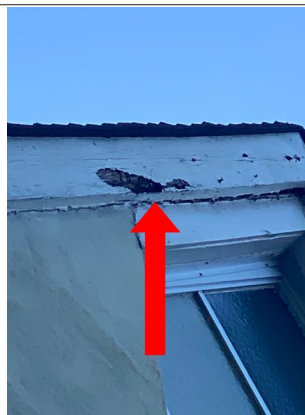
There was moisture damage on the upper fascia on the front side of the building. Recommend repair by qualified carpenter.

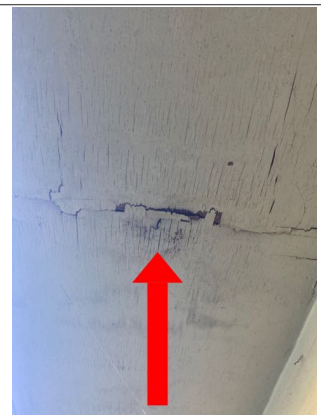
There was moisture damage on the soffit on the left front side of the building. Recommend repair by qualified carpenter.

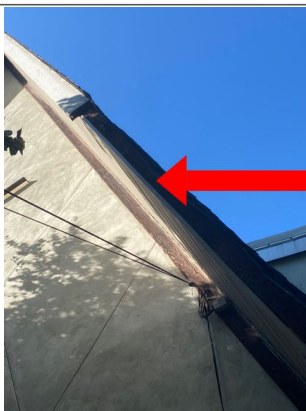
The fascia was missing on the rear left side of the building. Recommend repair by qualified carpenter.

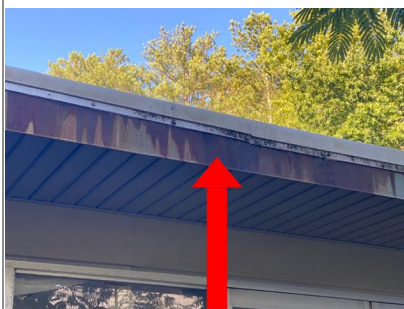
There was corrosion on the fascia on the right front side of the building. Recommend painting.

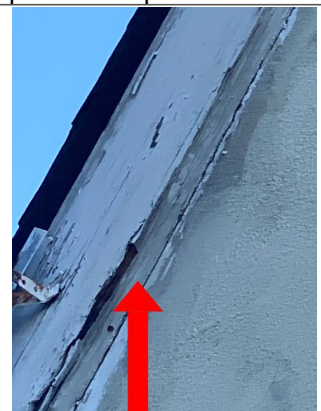
Recommend painting the wooden fascia on the front and rear sides of the building.

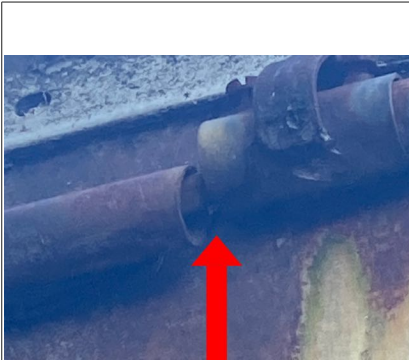
The conduit protecting the electrical wire to the light fixtures on the front side of the building was disconnected in several areas. Recommend repair by qualified electrician.

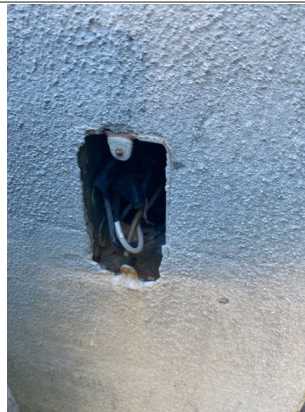
Recommended installing a cover plate on the electrical box on the left middle side of the building.

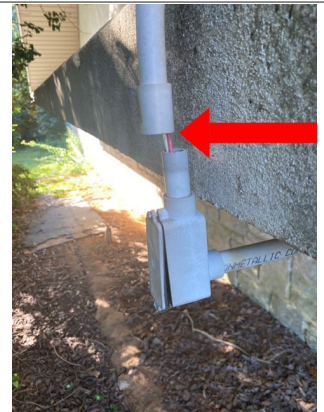
The conduit protecting the lower electrical wires on the rear side of the building was not safely installed. Recommend repair by qualified electrician.

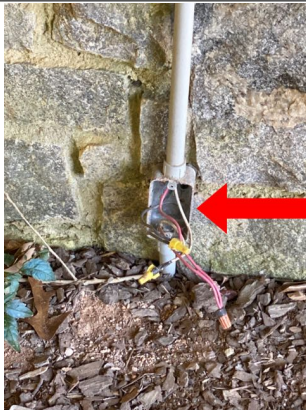
The conduit protecting the lower electrical wires on the rear side of the building was not safely installed. Recommend repair by qualified electrician.

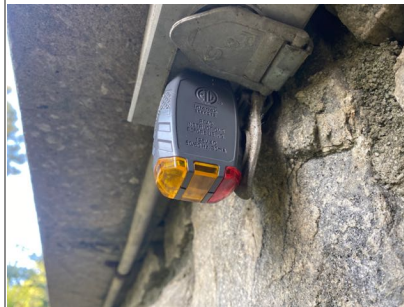
The electrical receptacle on the right side of the building was not working and did not appear to be GFCI protected. Recommend repair by qualified electrician.

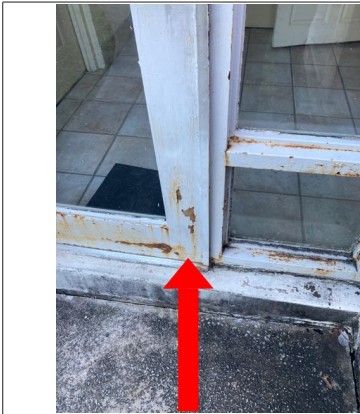
There was corrosion on the left entry doors and openings. Recommend painting.

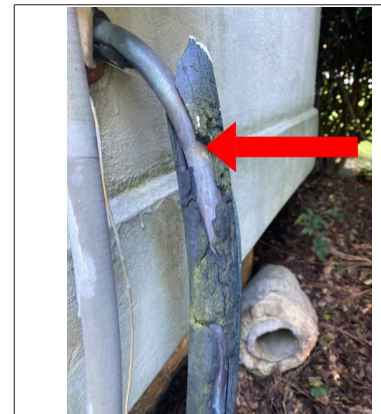
Recommend replacing the insulation on the suction lines for all of the exterior AC units.

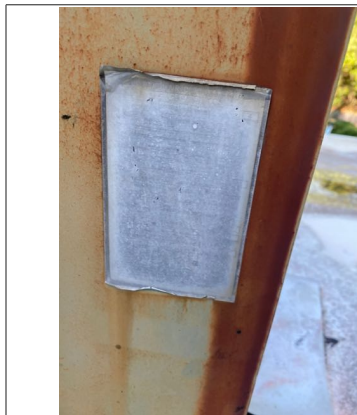
Unable to determine the exact age of exterior AC unit four because the manufacturer's data plate was not legible. It appeared to be 40+ years old.

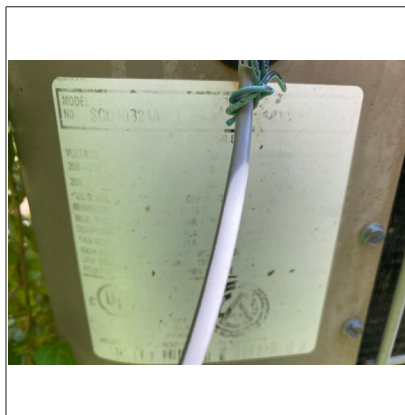
Unable to determine the exact age of exterior AC unit four because the manufacturer's data plate was not legible. It appeared to be 20+ years old.

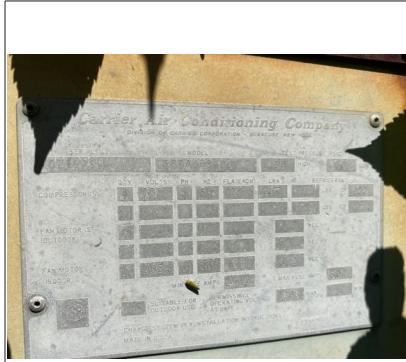
Unable to determine the exact age of exterior AC unit five. It appeared to be 45+ years old.

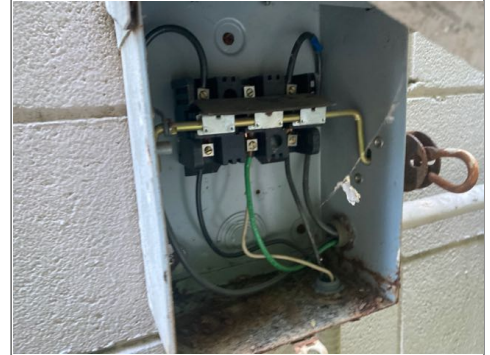
Dead front covers were not mechanically fastened to all of the electrical disconnect boxes for the exterior AC units. Recommend repair by qualified electrician.

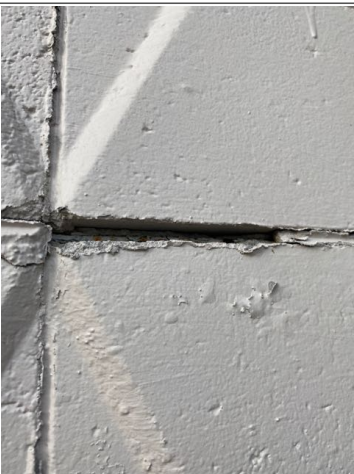
The block mortar needed to be re-pointed in several areas on the front side of the building. Recommend repair by qualified brick mason.

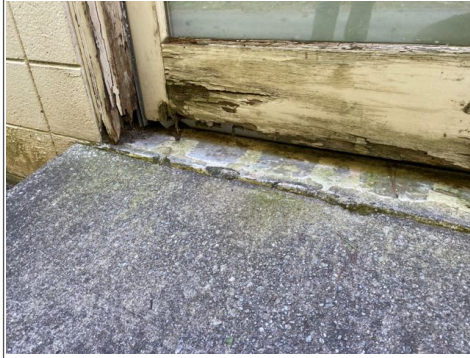
There was moisture damage on the door and door frame on the wooden door on the right side of the building. Recommend repair by qualified carpenter.

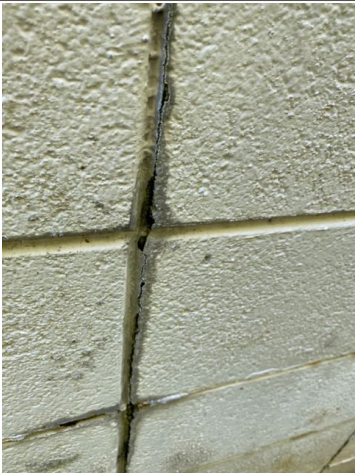
The block mortar needed to be re-pointed in several areas on the right side of the building. Recommend repair by qualified brick mason.

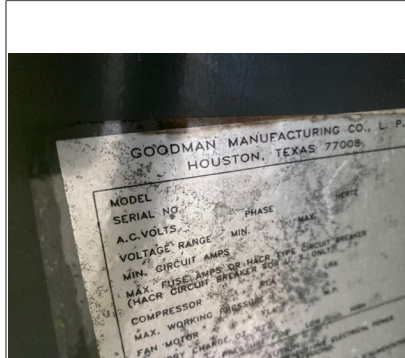
Unable to determine the exact age of exterior AC unit three because the manufacturer's data plate was faded. It appeared to be 12+ years old.

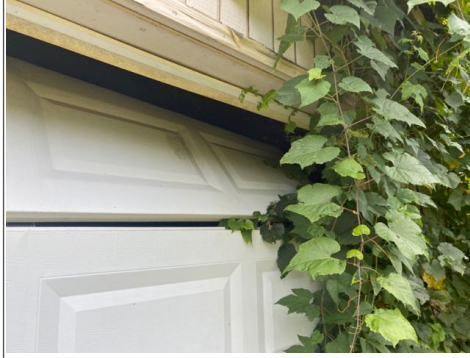
The rear left garage was in overall poor condition.

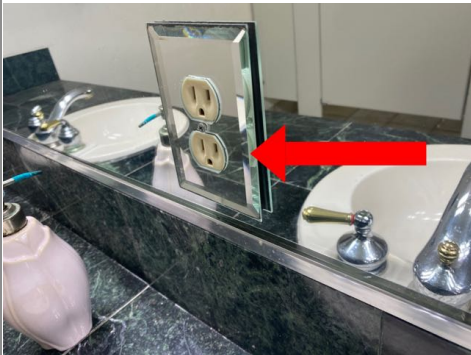
The electrical receptacles in the women's restroom were loose. Recommend repair by qualified electrician.

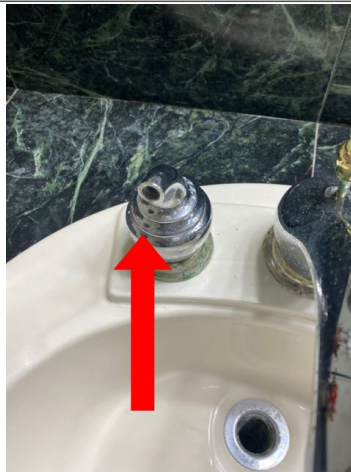
The hot water handle on the left sink in the women's bathroom was missing. Recommend repair by qualified plumber.

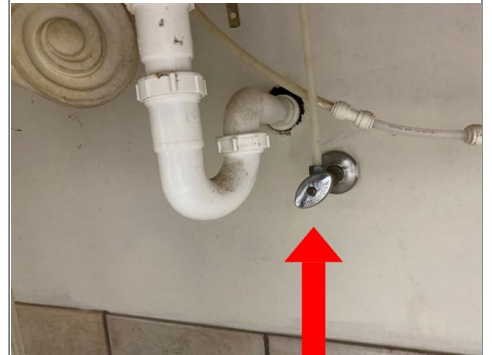
The water was turned off to the left sink in the women's restroom. It was not tested.

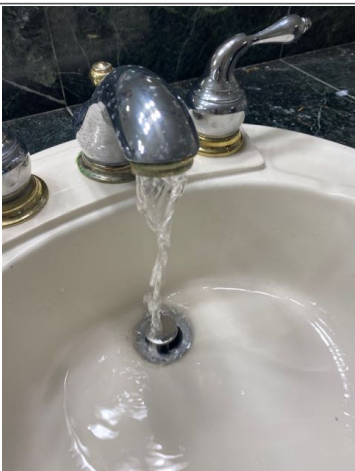
The hot water flow was poor in the women's restroom. Recommend repair by qualified plumber.

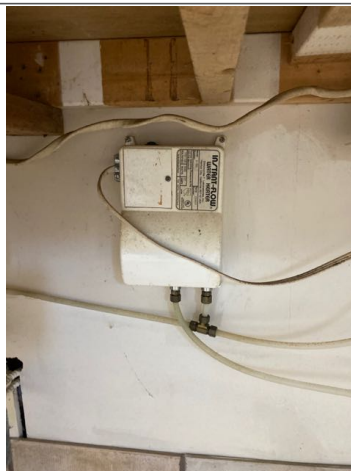
The water heater for the sinks in the women's bathroom did not appear to be working. Recommend repair by qualified plumber.

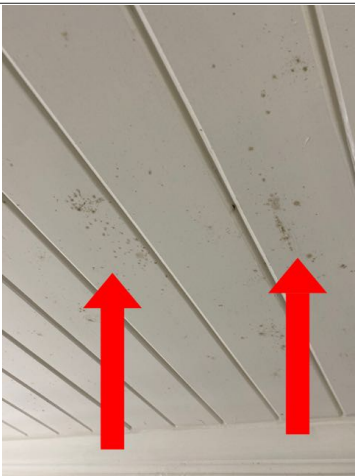
There was possible fungal growth on the ceiling in the women's bathroom. Recommend evaluation/repair by mold remediation specialist.

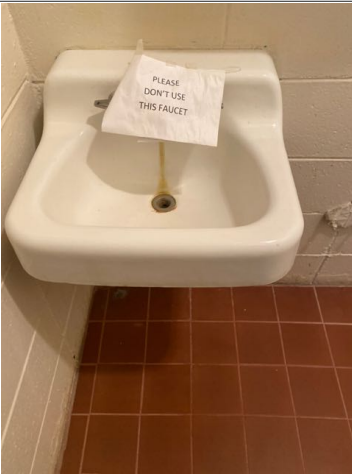
The rear utility sink was not functional.

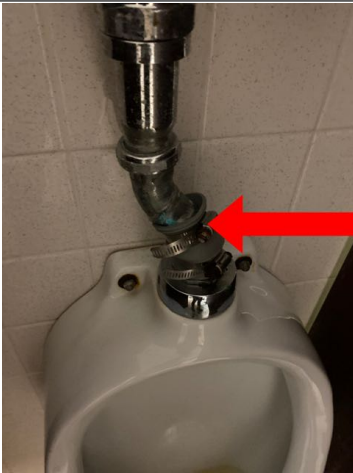
Both of the urinals in the men's bathroom were leaking. Recommend repair by qualified plumber.

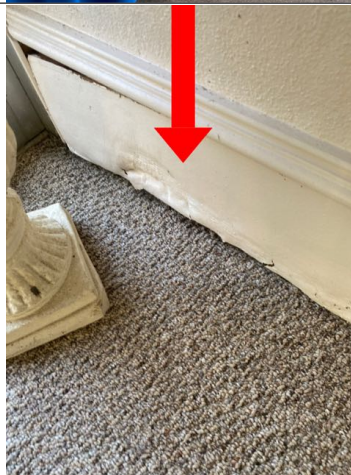
There was active moisture damage at the bottom of the rear walls in the front foyer. Recommend repair by qualified contractor.

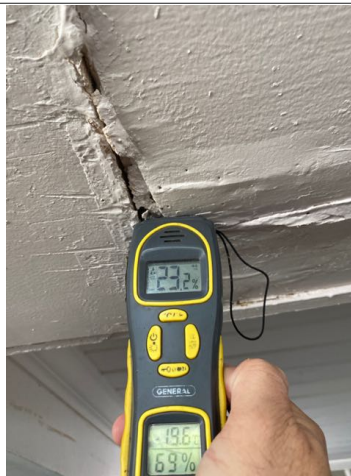
There was active moisture damage on the ceiling between the front entry and stairwell. Recommend repair by qualified contractor after the roof leaks are repaired.

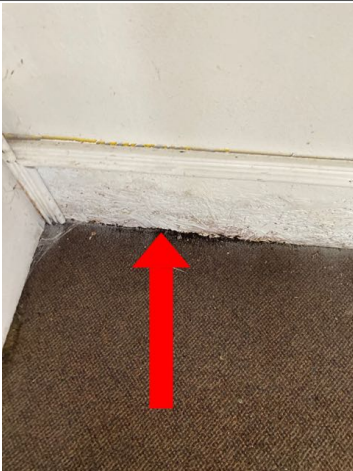
There was active moisture damage on the baseboards throughout the stairwell. Recommend repair by qualified contractor.

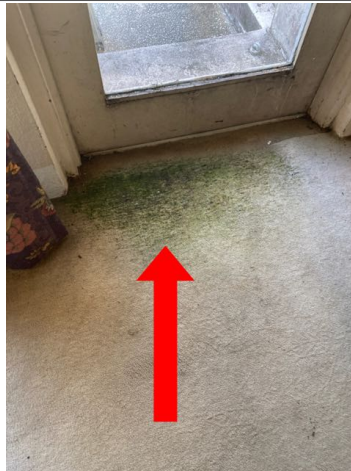
There was possible fungal growth on the floors in many areas in the sanctuary. Recommend evaluation/repair by mold remediation specialist.

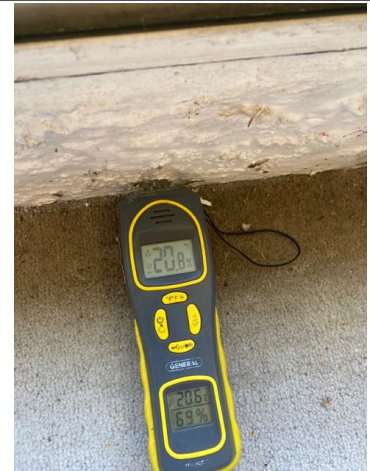
The moisture content was elevated in the walls below the windows in the chapel. Recommend repair by qualified contractor.

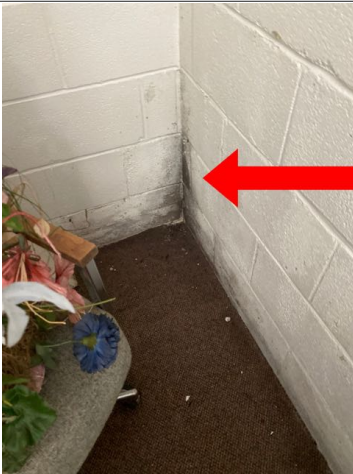
There was active moisture intrusion in the rear right corner of the building. Recommend repair by qualified contractor.

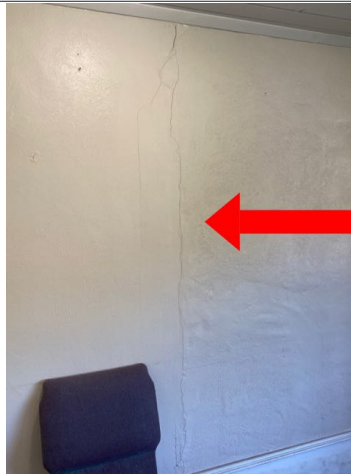
There was a crack in the front left wall of the sanctuary. No action recommended.

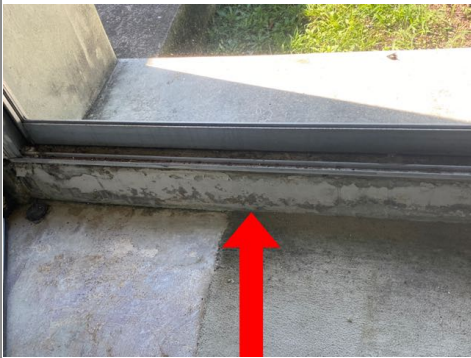
The moisture content was elevated in the walls below the windows in the police department. Recommend repair by qualified contractor.

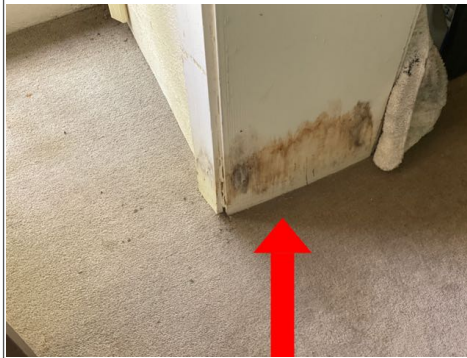
There was old moisture damage on the bottom of the trim on the left side of the Police Department closet.

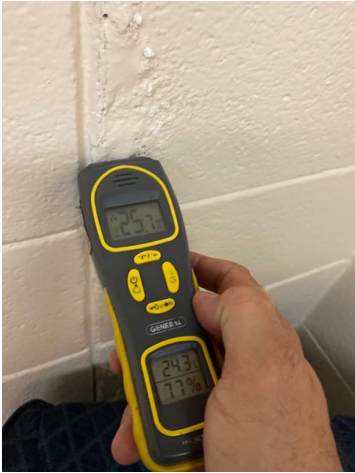
There were moisture stains on the front walls in several areas and the moisture content was elevated. Recommend repair by qualified contractor.

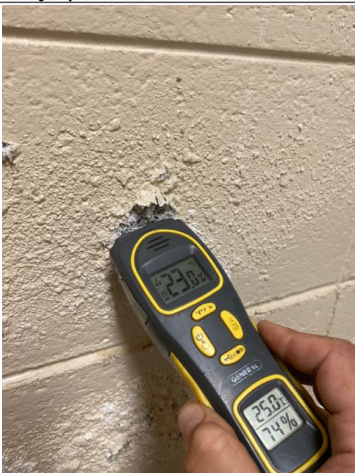
There were moisture stains on the left walls in several areas and the moisture content was elevated. Recommend repair by qualified contractor.

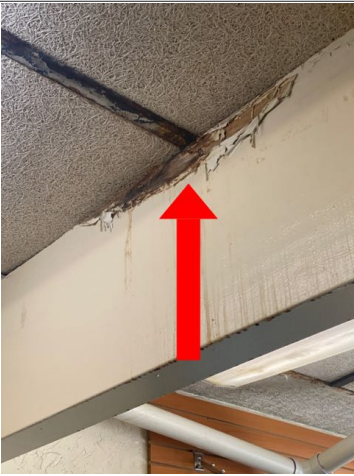
There was active moisture damage on the right beam in the bookstore. Recommend evaluation/repair by qualified contractor.

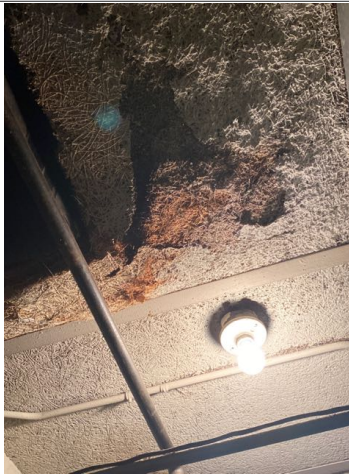
There was active moisture damage on the ceilings throughout the building. Recommend repair by qualified contractor.

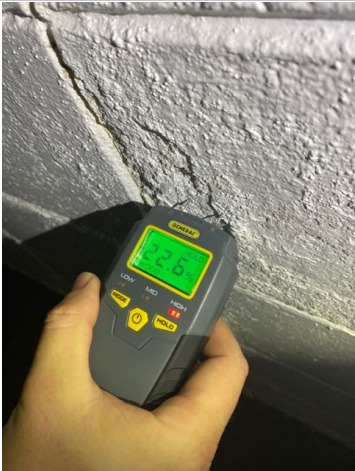
There was active moisture damage on the ceiling and walls in the front of the library. Recommend repair by qualified contractor after the roof is repaired.

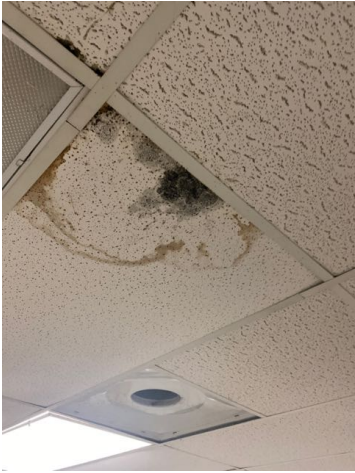
There was possible fungal growth on the ceiling throughout the building. Recommend evaluation/repair by mold remediation specialist.

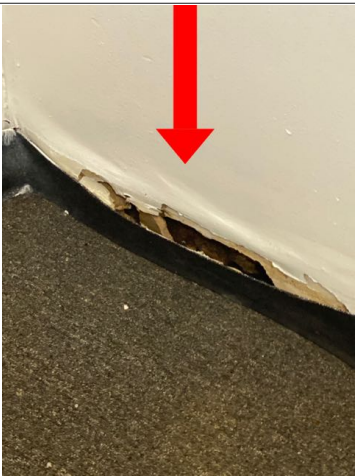
There was moisture damage on the bottom of the front wall in the upper right room from an active roof leak. Recommend repair by qualified contractor.

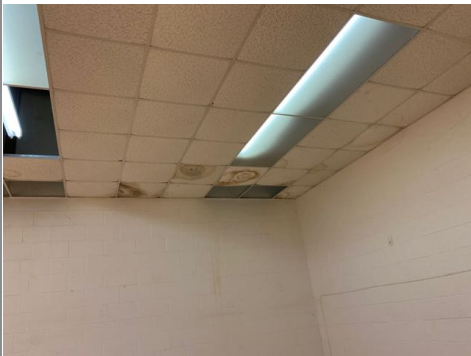
There were moisture stains on the ceiling in the rear right room but the moisture content was not elevated.

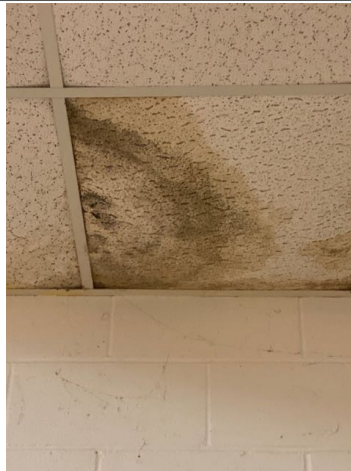
There was possible fungal growth on the ceiling tiles in the rear right room. Recommend evaluation/repair by mold remediation specialist.

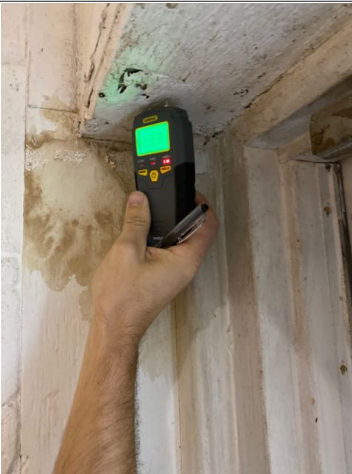
There was active moisture damage on the left side of the rear left entry doors. Recommend repair by qualified contractor.

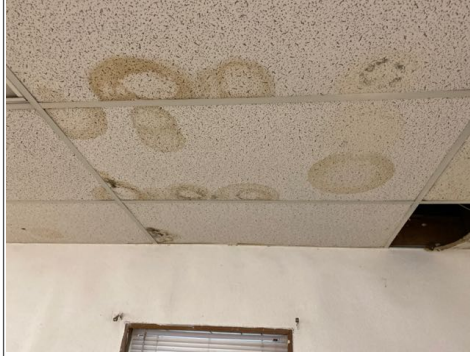
There was active moisture damage on the rear ceiling in the rear left room. Recommend repair by qualified contractor after the roof leaks are repaired.

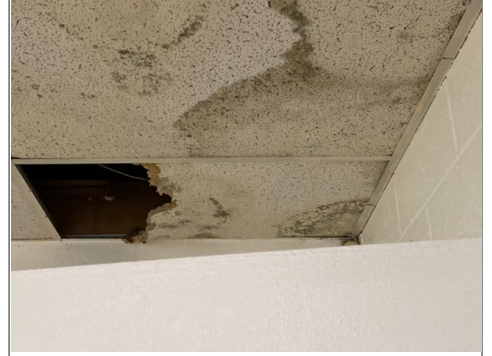
There was possible fungal growth on the ceiling in the rear left room. Recommend evaluation/repair by mold remediation specialist.

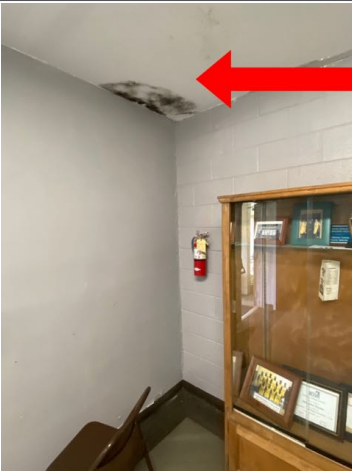
There was active moisture damage on the wall and ceiling in the front left room. Recommend repair by qualified contractor after the roof leak is repaired.

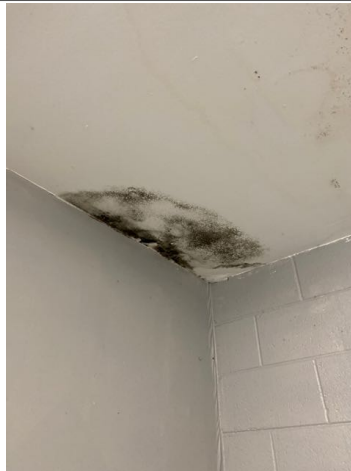
There was possible fungal growth on the ceiling in the front left room. Recommend evaluation/repair by mold remediation specialist.

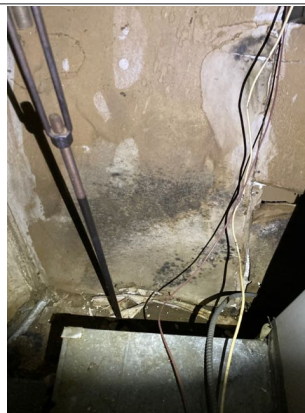
There was possible fungal growth on the attic walls. Recommend evaluation/repair by mold remediation specialist.

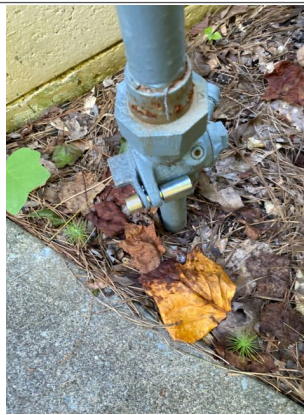
The gas meter was locked.

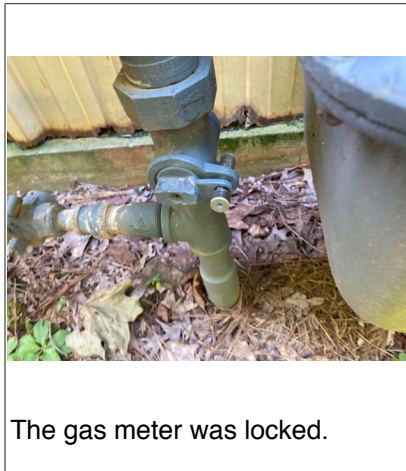
The gas meter was locked.

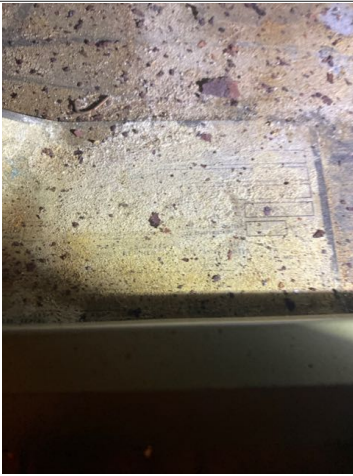
Unable to determine the exact age of furnace four because the manufacturer's data plate was not legible. It appeared to be 40+ years old.

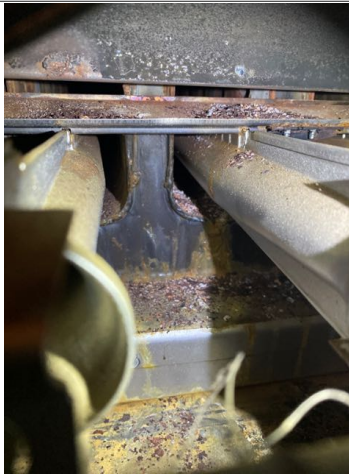
There was heavy corrosion inside furnace four. Recommend evaluation by qualified HVAC technician.

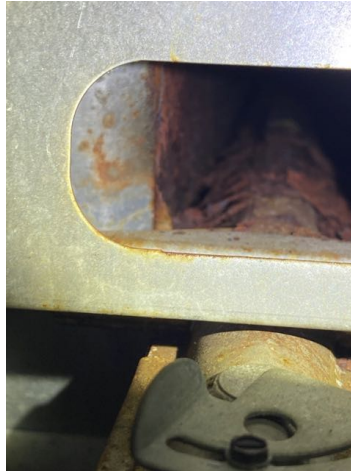
The interior of furnace two was heavily corroded. Recommend evaluation/repair by qualified HVAC technician.

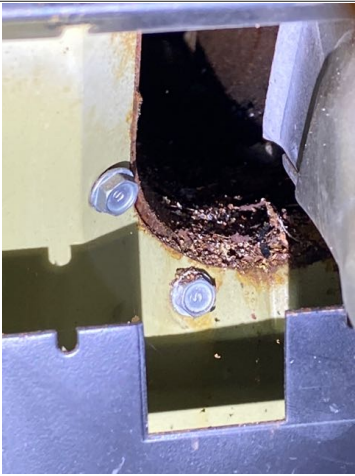
The interior of furnace four was heavily corroded. Recommend evaluation/repair by qualified HVAC technician.

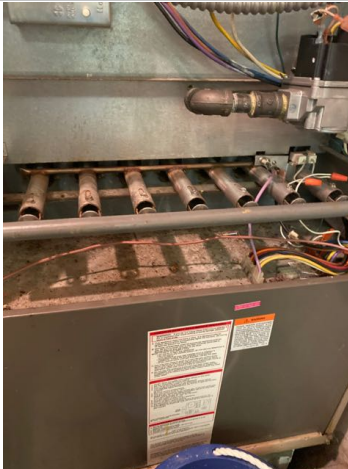
Furnace one would not ignite using the thermostat. Recommend repair by qualified HVAC technician.

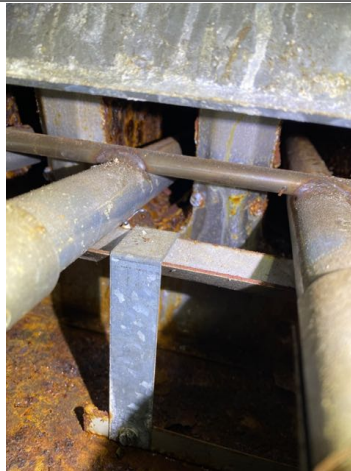
There was heavy corrosion inside furnace two. Recommend evaluation/repair by qualified HVAC technician.

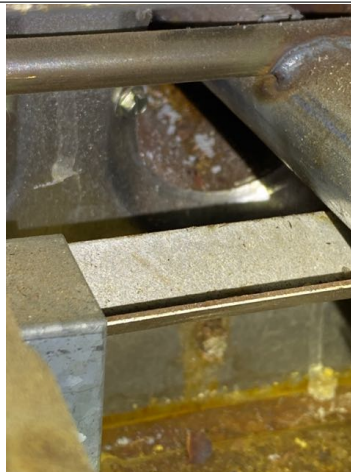
There was heavy corrosion inside furnace three. Recommend evaluation/repair by qualified HVAC technician.

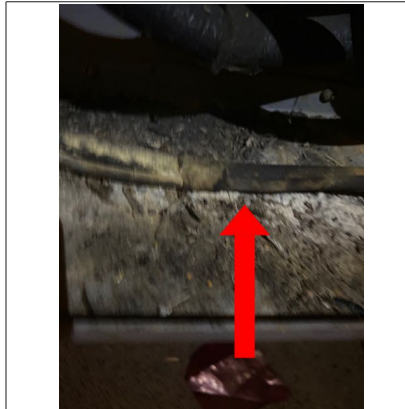
Wires in the bottom of the main electrical panel appeared to be scorched. Recommend evaluation by qualified electrician.

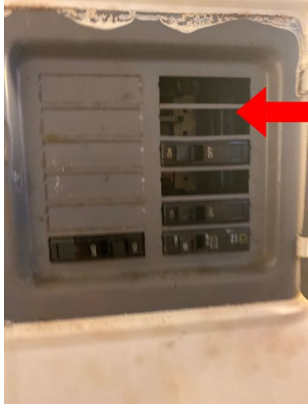
Several breaker filler plates were missing in electrical sub panel two. Recommend repair by qualified electrician.

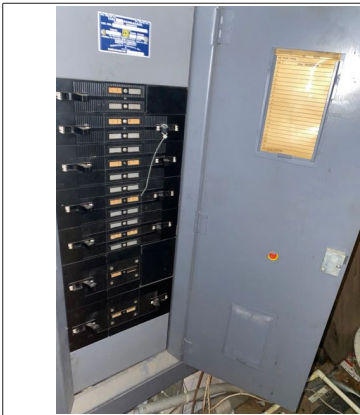
Recommend labeling all of the breakers in the electrical sub panel four.

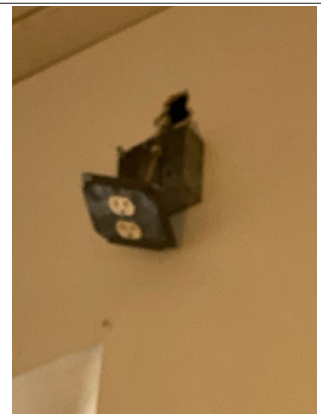
The upper electrical receptacle on the rear wall of the sanctuary was not securely attached. Recommend repair by qualified electrician.

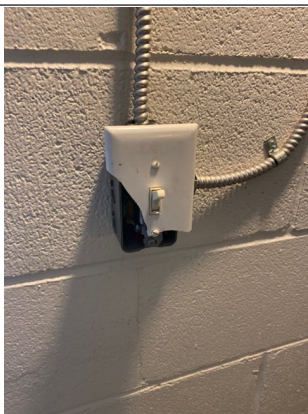
Recommend replacing the cover plate on the light switch on the rear left wall of the sanctuary.

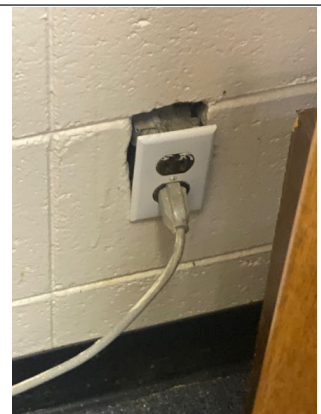
The electrical receptacle on the front wall of the conference room was not securely attached. Recommend repair by qualified electrician.

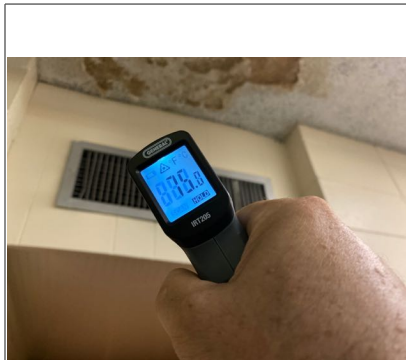
Condition  Poor  Recommend HVAC technician examine/clean/service

Air conditioning system two was not cooling properly. Recommend repair by qualified HVAC technician.

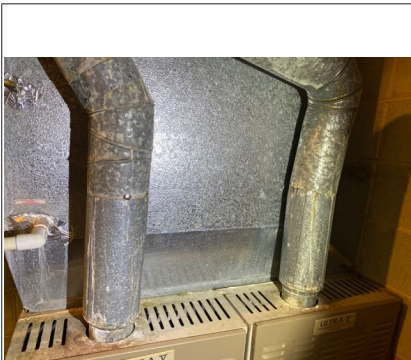
Unable to determine the age of interior AC unit five because the manufacturer's data plate was not visible.

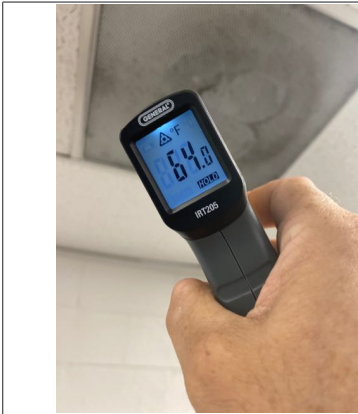
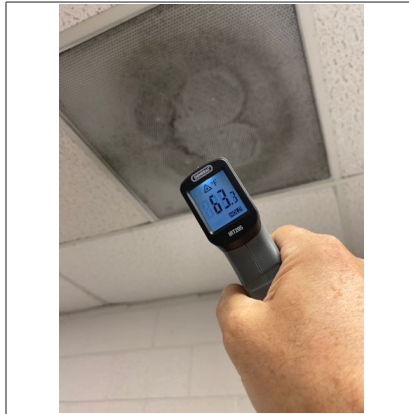
Several of the air conditioning systems were not cooling properly. Recommend repair by qualified HVAC technician.

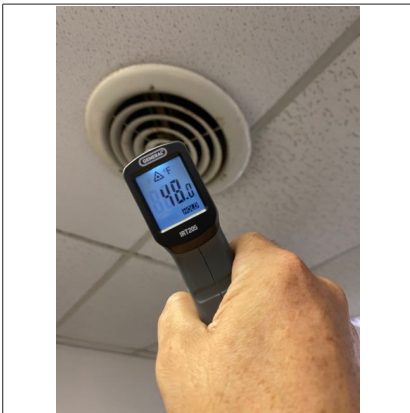
**Condition**  Marginal  Recommend HVAC technician examine/clean/service

System two air conditioning temperature at register

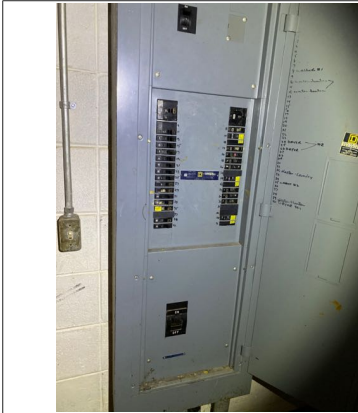
Main electrical panel located in laundry room

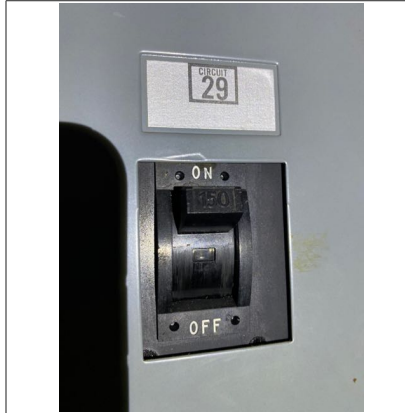
Main electrical disconnect one

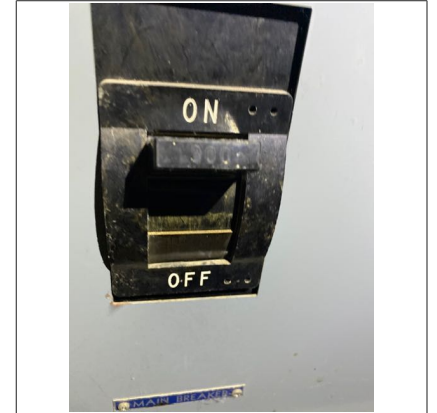
Main electrical disconnect two
