Investor Inspection Report

Fulmar Dr, Irondale , Alabama 35210

Inspection Date: Tuesday,
February 11, 2020

Report Number:
211201

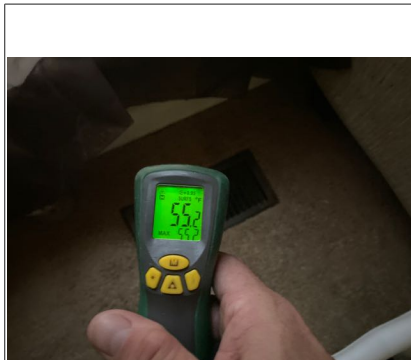
Air conditioning temperature at register for 4928

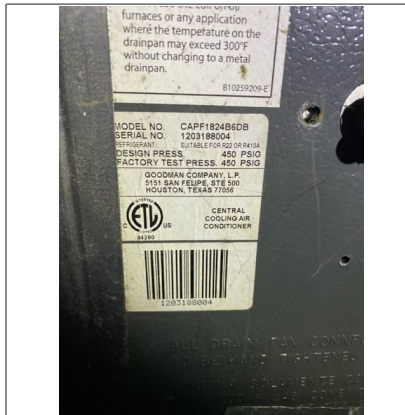
Interior AC unit for 4928
