New Construction Inspection Report

5608 Brayden Circle, Lot 3081

Monday, July 6, 2020

Report Number:

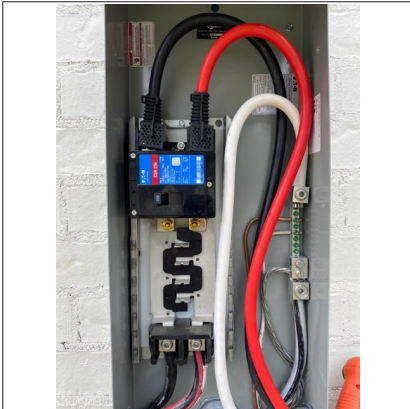
Location Right side of house
Condition Satisfactory
Adequate Clearance to Panel Yes
Amperage/Voltage 200a
Breakers/Fuses Breakers
Appears grounded Yes
GFCI breaker Yes Operable: Yes
AFCI breaker Yes Operable: Yes
Main wire Aluminum Condition: Satisfactory
Branch wire Copper
Branch wire condition Satisfactory Romex
Photos

Interior of main electrical panel one located on right side of house

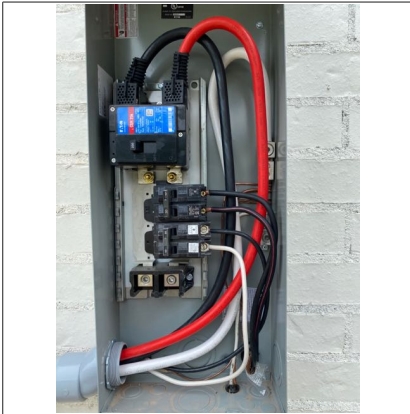
Location Right side of house
Condition Satisfactory
Amperage/Voltage 200a
Adequate Clearance to Panel Yes
Breakers/Fuses Breakers
Appears grounded Yes
GFCI breaker No
AFCI breaker No
Main wire Aluminum Condition: Satisfactory
Branch wire condition Satisfactory Romex
Branch wire Copper

Interior of main electrical panel
two located on right side of house

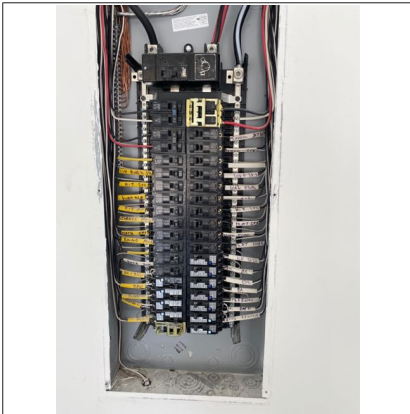
Location(s) Location 1:Garage
Branch wire Copper Neutral/ground separated: Yes Neutral isolated: Yes
Condition Satisfactory

Interior of electrical sub panel
located in garage

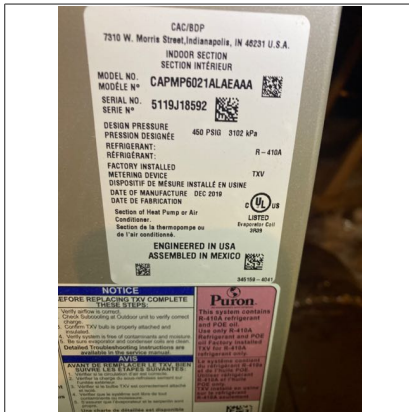
General Central system
Location:Attic
Age:New
Evaporator coil Not Visible
Refrigerant lines Satisfactory
Condensate line/drain To exterior
Secondary condensate line/drain Present: Yes
Operation Differential: 18 degrees
Condition Satisfactory
Brand Carrier

Interior AC unit one

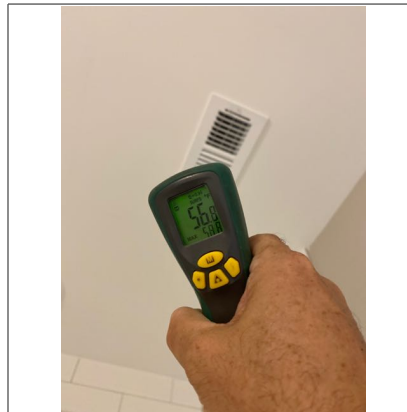
Air conditioning system one temperature at register

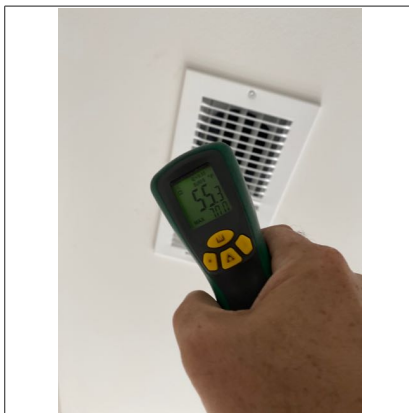
Air conditioning system two temperature at register
