Pre-Listing Inspection Report

229 Nesbitt Dr NE, Atlanta, GA 30319

Thursday, February 20, 2020

022120

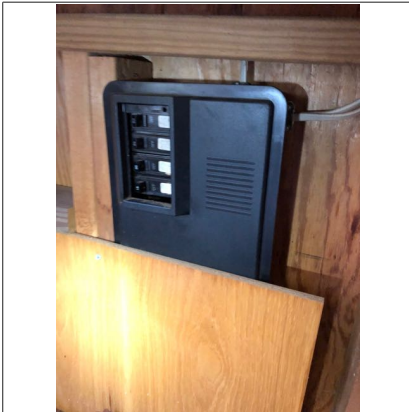
Small sub panel located in shed.
