## Commerical Inspection Report

**3870 Cascade Rd, Atlanta, GA 30331**

Monday, September 21, 2020

921201

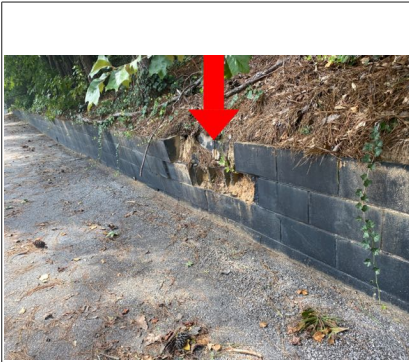
The block retaining wall on the right side of the main entrance was damaged in several areas and leaning. Recommend repair by qualified contractor.

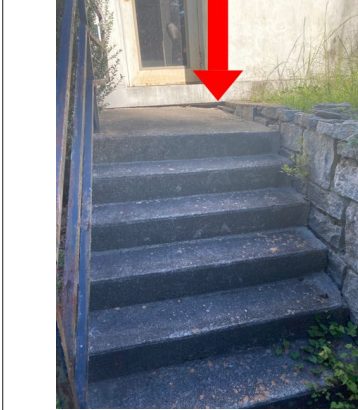
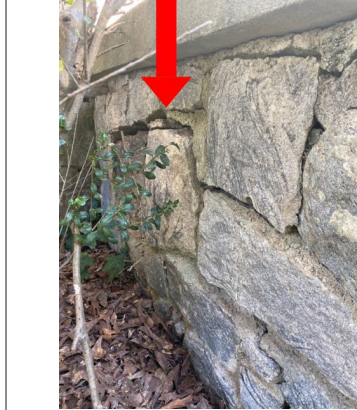
1. The grading was negative on the front side of the building and surface water appear to be entering through the entry doors. Recommend repair by qualified contractor.
2. The steps on the right side of the building had settled significantly. Recommend evaluation/repair by qualified contractor.

The steps on the right side of the building had settled significantly. Recommend evaluation/repair by qualified contractor.

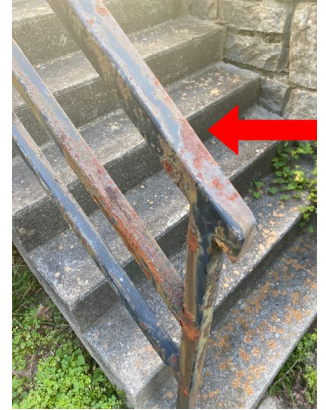
There was corrosion on the handrail for the steps on the right side of the building. Recommend painting.

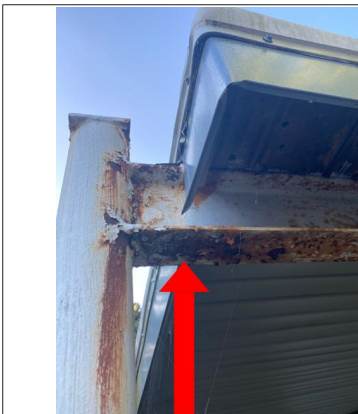
There was corrosion on the support for the overhang on the front left side of the building. Recommend painting.

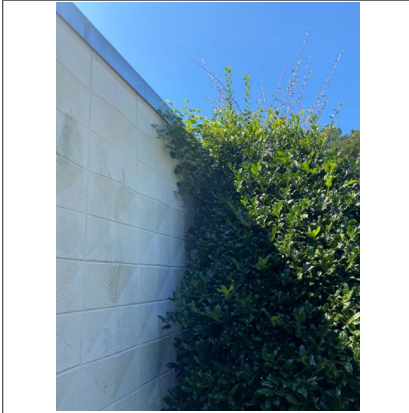
Recommend cutting the vegetation back from the building.

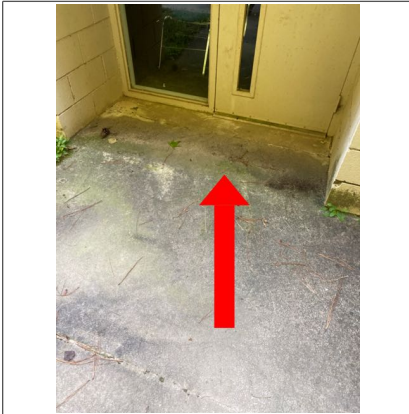
The grading was negative on the right side of the building in front of the rear entry door. Recommend evaluation/repair by qualified contractor.

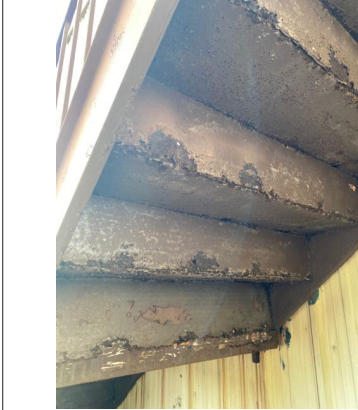
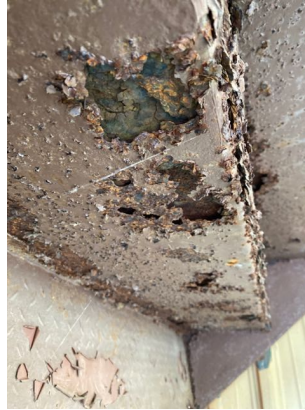
1. The stairs on the front side of the building were heavily corroded and were not safe for use. Recommend repair by qualified contractor.

The stairs on the front side of the building were heavily corroded and were not safe for use. Recommend repair by qualified contractor.

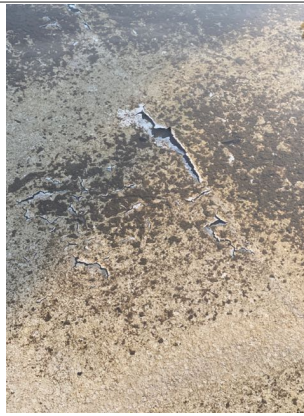
The rolled roofing was in overall poor condition due to cracking and granular loss. All of the seams needed to be resealed, and the sealant between the sections of roofing was in poor condition. Recommend repair by qualified roofer.

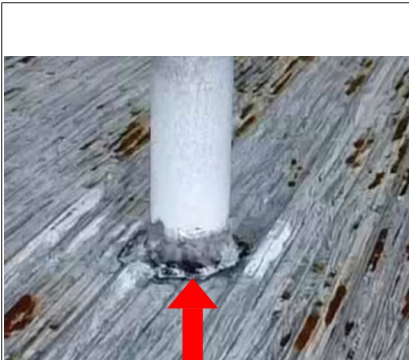
The sealant around the roof penetrations was in poor condition and pipe boots were not installed on the plumbing vents. Recommend repair by qualified roofer.

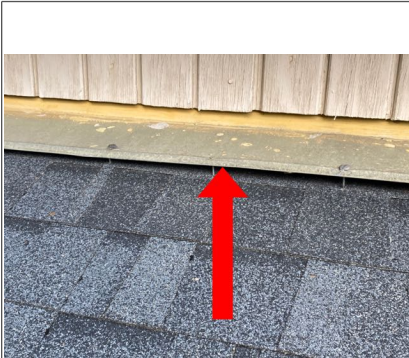
The flashing below the upper roof  
 needed to be re-nailed.  
 Recommend repair by qualified  
 roofer.

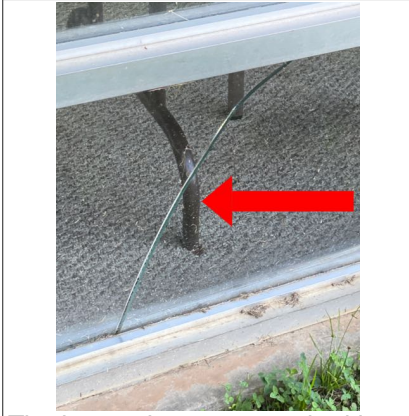
The lower glass was cracked in the window on the front left side of the building. Recommend repair by qualified carpenter.

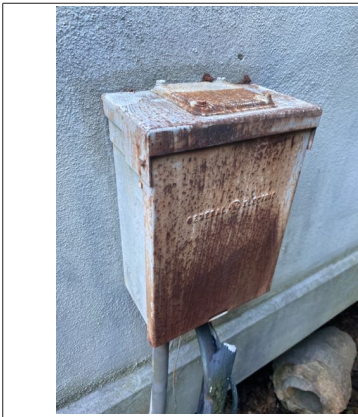
There was corrosion on the electrical disconnect box for exterior AC unit one. Recommend painting.

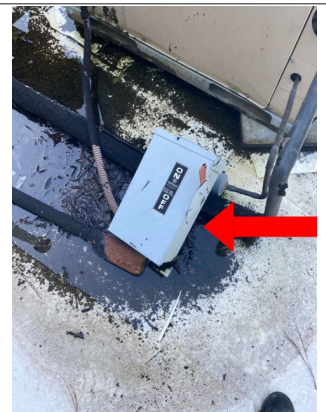
The electrical disconnect box for exterior AC unit two was not safely installed. Recommend repair by qualified electrician.

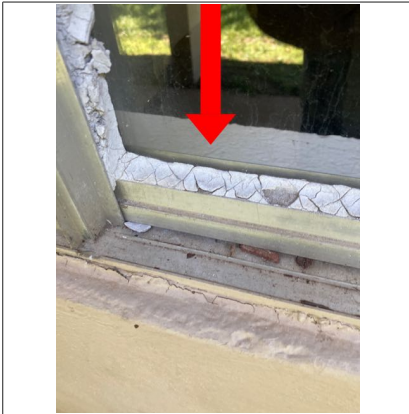
The vinyl window glazing was in poor condition on several of the windows on the right side of the building. Recommend repair by qualified carpenter.

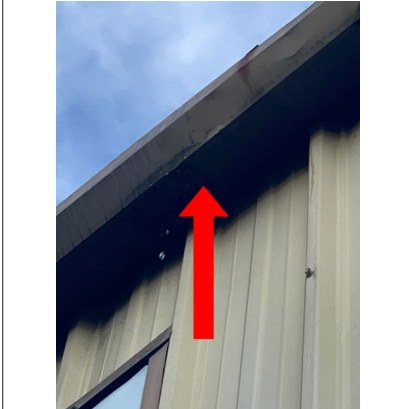
The gutters were in overall poor condition due to corrosion. Recommend repair by qualified contractor.

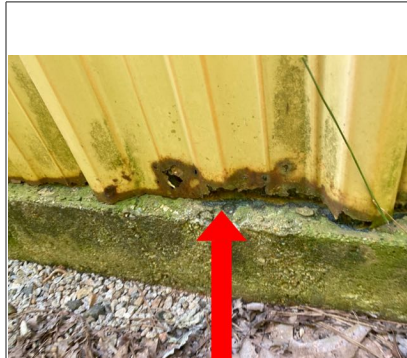
There was corrosion on the bottom of the siding on the right and rear sides of the building. Recommend repair by qualified contractor.

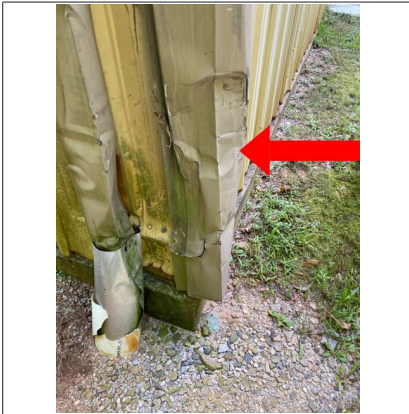
The lower siding and trim was damaged on the rear right corner of the building. Recommend repair by qualified contractor.

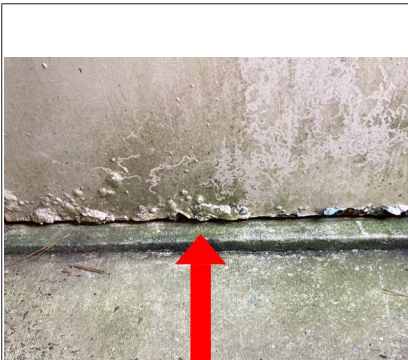
The bottom of the rear door on the left side of the building was in poor condition. Recommend repair by qualified carpenter.

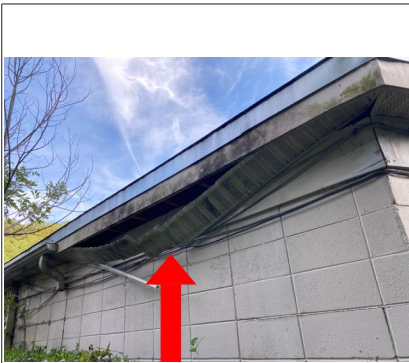
The soffit was damaged on the right side of the building. Recommend repair by qualified carpenter.

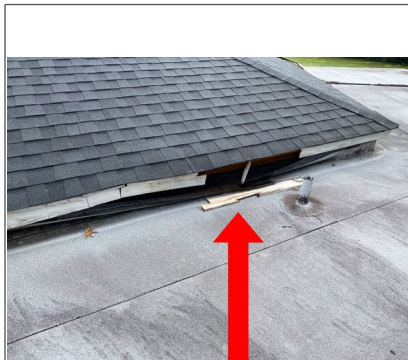
The wooden fascia was damaged on the right side of the building. Recommend repair by qualified carpenter.

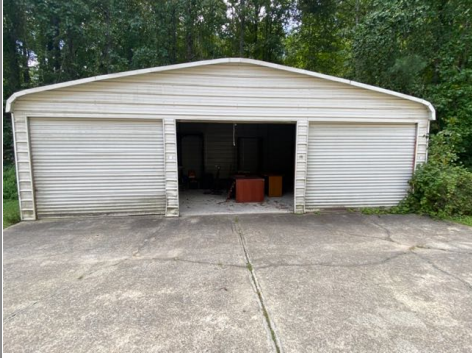
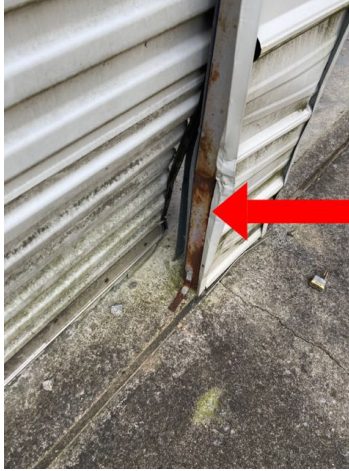
The far left overhead door was damaged and the supports next to the overhead doors were damaged. Recommend repair by qualified contractor.

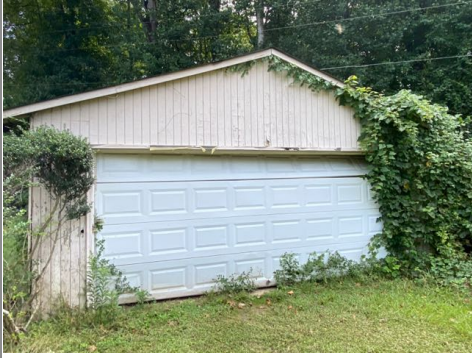
The rear left garage was in overall poor condition.

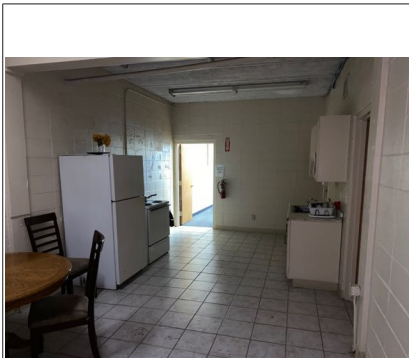
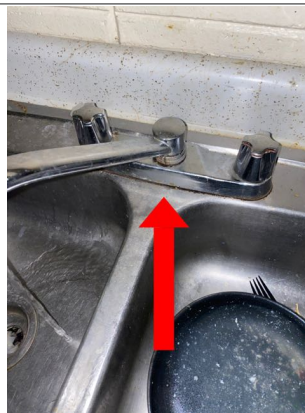
The sink faucet was leaking and was not securely attached. Recommend repair by qualified plumber.

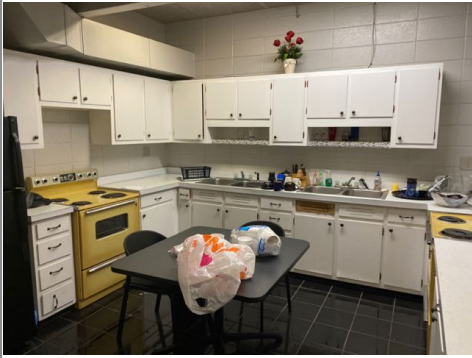
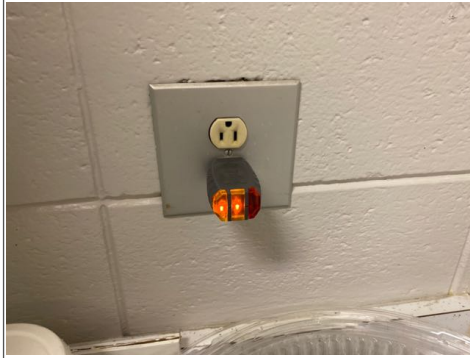
The electrical receptacles next to the sink were not GFCI protected. Recommend repair by qualified electrician.

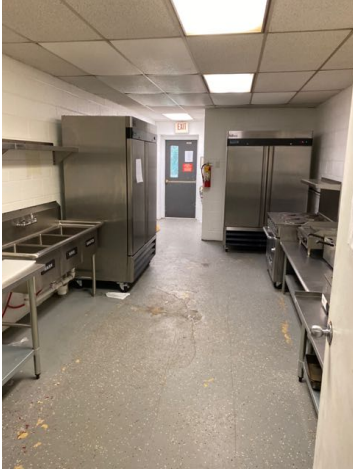
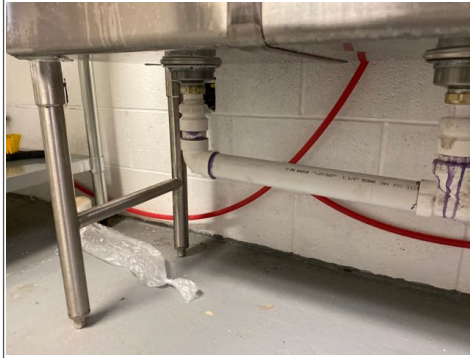
P traps were not installed underneath the sinks. Recommend repair by qualified plumber.

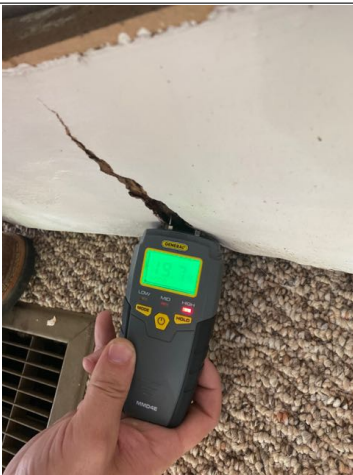
There was active moisture damage at the bottom of the rear walls in the front foyer. Recommend repair by qualified contractor.

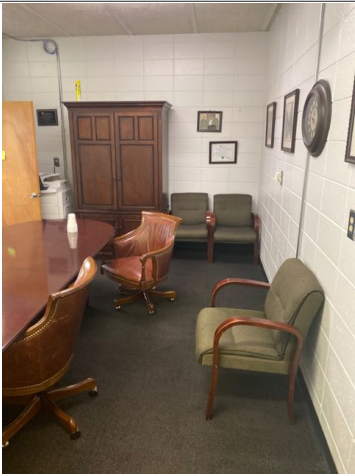
The front electrical receptacles on the left wall of the library we're not working. Recommend repair by qualified electrician.

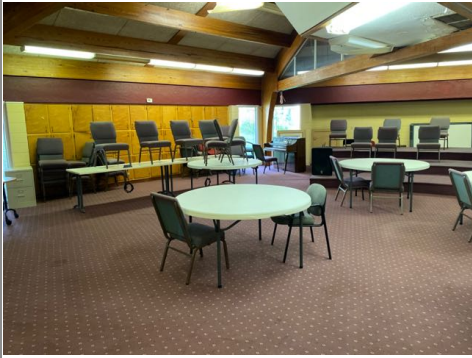
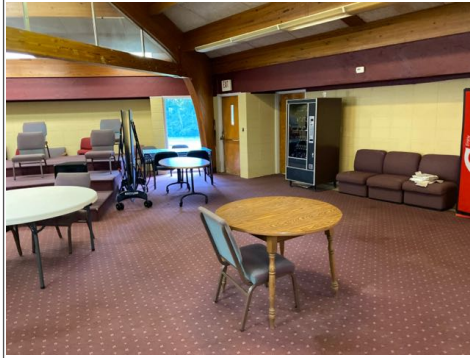
There were several moisture stains on the ceiling and the moisture content was elevated. Recommend repair by qualified contractor.

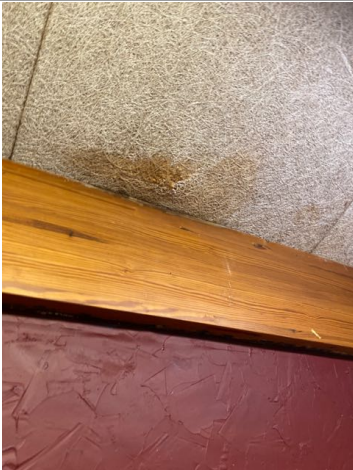
There were several moisture stains on the ceiling and the moisture content was elevated. Recommend repair by qualified contractor.

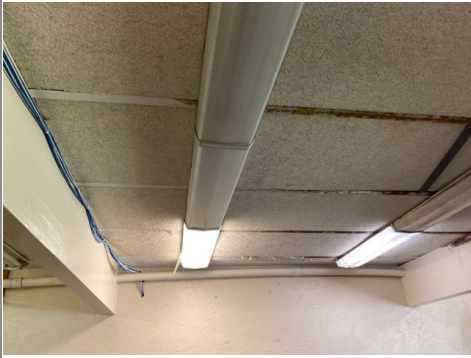
Several light fixtures throughout the building were not working.

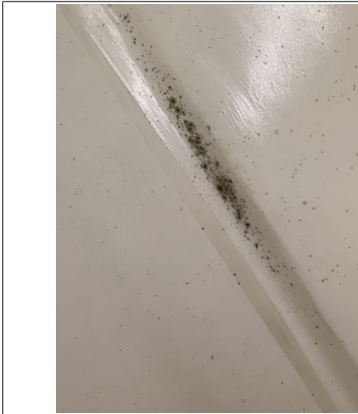
There was possible fungal growth on the ceiling insulation in many areas. Recommend evaluation/repair by mold remediation specialist.

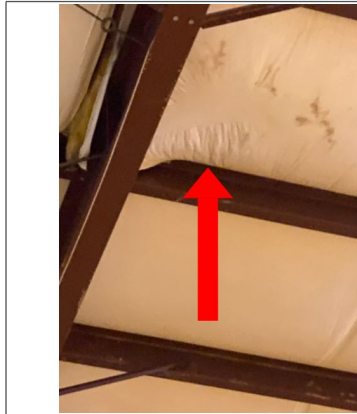
The ceiling insulation was damaged in several areas and there were moisture stains present. Recommend repair by qualified contractor after the roof leaks are repaired.

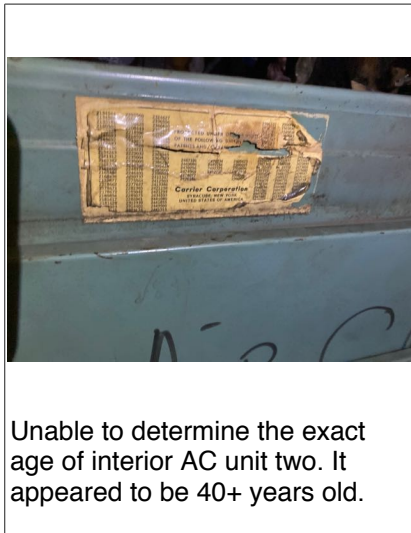
Unable to determine the exact age of interior AC unit two. It appeared to be 40+ years old.

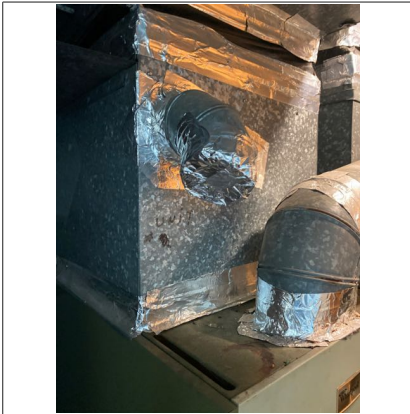
Unable to determine the age of interior AC unit three because the manufacturer's data plate was not visible.

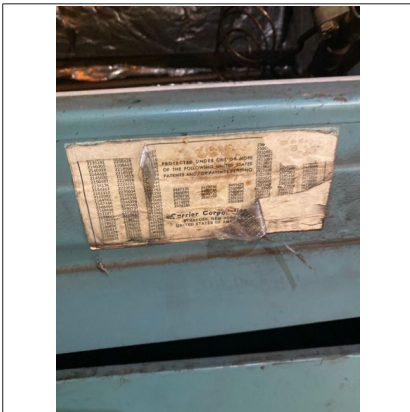
Unable to determine the exact age of interior AC unit four. It appeared to be 40+ years old.
