Investor Inspection Report

Fulmar Dr, Irondale , Alabama 35210

Inspection Date: Tuesday,
February 11, 2020

Report Number:
211201

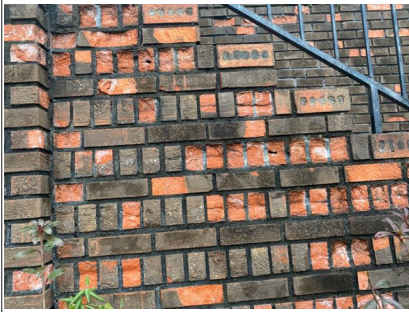
Brick spalling was occurring in many areas around the front porches, and the brick mortar needed to be repointed in several areas. Recommend repair by qualified brick mason.

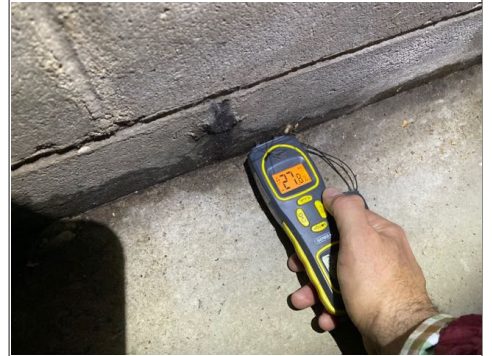
There was active moisture intrusion in the foundation wall on the front right corner and on the left side of the laundry area for 4928. Recommend repair by waterproofing specialist.

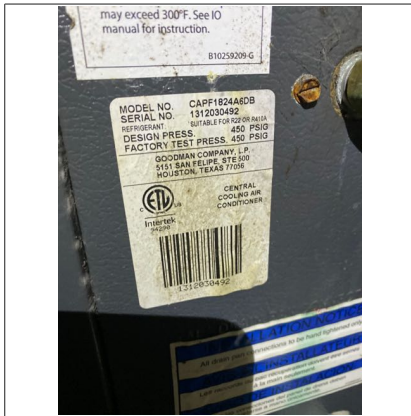
Interior AC unit for 4926
