Pre-Listing Inspection Report

229 Nesbitt Dr NE, Atlanta, GA 30319

Thursday, February 20, 2020

022120

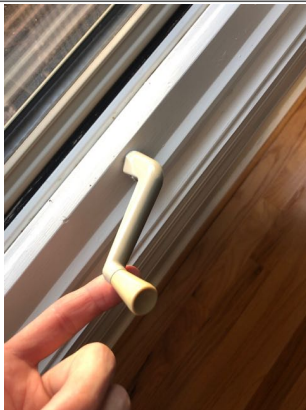
Multiple crank handles for the windows were worn out. Recommend replacing them.

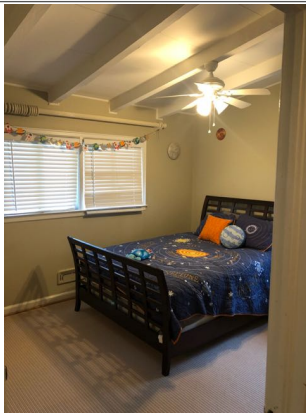
The electrical receptacles in the bedroom had an open ground. Recommend repair by qualified electrician.

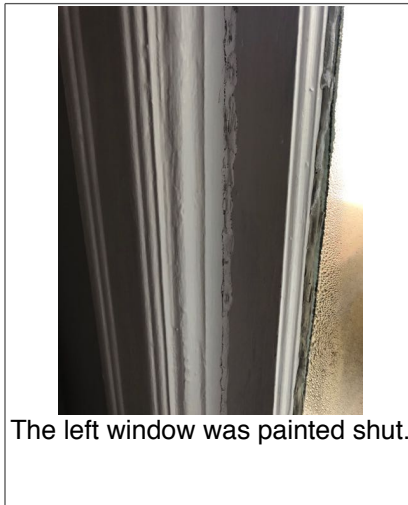
The left window was painted shut.

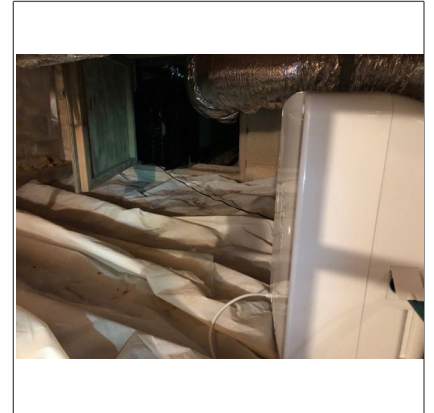
Water entering crawlspace on right rear corner. Additional backfill on the exterior of this area will likely solve the issue.
