Home Inspection Report

2699 Whispering Pine Dr, Montgomery , Alabama 36116

Monday, November 2, 2020

Ally Property Inspections
PO Box 43302
Vestavia Hills , AL 35243
2057905510

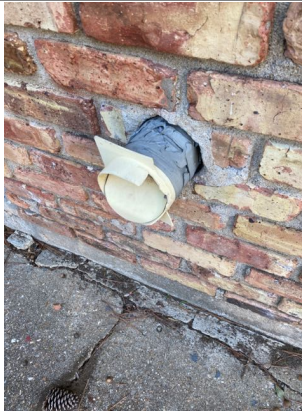
The dryer vent cover on the left side of the house was damaged. Recommend replacement.

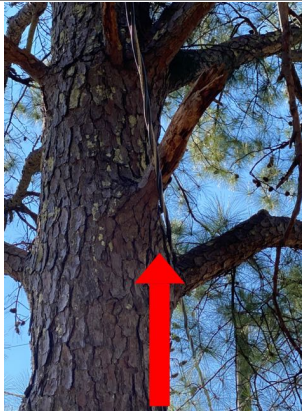
1. The main electrical service cable was in contact with a tree. Recommend contacting the power utility company regarding removal.
2. The sashes were not securely attached in the storm window on the right side of the house. Recommend repair by qualified carpenter.
3. The electrical receptacle on the rear side of the house was not GFCI protected and was not safe for outdoor use. Recommend repair by qualified electrician.

The main electrical service cable was in contact with a tree. Recommend contacting the power utility company regarding removal.

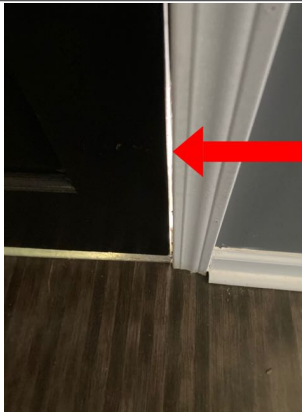
Recommend installing additional weatherstripping on the main entry door.

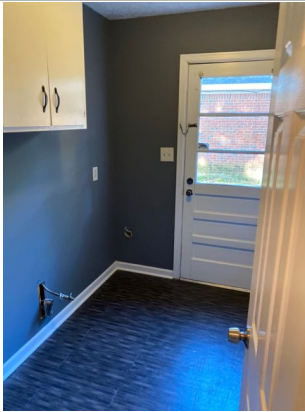
1. Recommend attaching the electrical receptacle for the dryer to the wall.

Recommend attaching the electrical receptacle for the dryer to the wall.

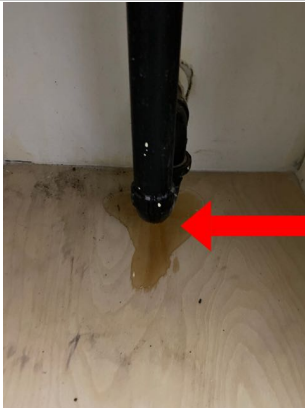
1. The sink drain was leaking. Recommend repair by qualified plumber.

The sink drain was leaking. Recommend repair by qualified plumber.

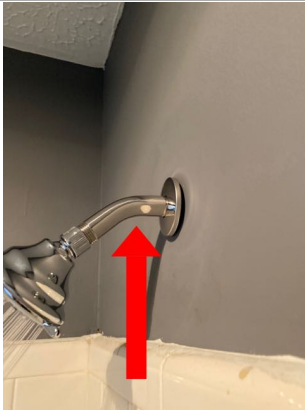
The shower spout was loose. Recommend repair by qualified plumber.

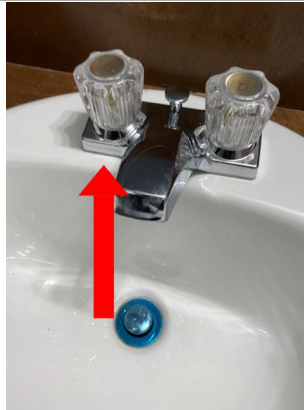
The left sink faucet was not securely attached. Recommend repair by qualified plumber.

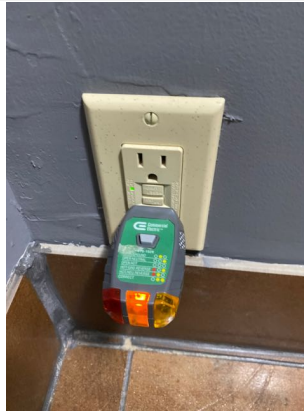
1. The electrical receptacle next to the bar sink was not grounded but was GFCI protected which makes the receptacle safer but there is no protection for electrical equipment connected to the receptacle. Recommend installing a label on the receptacle stating "no equipment ground".

The electrical receptacle next to the bar sink was not grounded but was GFCI protected which makes the receptacle safer but there is no protection for electrical equipment connected to the receptacle. Recommend installing a label on the receptacle stating "no equipment ground".

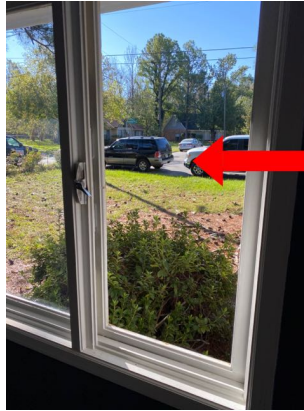
1. The glass was missing in the left window. Recommend repair by qualified carpenter.

The glass was missing in the left window. Recommend repair by qualified carpenter.

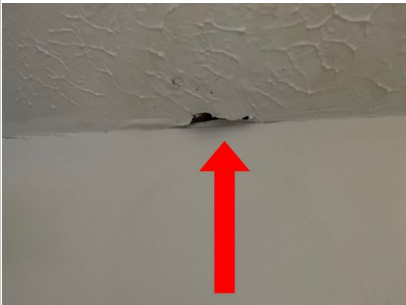
There was a hole in the front of the closet ceiling that was open to the attic. Recommend repair by qualified carpenter.

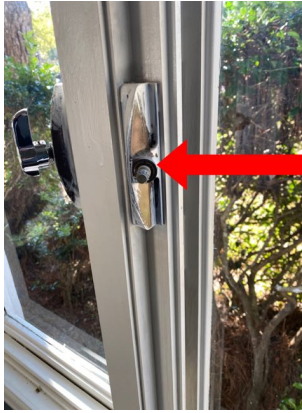
Window opening hardware was missing on the front left window. Recommend repair by qualified carpenter.

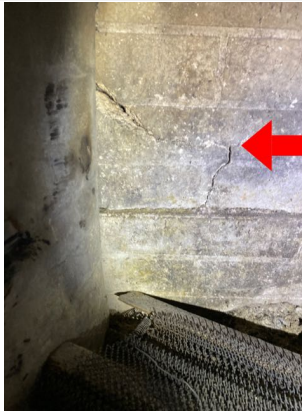
There were cracks in the rear wall of the fireplace box. Recommend repair by qualified chimney sweep.

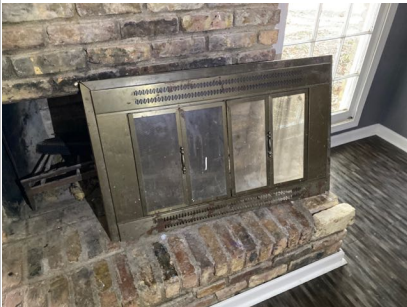
The fireplace doors were not attached. Recommend repair by qualified chimney sweep.

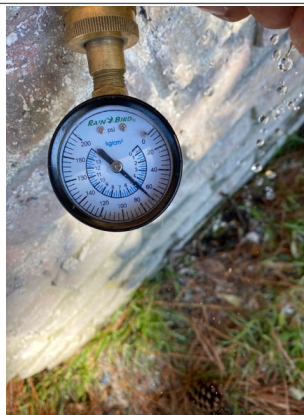
The water pressure was approximately 70 psi

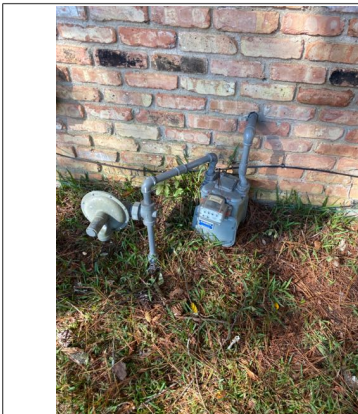
Main fuel shut off and gas meter located on right side of house

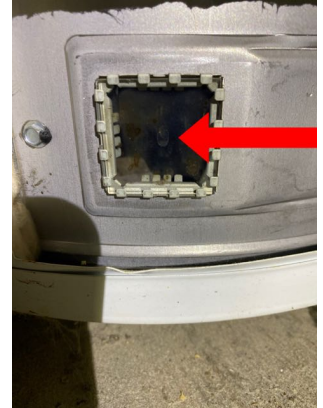
The water heater was not tested because the pilot was not lit.

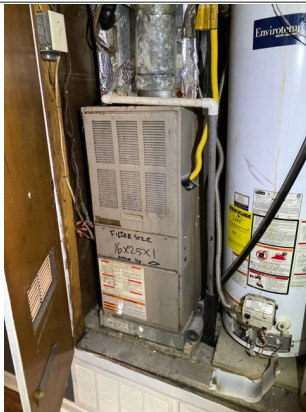
Interior HVAC system located in utility closet

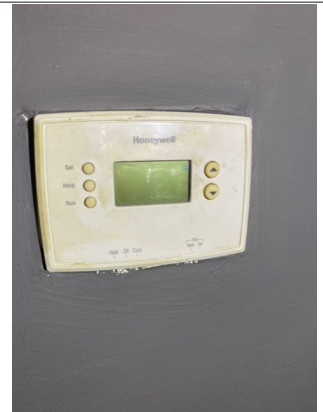
The system was not tested because the thermostat was not working.

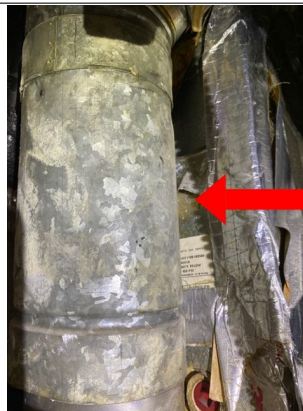
The vent pipe for the furnace was not securely attached and was in contact with the ductwork. Recommend repair by qualified HVAC technician.

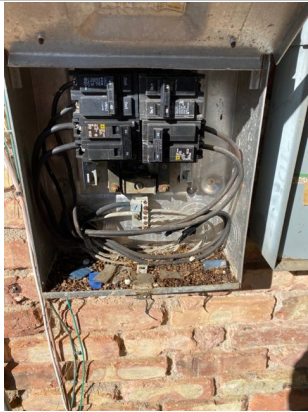
Interior of main electrical panel located on right side of house

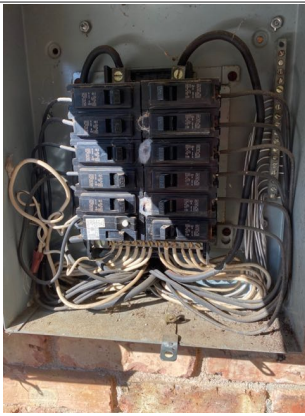
Branch wire ☒ Aluminum ☒ Safety hazard Neutral/ground separated: ☒ Yes Neutral isolated: ☒ Yes

Interior of electrical sub panel located on right side of house
